Feasibility/Alternatives Analysis Report Montgomery Dam, Megunticook River Camden, ME

May 3, 2019

Town of Camden,
Maine

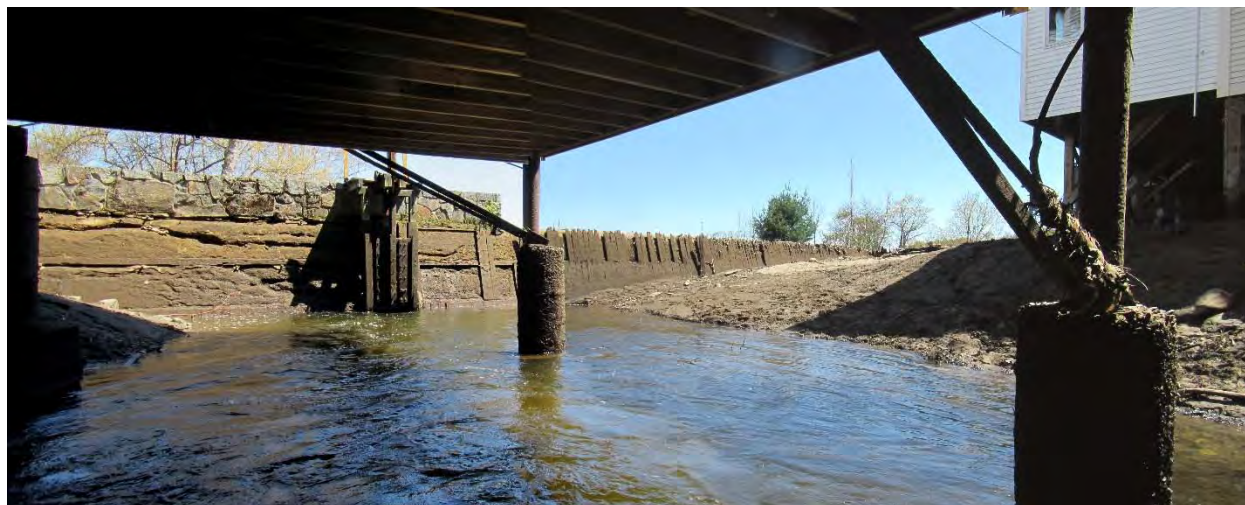
As it exists today, Montgomery dam is a mass gravity, cut-stone and concrete dam, founded on bedrock. The primary spillway forms a right angle and discharges in two directions down a bedrock cascade directly to Camden Harbor. The height of the dam varies between 12 feet at the low-level outlet control structure and 3 feet at the river right (west) side of the spillway. The primary spillway is a 2-foot wide, broad-crested weir 75 feet in length along the long face (south) and 25 feet in length along the short face (west). The spillway section is in a degrading condition, with the concrete/bedrock foundation interface considered to be in poor condition (GEI Consultants 2015).

Figure 21. View of lower impoundment in drawn down condition, May 8, 2018. Non-overflow portion of dam and headgate at left half of image, spillway at right half of image. Normal pool elevation at spillway crest.

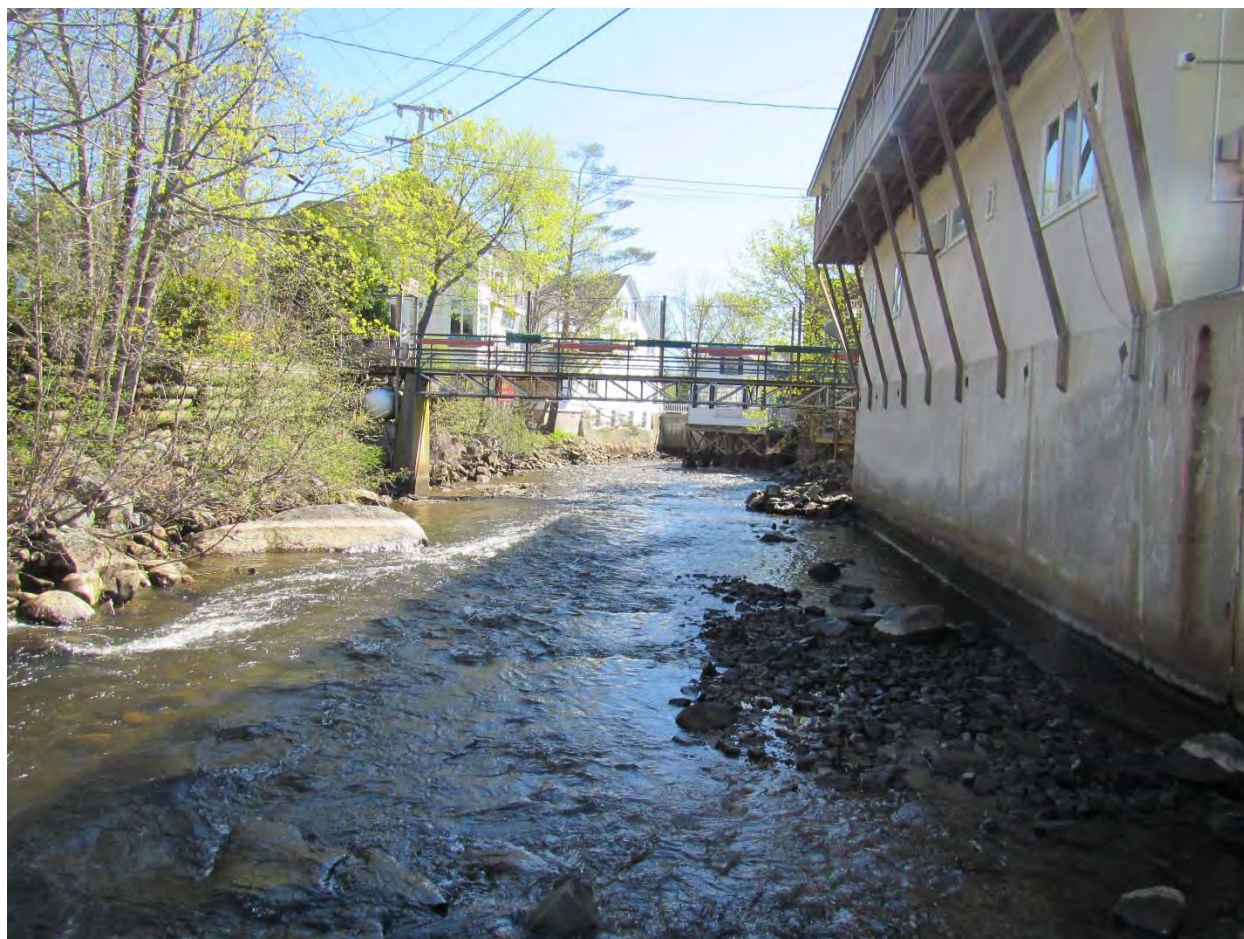
Figure 22. View of upper impoundment looking downstream from Brewster building in drawn down condition, May 8, 2018. Stain lines on large boulder at left, and concrete wall at right indicate normal pool elevation. The ground to the left of the channel is comprised of urban fill.

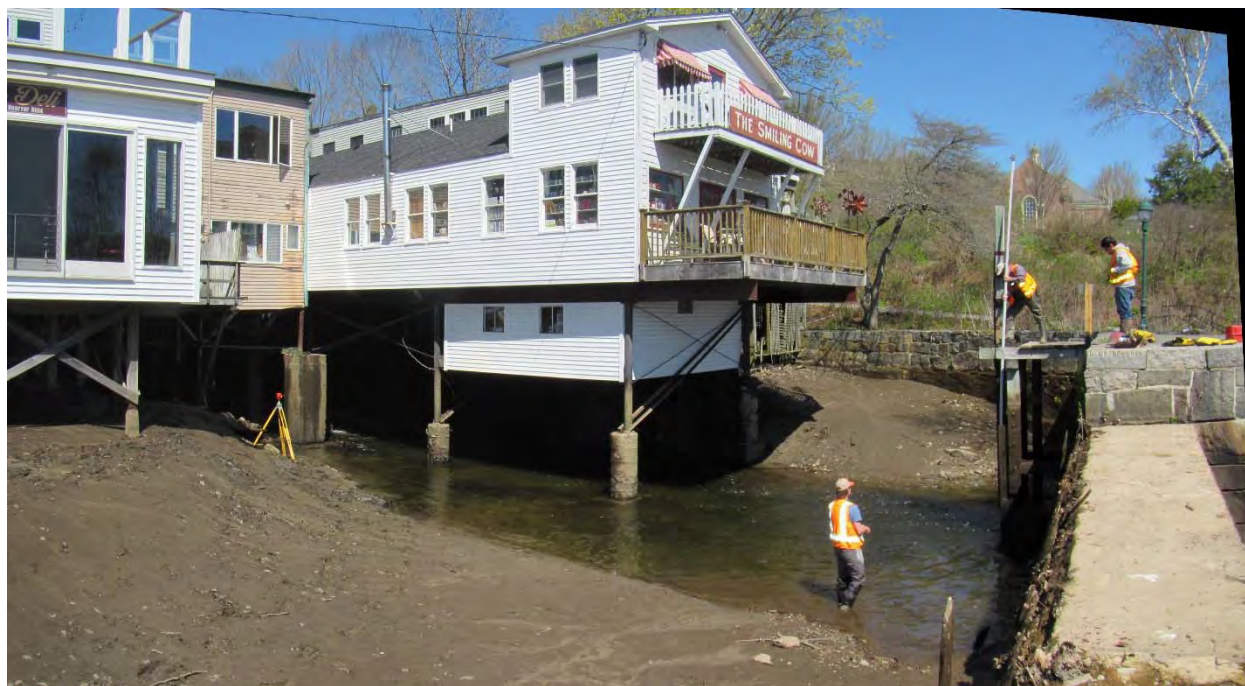
During the field investigation, the impoundment was drawn down, which afforded a view of the condition of the stream in the study reach if the dam were lowered. Immediately upstream of the dam, the channel concentrates in the vicinity of the existing head gate between ledge outcrops under a shallow mantle of accumulated sediment. During the field assessment, an abandoned relict tank was observed in the lower impoundment on the south side of the channel (Figure 24). The origin and purpose of the tank is unknown, but observations by Town of Camden staff suggest that the tank is empty. In conjunction with sediment testing, a composite sediment sample was retrieved from the tank area. See Section 4.5.1 for more details.

Figure 24. View of lower impoundment and north end of spillway in drawn down condition, May 8, 2018. Relict tank is located in the vicinity of the survey tripod at the left of the image.

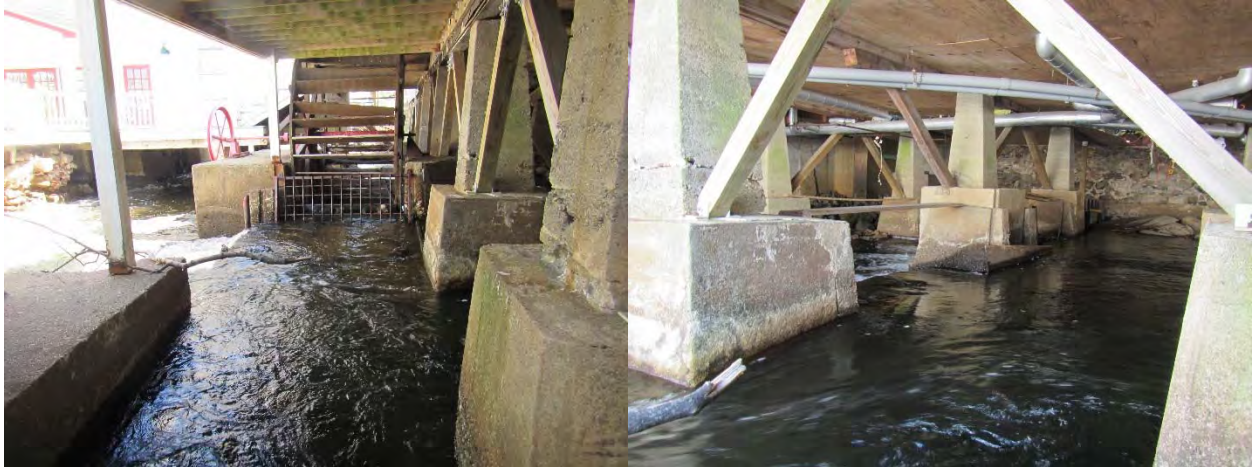
The effective end of the Montgomery dam impoundment is located approximately 350 feet upstream of the bridge, and 525 feet upstream of the dam. From this point upstream to Washington Street, the river again flows under residential and commercial buildings, including the Brewster building, the site of a former mill. A relict water wheel and a line of weirs extend across the channel beneath this building, creating a hydraulic drop of approximately 1 foot (Figure 28). These features were not assessed to be a full fish passage barrier, but modest management of the conditions beneath the building would enhance full fish passage potential.

Figure 28. Looking downstream beneath Brewster building, May 8, 2018. Relict water wheels and weirs between pier footings visible in images.

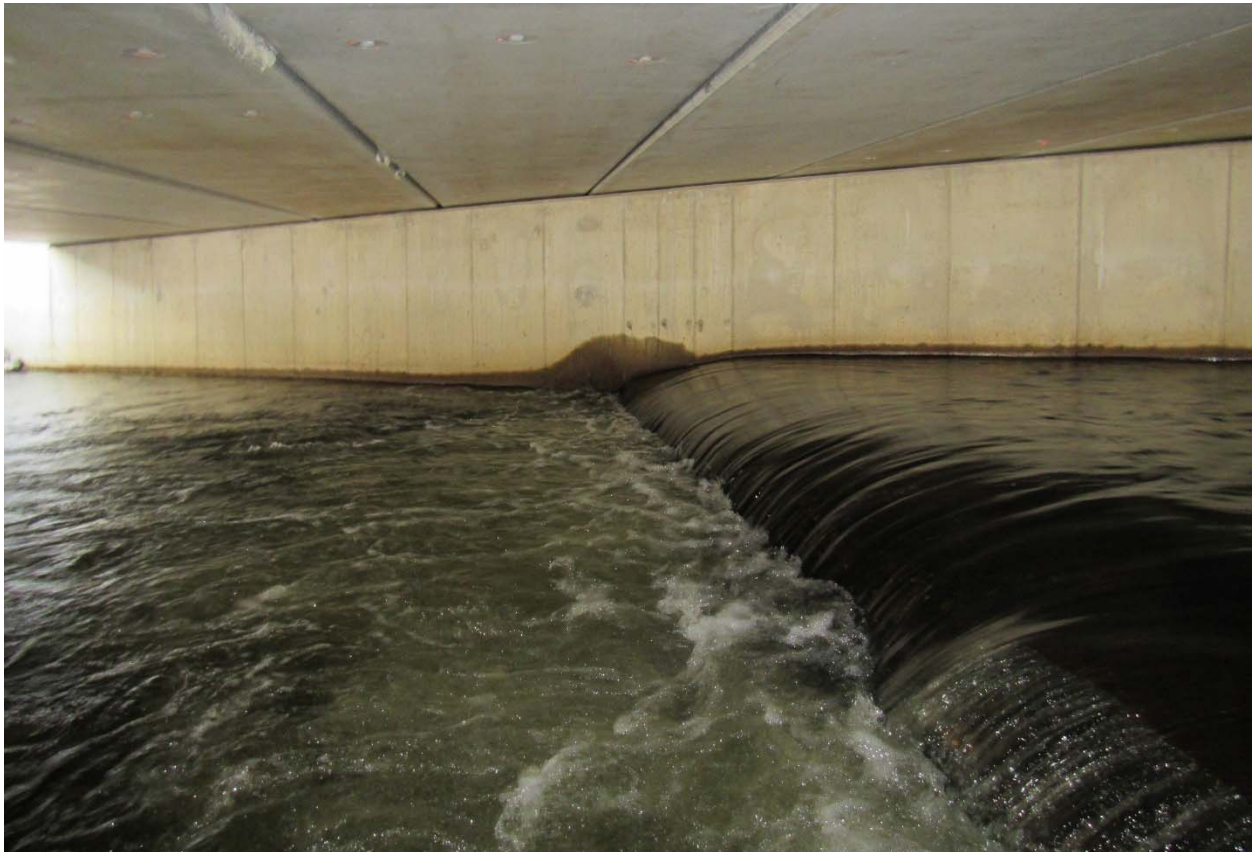
Lastly, the river flows under the Washington Street ('Bakery') Bridge (MDOT# 2981) approximately 500 feet upstream of Main Street. The super structure of the clearspan bridge was replaced in 2017. Beneath the bridge, a concrete-encased sewer pipe creates an approximate 9 inch to 12 inch hydraulic drop, which was also not assessed to be a full fish passage barrier (Figure 29).

Figure 29. View across channel beneath Washington Street bridge, May 8, 2018. Concrete sewer line encasement creates hydraulic drop of approximately 9 inches.

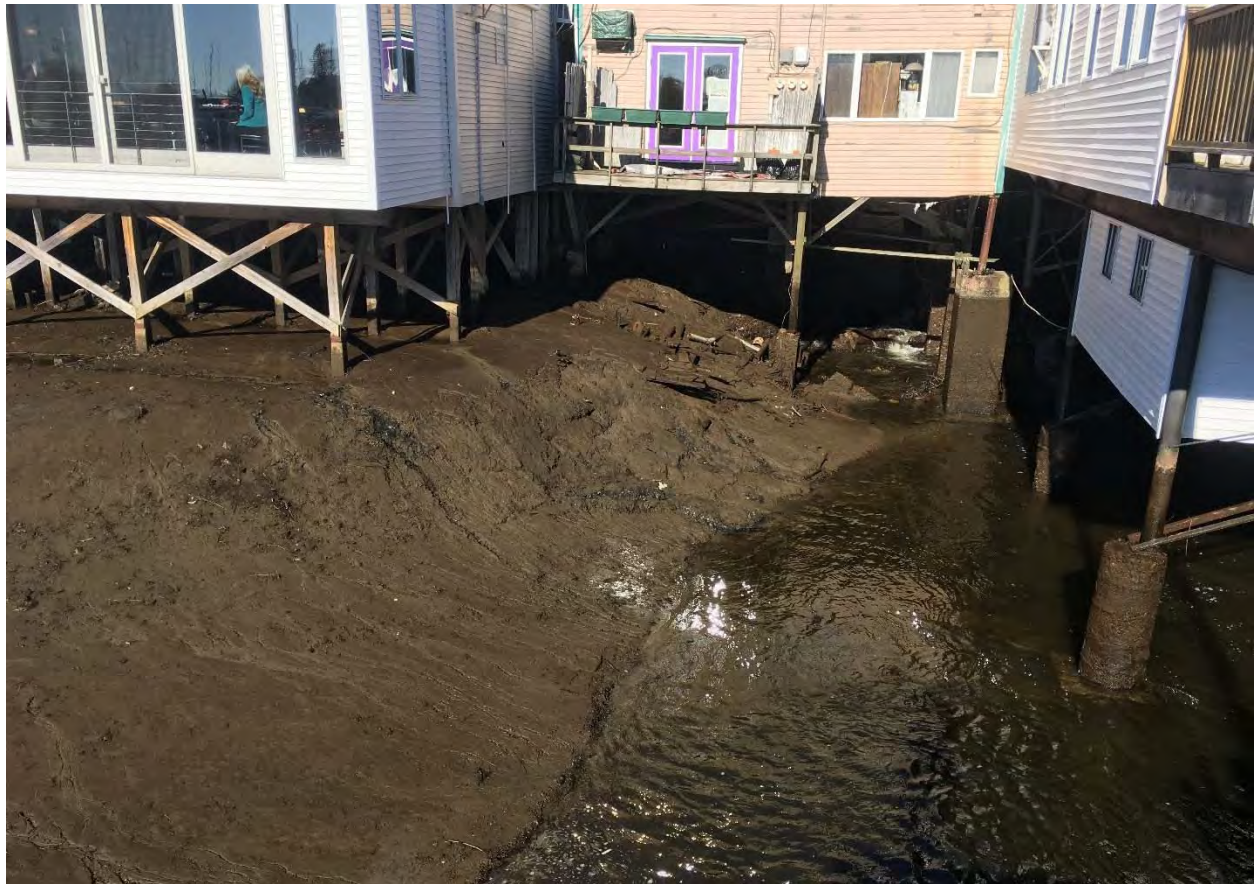
Figure 30. The impoundment with the water level drawn down. A modest volume of fine-grained sediment is trapped behind the dam. May 8, 2018. Relict tank location is immediately below and several feet downstream of the purple French doors in the image.

Complete results of the sediment testing program can be found in Appendix A. Selected results exceeded screening levels, predominantly for metals and semi-volatile organic compounds. In general, within the impoundment, the highest concentrations were found immediately adjacent to the tank. In some cases, the harbor sample had higher concentrations of a given analyte, which would indicate that releasing the impounded sediment would not increase the concentration of that analyte in the harbor.

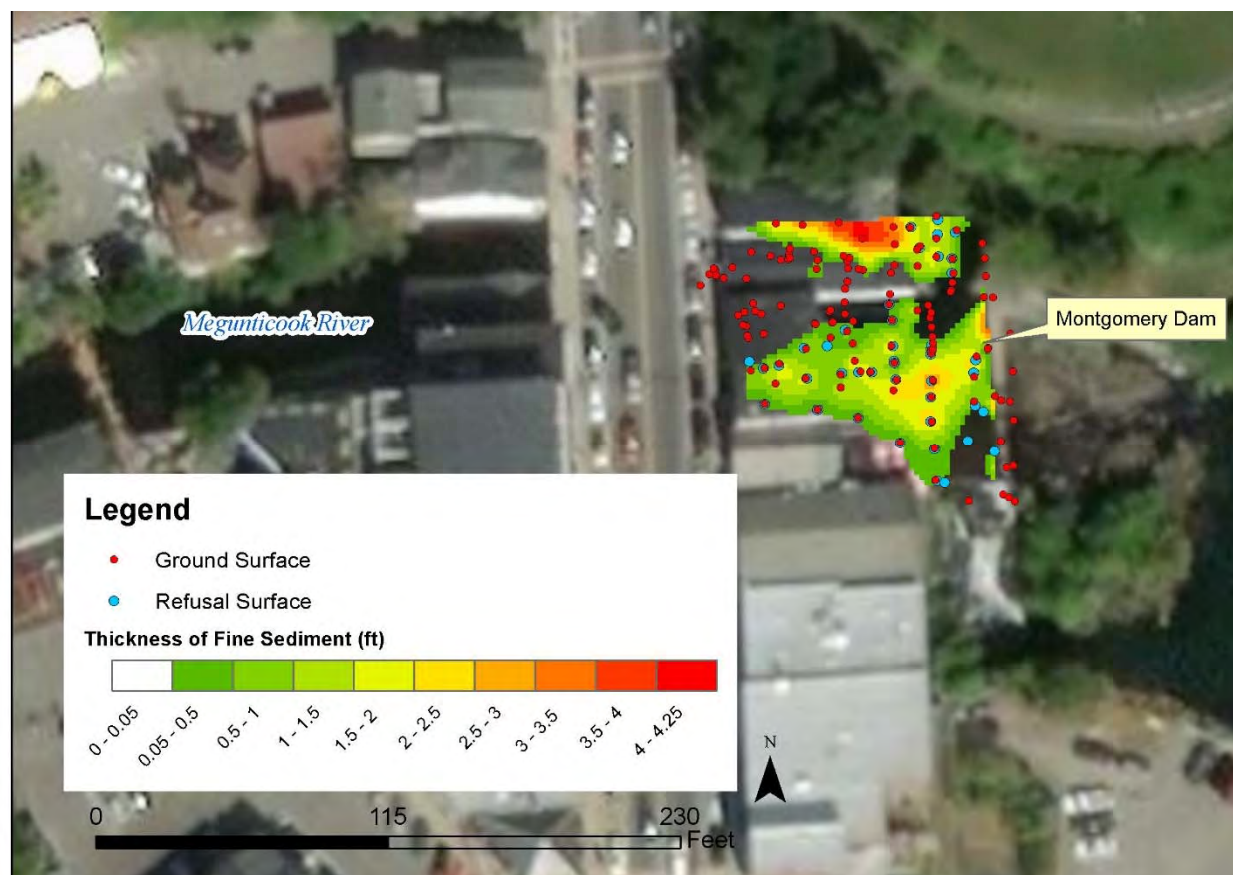
Figure 31. Estimated thickness of fine sediment trapped behind the dam.
