Megunticook River Feasibility Report

Camden, ME

July 31, 2021

Town of Camden,
Maine

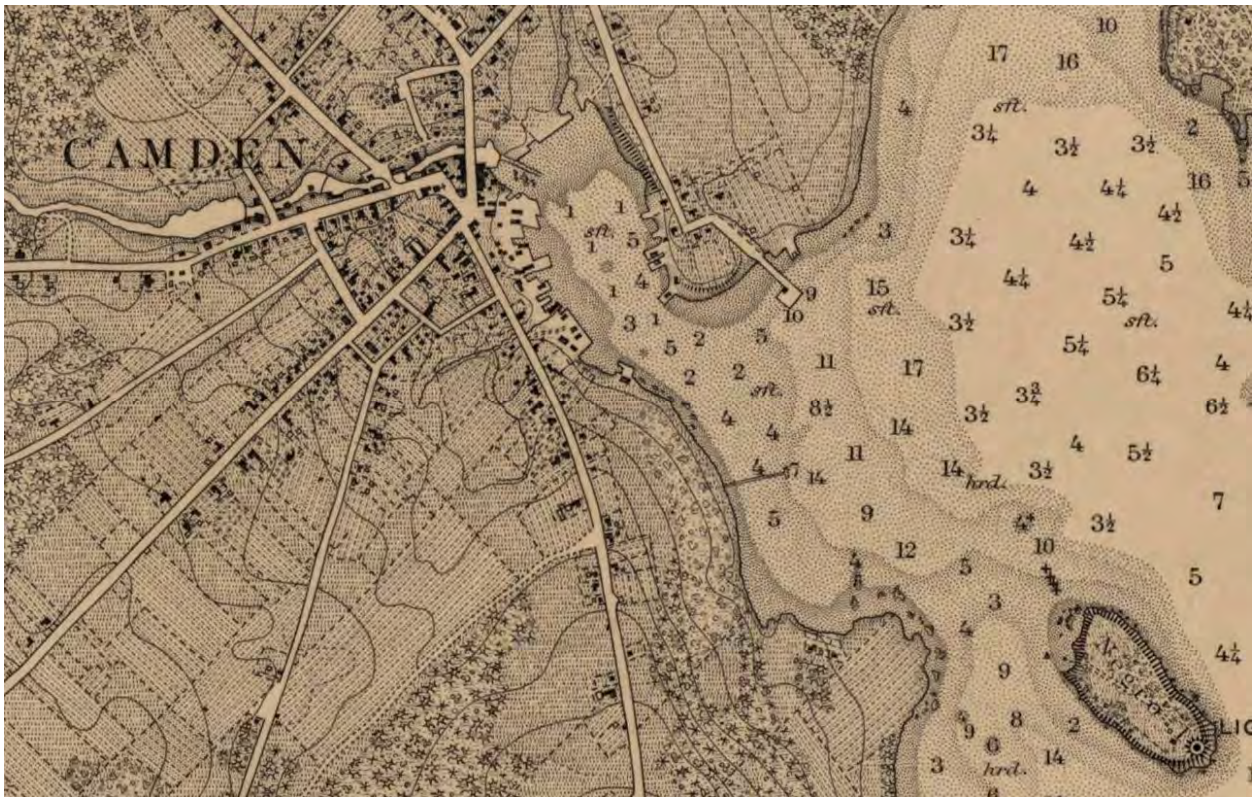
Figure 3. Excerpt from 1864 US Coast Survey map showing shallow depths and mudflats in the inner harbor. Source: American Geographical Society.

The area surrounding Montgomery Dam has been highly modified throughout the years. The inner harbor was dredged substantially in the late 1800s (Figure 3). Fill has been placed on the north side of the river both upstream of Main Street (now a parking lot) and downstream of the Montgomery Dam (now Harbor Park; Figure 4). More detail on the history of the Montgomery Dam and surrounding area is provided in the 2019 feasibility study (Inter-Fluve and Gartley & Dorsky 2019).

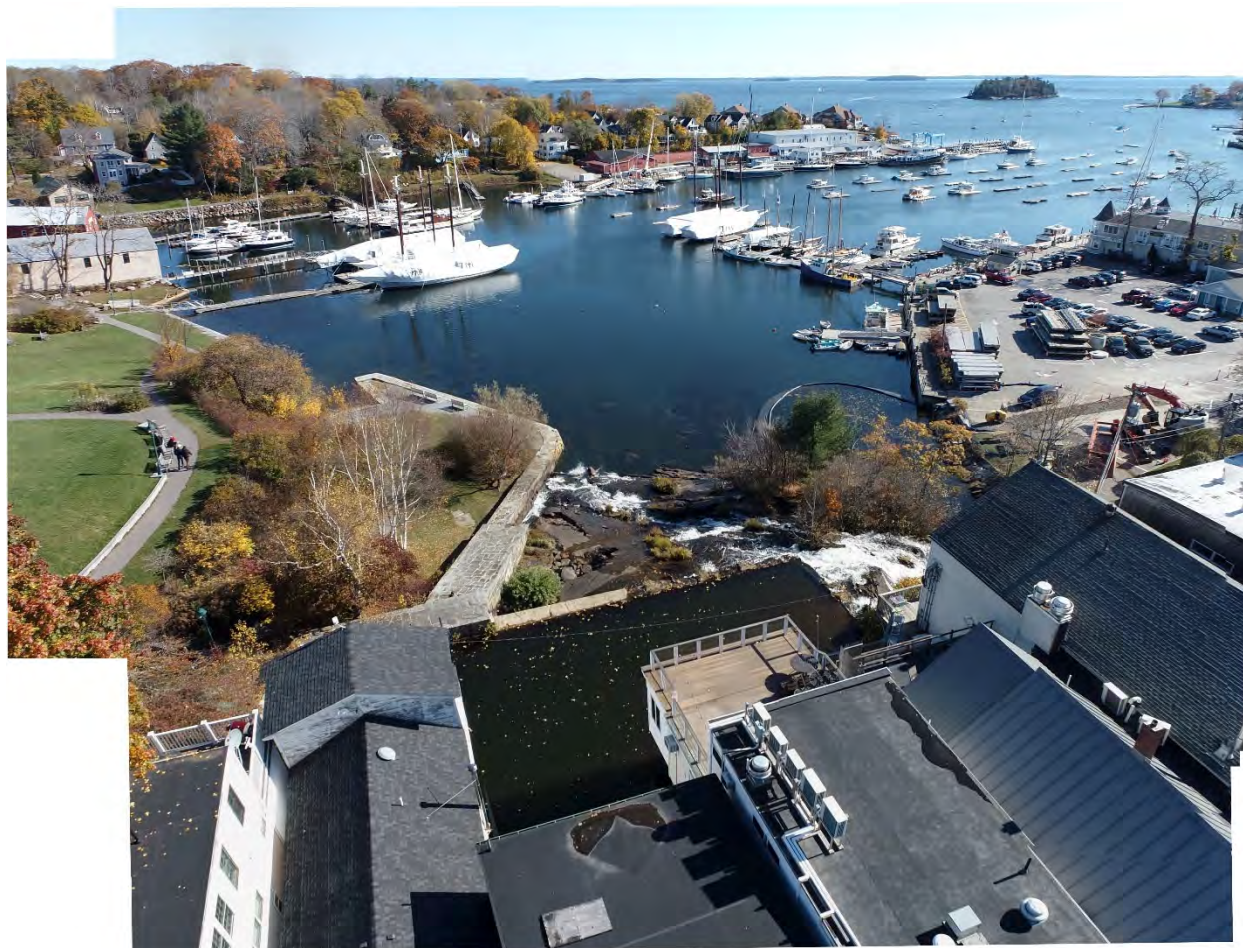
Figure 4. Composite aerial photograph of the Montgomery Dam and surroundings in 2020. Buildings along Main Street are in the foreground, Camden Harbor is beyond the dam, the Harbor Park is to the left, and the public landing parking area is to the right. Photo courtesy of Tom Massey.

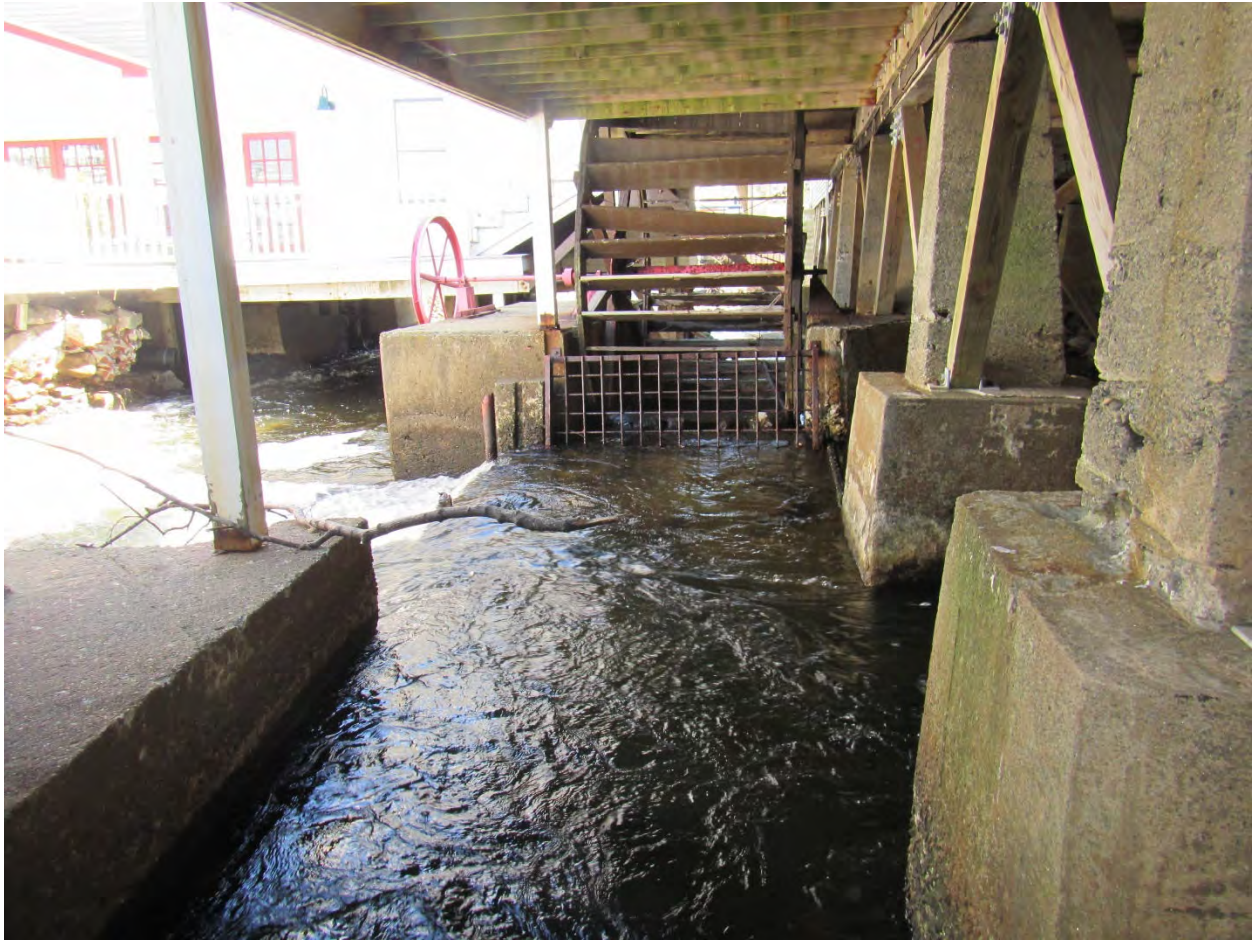
Figure 5. Relict water wheel and weirs beneath the former Brewster Shirt Factory.

Located near the upstream end of the Montgomery Dam impoundment, immediately downstream of Washington Street, the former Brewster shirt factory spans the channel. The shirt factory operated from the early 1900s until 1964 (Dyer 2012). Infrastructure associated with the factory, including a waterwheel and associated weirs remain in the channel. The building is presently occupied by several businesses, including the Camden Bagel Café.

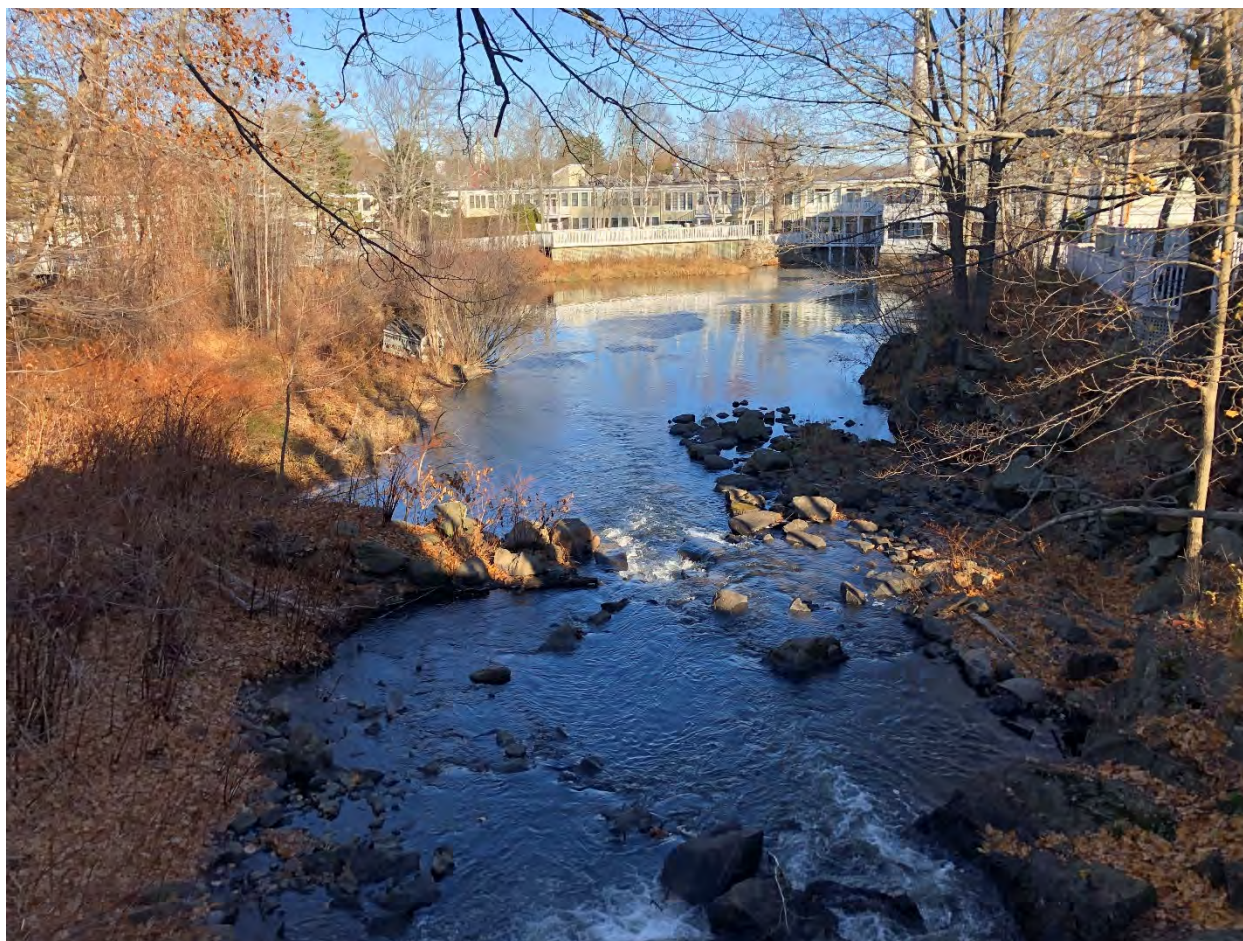
Figure 9. The remnants of an old stone dam on river left, upstream of the Knox Mill impoundment. Likely part of the Alden Oakum Factory.

The ruins of another dam composed of stones sit near the head of the Knox Mill impoundment (Figure 9). The dam ruins likely once served the Alden oakum factory that was located between Knox Mill and Knowlton Street (Wells 1868).

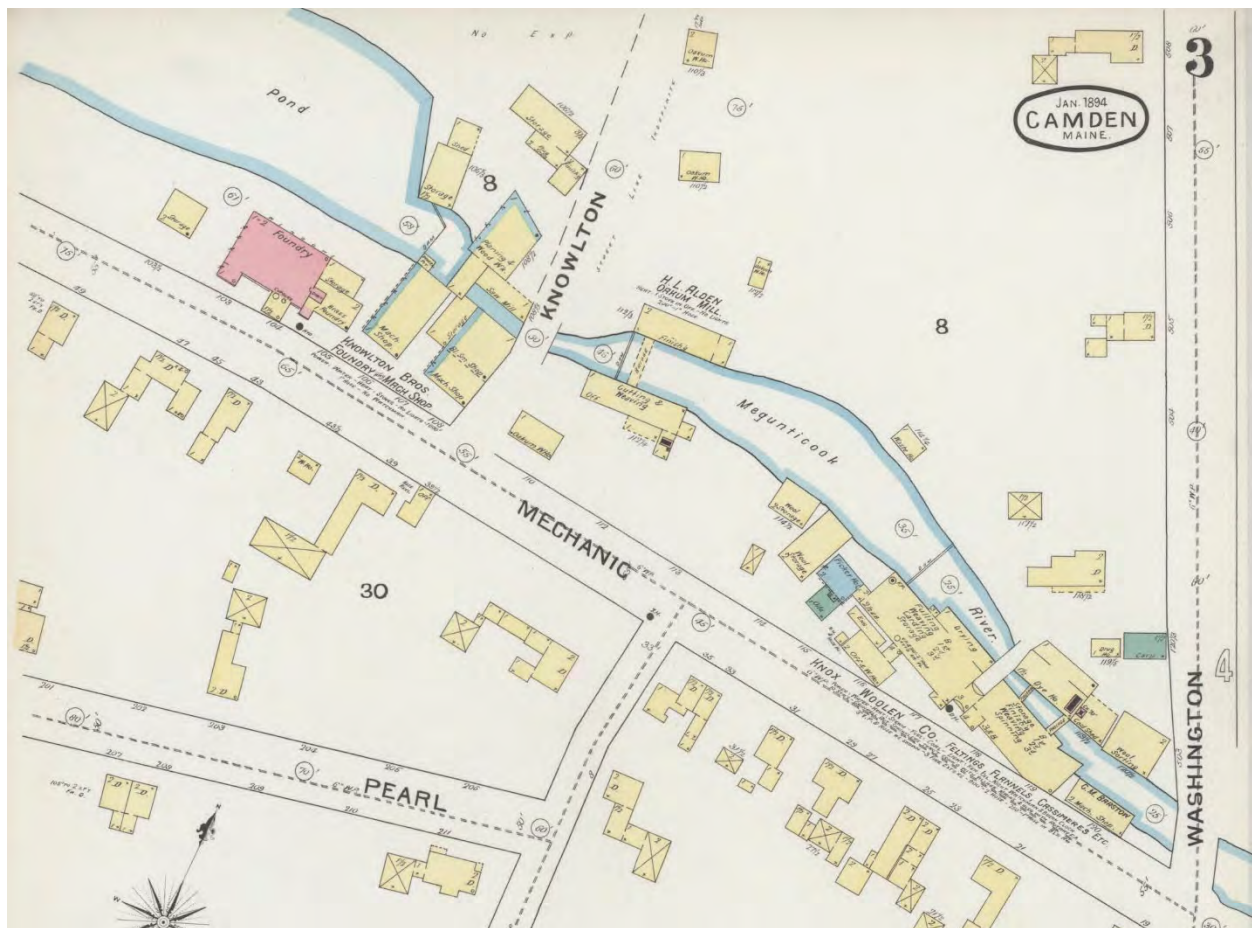
Figure 10. 1894 Sanborn Map of the Knox Mill and Knowlton Street Dam area. Map details the indicate the nature of work at each facility- a woolen mill at Knox and a foundry and block factory at Knowlton.

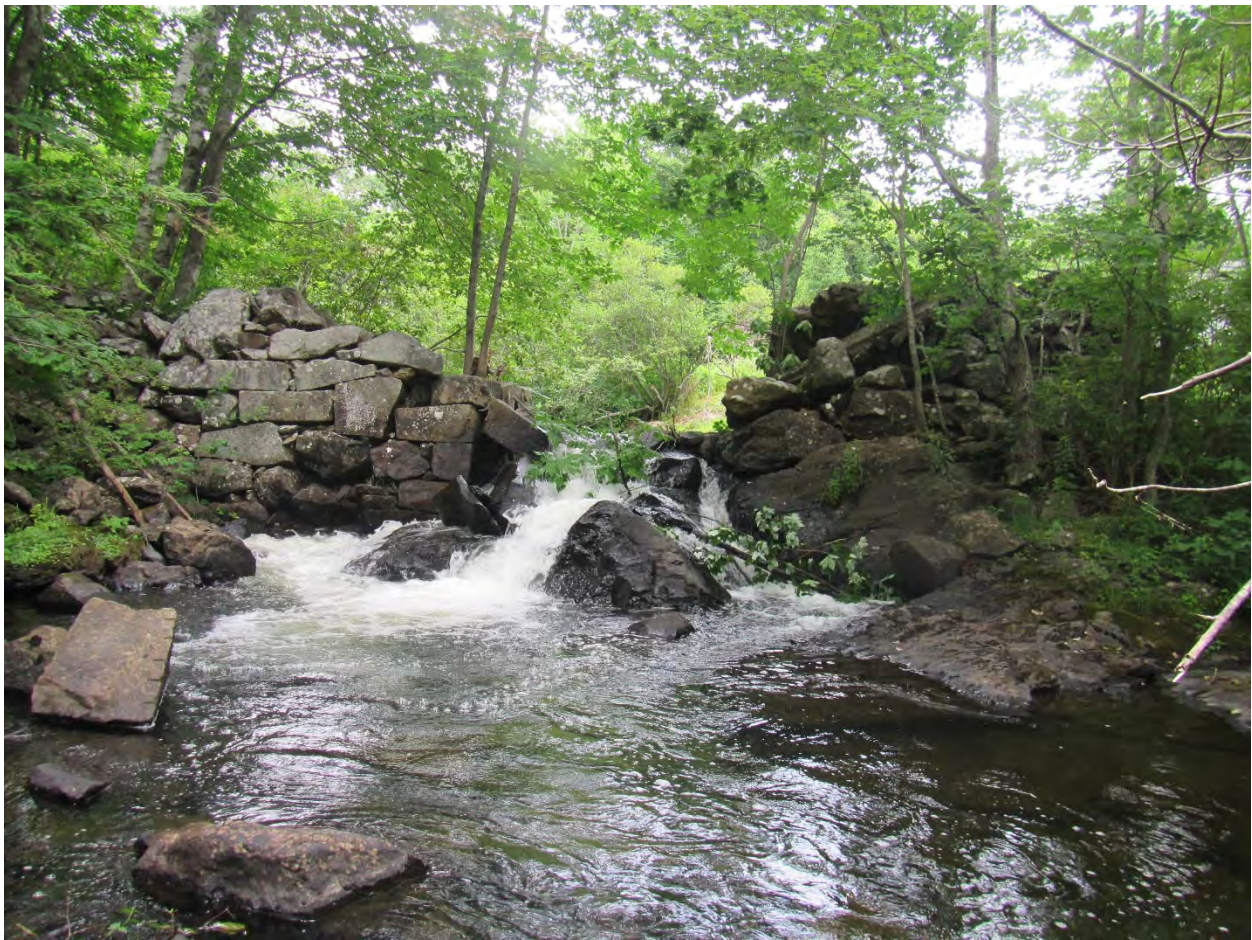
Figure 13. The remains of the Powder Mills Dam in 2020.

Ruins are all that remain of this masonry dam structure located approximately 1.1 miles upstream of the Knowlton Street Dam in a more suburban setting. In the 1820s, a paper mill was constructed at the present-day Powder Mill Dam ruins. The mill burned in 1841 but was rebuilt as a powder mill in 1845 by D.H. Bisbee, providing blasting powder to the quarrying operations in the region. The powder operation included two dams - the stone dam that is partially breached today, and a smaller dam 330 feet downstream, whose remains consist of a small crib structure spanning the channel (Wells 1868). Perennial challenges with factory explosions led to the eventual closure of the powder mill and conversion to a range of operations over following decades, including a woolen mill, poultry factory, and tent manufacturer (Dyer 2019a).

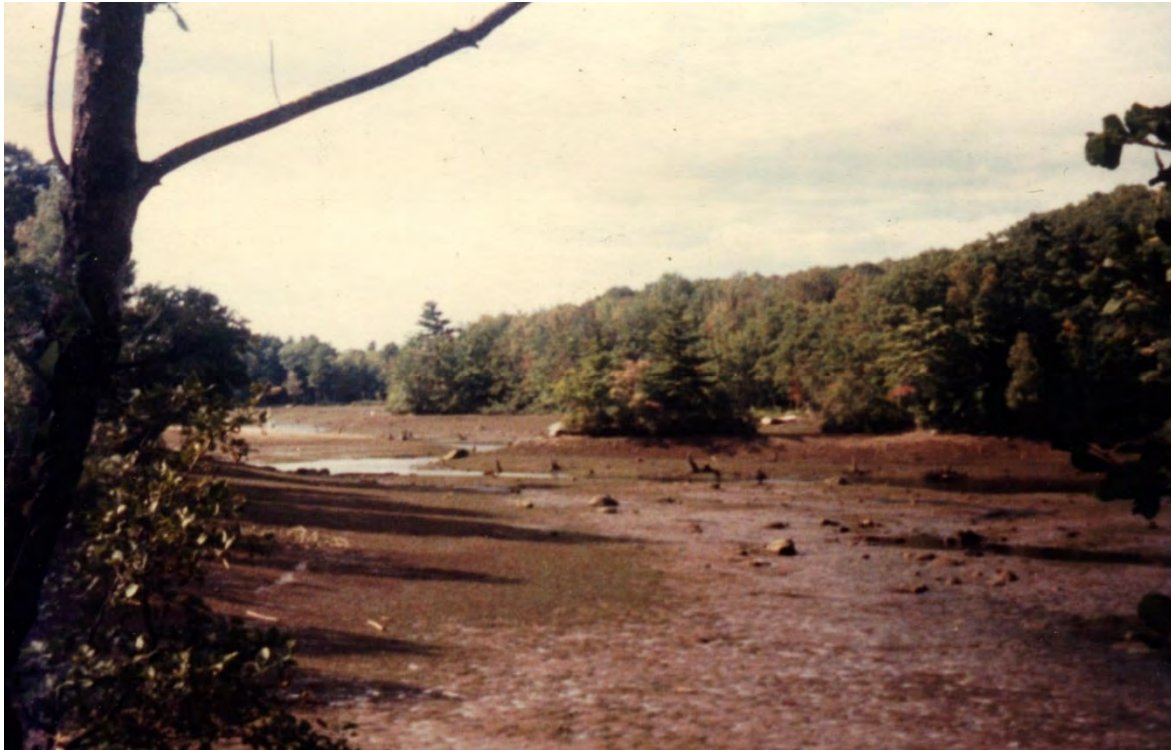
Figure 15. The impoundment behind Seabright Dam in a drawn-down condition. Old tree stumps are visible along the lake bed. Date unknown. (Town of Camden)

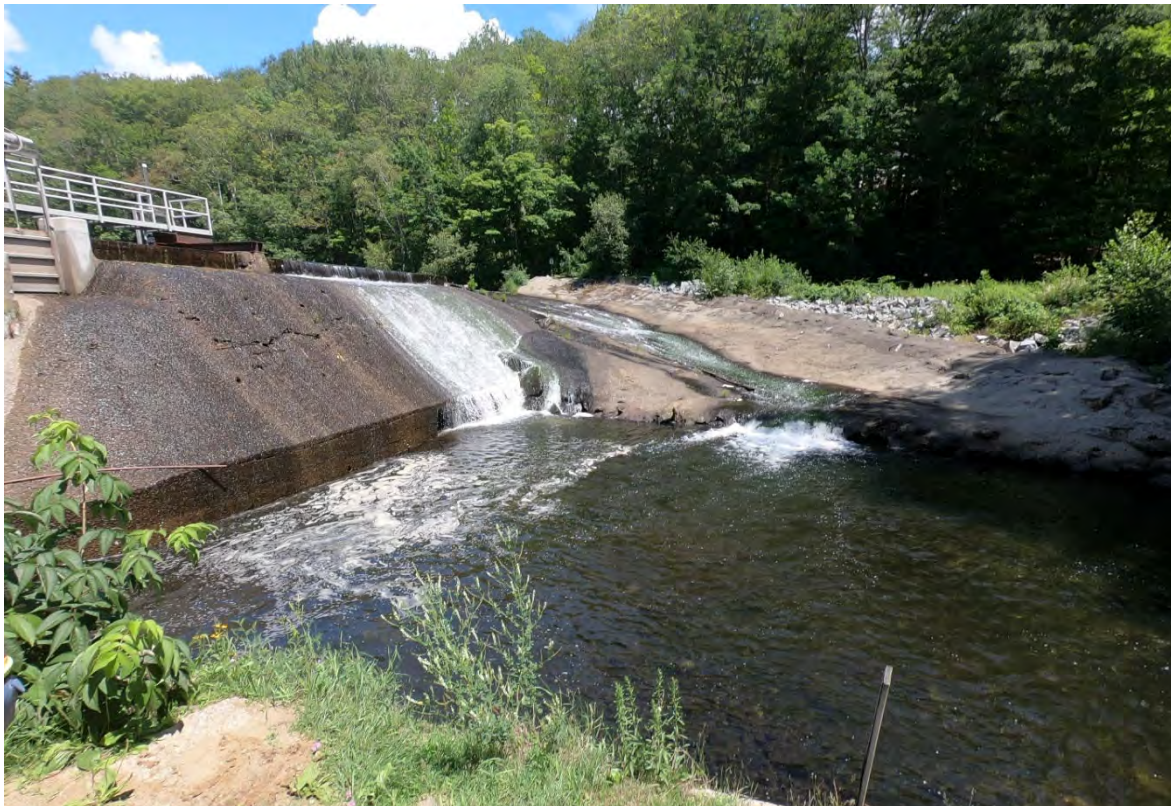
Figure 16. Seabright Dam in 2020.

The Seabright Dam is a high hazard stone masonry and concrete overlay dam owned by the Town of Camden and is located approximately 0.35 mile upstream of the Powder Mill Dam ruins. The Seabright Dam has been the site of a series of woolen mills over time, including the Seabright Woven Felt company, which was incorporated in the early 20th century by William Paige and had the first automatic looms in Camden. Joe Sawyer developed a hydroelectric plant at the dam in the 1980s which was transferred to the Town in 2007. The plant was decommissioned in 2017. Presently, the dam is operated by the Town and maintains water levels in Seabright impoundment.

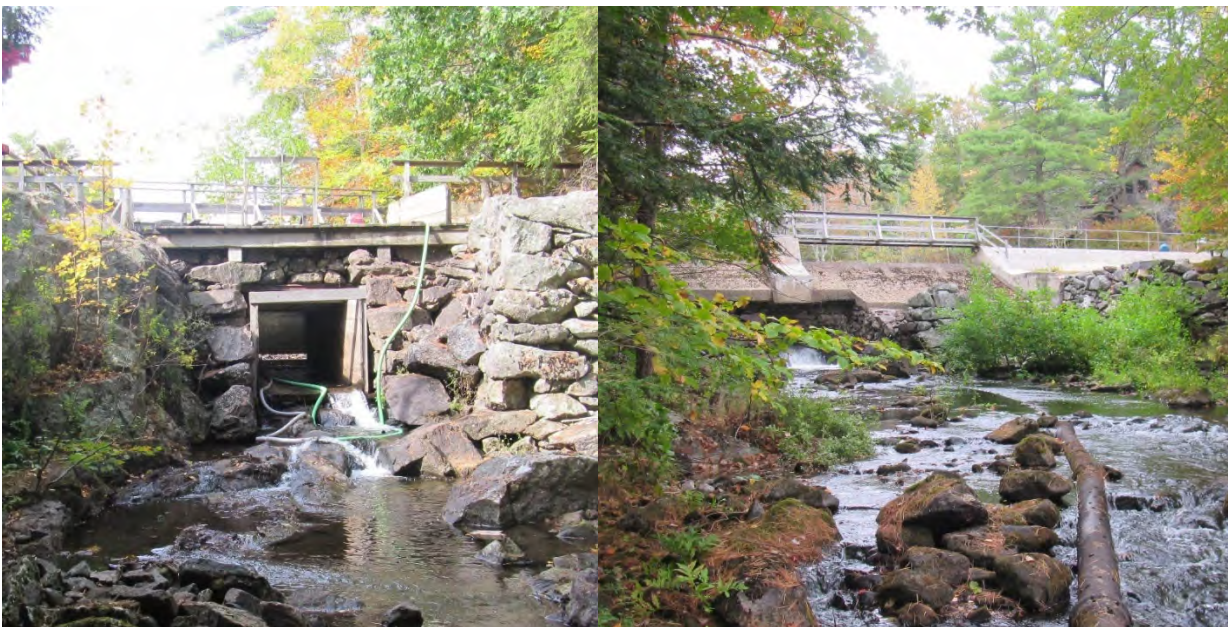
Figure 18. The West and East Megunticook Dams in 2020.

The Megunticook East and West Dams are owned by the Town of Camden and control water levels in Megunticook Lake. They are both high hazard potential dams. The lake is a key recreational amenity for the area. These dams sit on either side of a bedrock knob at the outlet of Megunticook Lake. Dams were initially constructed there by William Molyneux in the late 18th century. The dams initially served powered grist and saw mills (Wells, 1868). They were later integrated into water operations for the Knox Woolen Mill. The natural bedrock outlet of the lake was excavated and enhanced in the late 1800s to increase flow capacity out of the lake for manufacturing purposes (Rockland Courier-Gazette 1894). A fish hatchery was established just below the dams in the early 1900s (McKellar, 2018). Today the dams maintain the lake level in Megunticook Lake, and are operated to partially control flow in the downtown area during rainfall events.

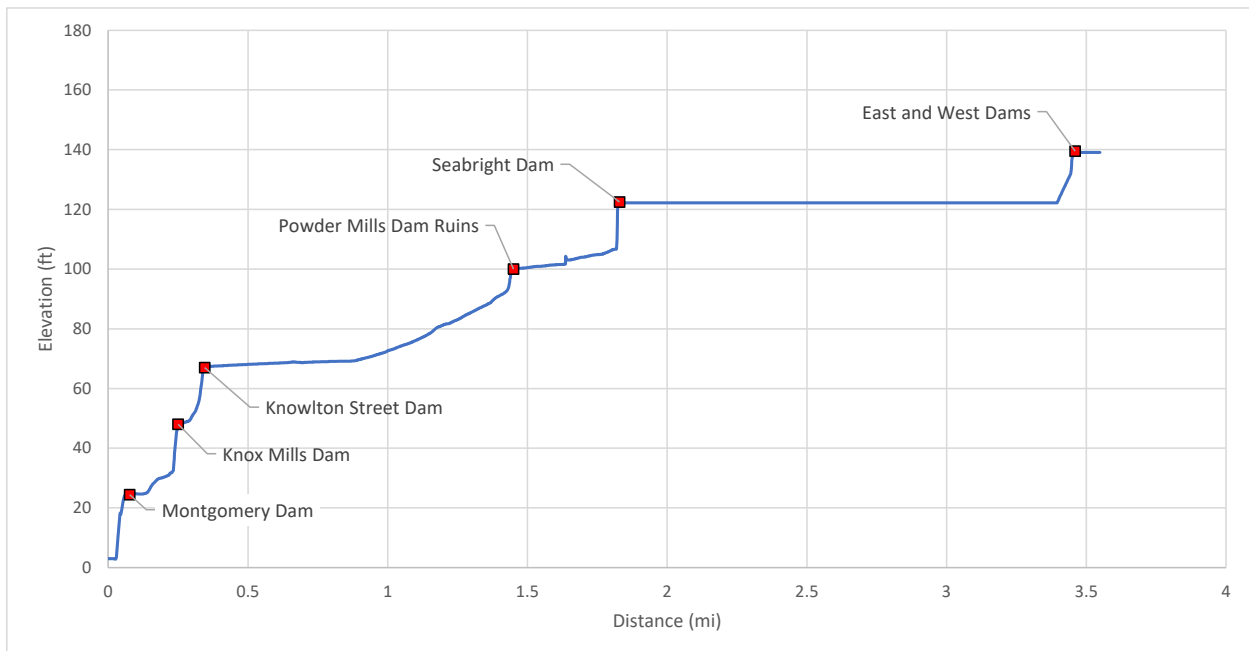
Figure 21. Elevation profile of the Megunticook River, from Camden Harbor to Megunticook Lake.

From the East and West dams at the outlet of Megunticook Lake, the river drops approximately 140 feet before emptying into Camden Harbor. From the upper watershed, the river passes over six intact dams and the relict, degraded dam at the former Powder Mills site. The river profile is dominated by the series of dams and the knickpoint, or local increase in slope, that occurs naturally at the Knowlton Street Dam (discussed in Section 4.3; Figure 21).

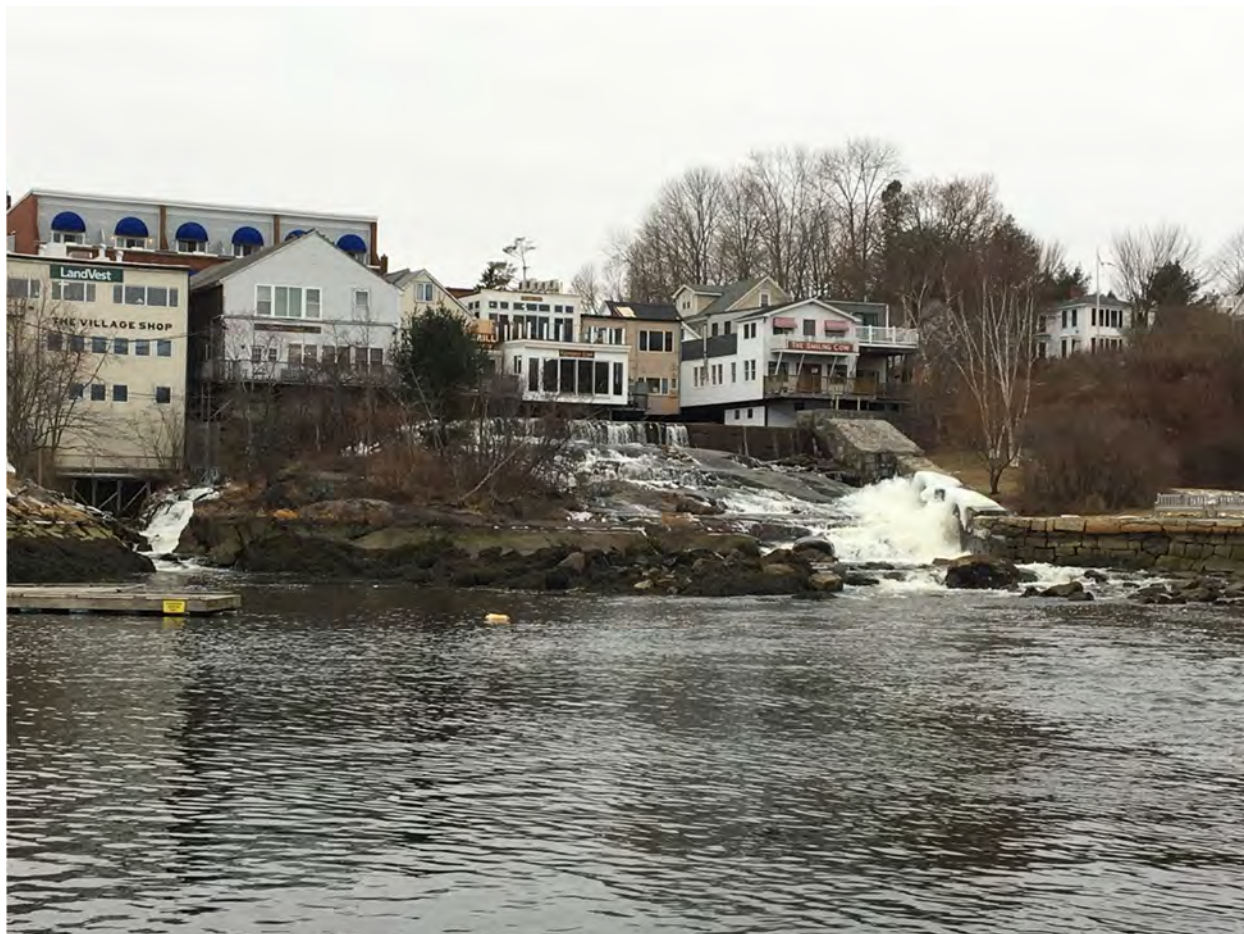
Figure 25. The outlet of the Megunticook River from Camden Harbor. Montgomery Dam sits atop the bedrock. The Harbor Park is to the right of the photo and the Public Landing is to the left.

The Megunticook River flows over a bedrock outcrop on top of which the L-shaped Montgomery Dam was constructed. The river drops approximately 17 feet from the dam spillway to the highest annual tide (HAT) elevation, and 25 feet to the mean tide level in Camden Harbor. The dam itself and Megunticook Falls pose barriers to fish passage.

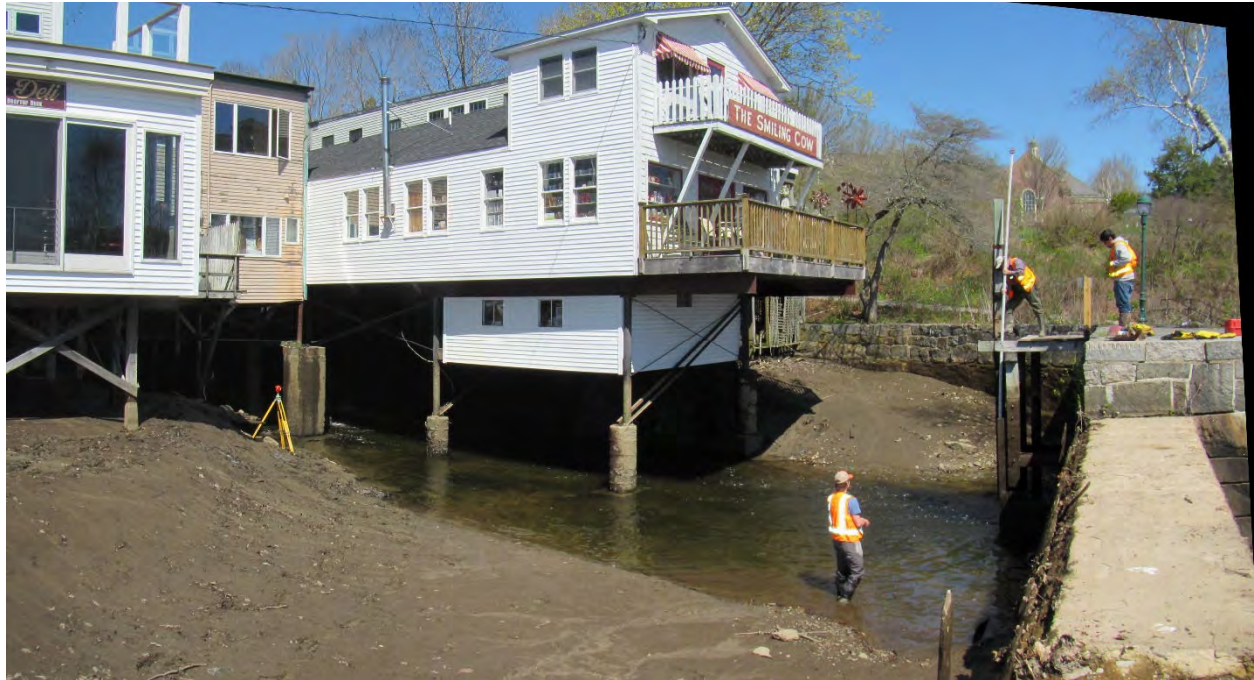
Figure 26. View of lower impoundment and north end of spillway in drawn down condition, May 8, 2018.

During the field investigation for the 2019 feasibility study (Inter-Fluve 2019), the impoundment was drawn down, which afforded an approximate view of the condition of the stream in the study reach if the dam were lowered. Immediately upstream of the dam, the channel concentrates in the vicinity of the existing head gate between ledge outcrops under a layer of accumulated sediment.

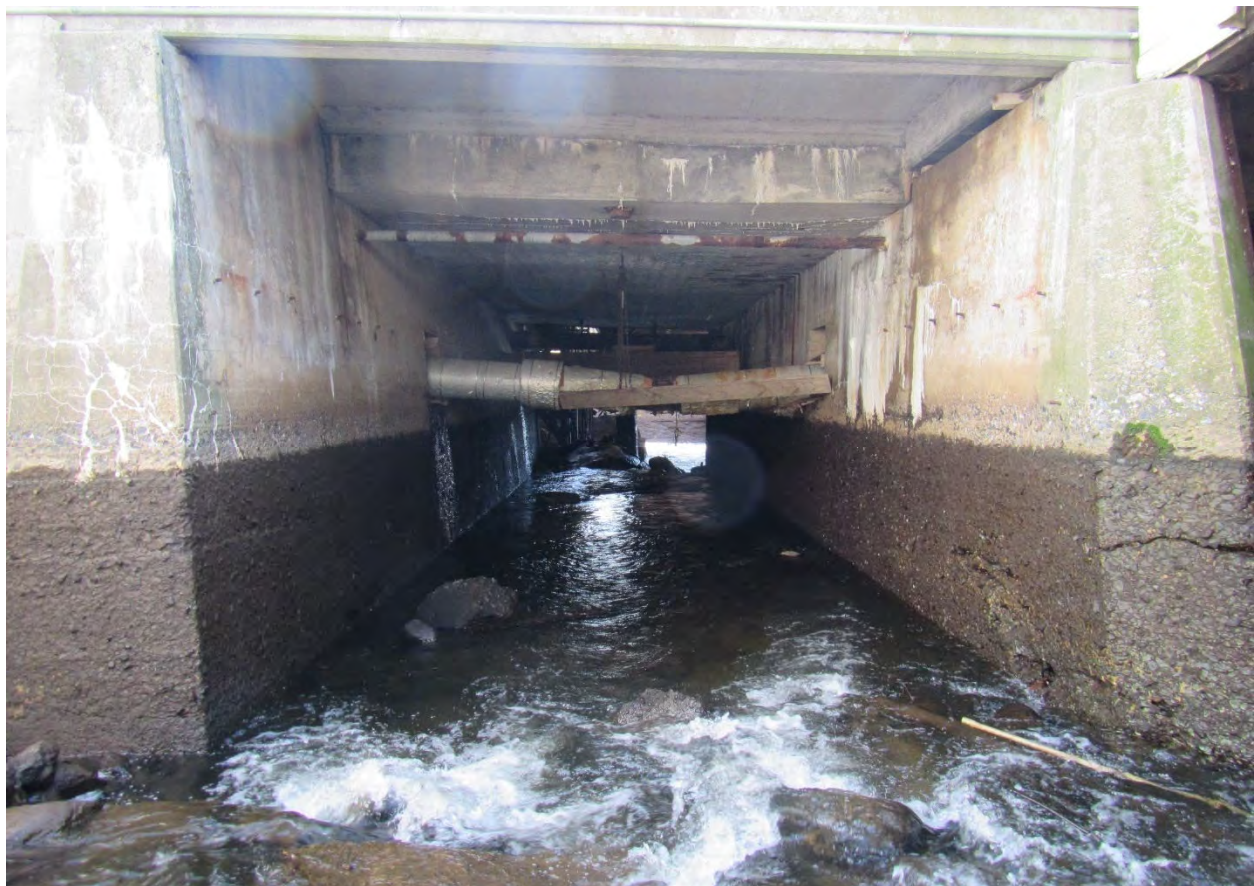
Figure 27. View downstream through north span of Main Street bridge in drawn down condition, May 8, 2018. Stain lines indicate normal pool elevation.

Between the Main Street (Route 1) crossing and the dam, the river flows under multiple commercial buildings with various supports and structural elements either landing in or adjacent to the river channel. Flow under Main Street (MEDOT# 2497) is split between parallel 14-foot-wide spans 68 feet in length. Multiple piped utilities cross beneath the bridge deck above the river and appear to be in various states of maintenance need (Figure 27). The river bed through the bridge is coarse-grained (gravel, cobbles and small boulders with some bricks).

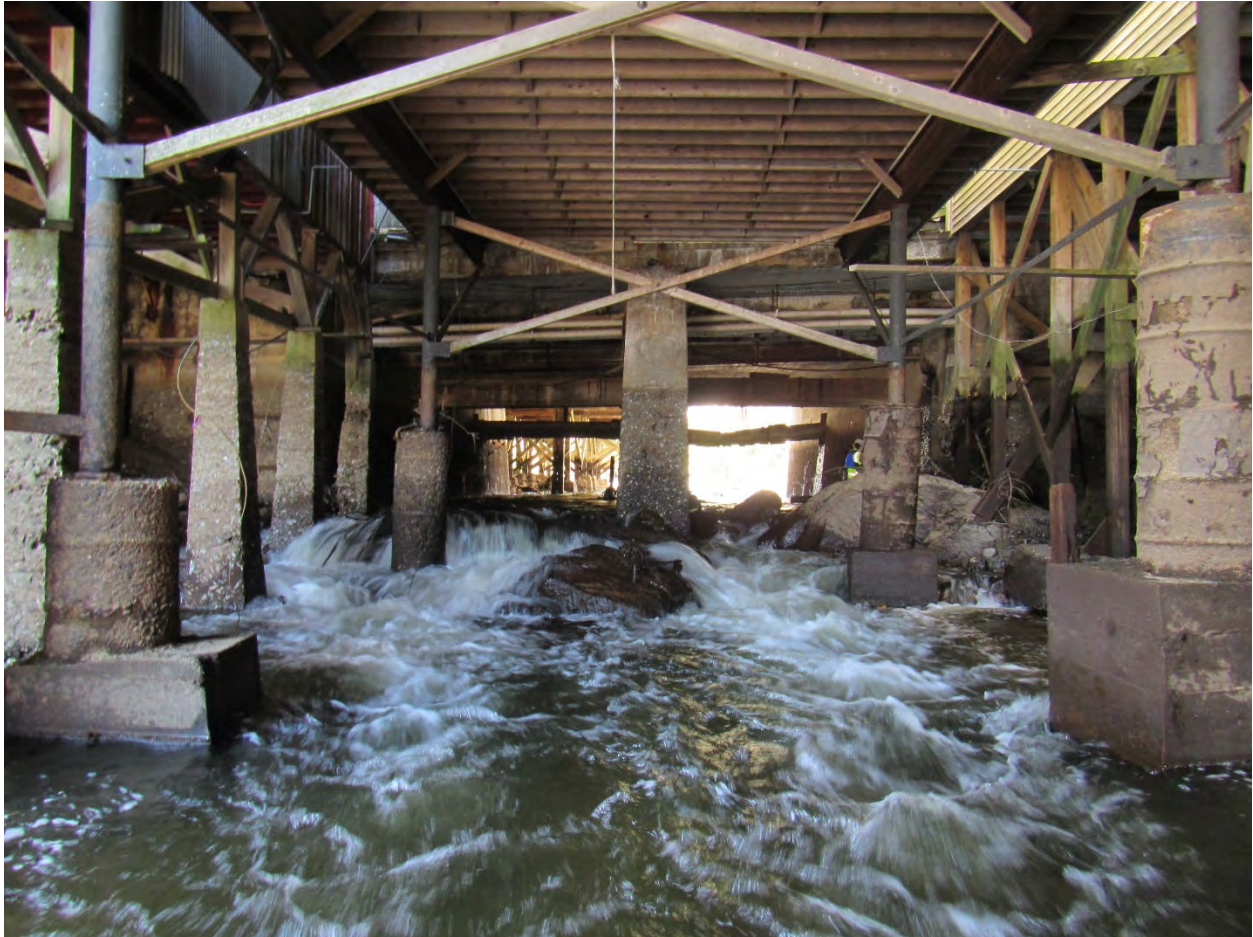
Figure 28. View upstream at Main Street bridge in drawn down condition, May 8, 2018. Hydraulic drop at downstream bridge opening in center of photo. Stain lines apparent on posts indicate normal pool elevation.

At the downstream end of the bridge, the flow concentrates around ledge and large boulders to create a pair of hydraulic drops totaling 2.7 to 3.0 feet in water surface level change over approximately 20 feet of stream length (Figure 28). This area is backwatered when the dam impounds the river. If the selected project approach led to reduction of the impoundment level, fish passage through this transition at Main Street would need to be managed. The Town of Camden is having ongoing discussions with MEDOT regarding the condition and potential replacement of the Main Street bridge in the future.

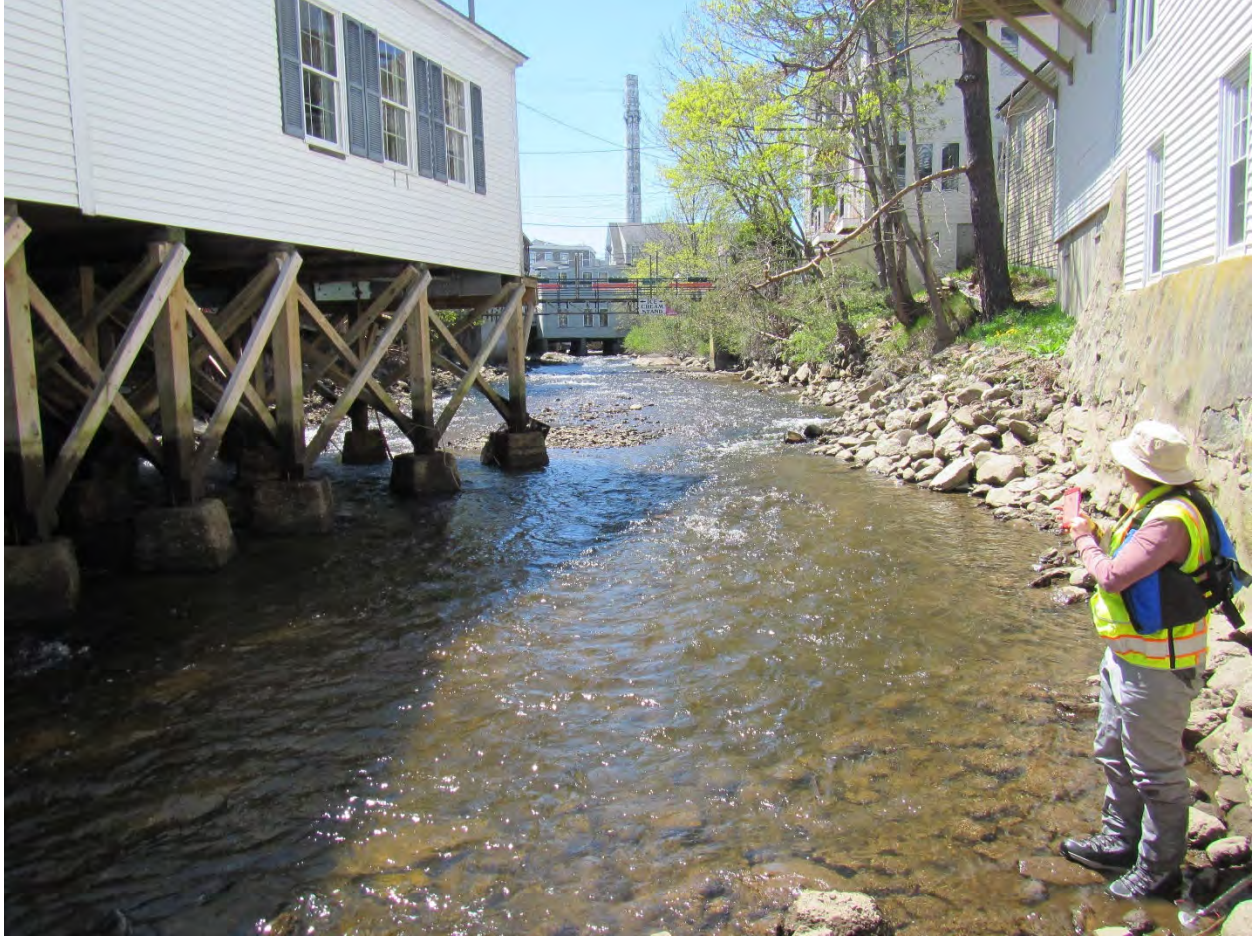
Figure 30. Looking upstream from Main Street with impoundment drawn down, May 8, 2018. In addition to infrastructure in the river, natural features such as boulders, mid-channel bars, riffles, and pools are all present through this reach.

Immediately upstream of the Main Street bridge, additional commercial structures extend over one-half of the river for approximately 60 feet. In the drawn-down condition, the channel exhibits geomorphic sequences of a natural stream over the next 275 feet (Figure 30). Gravel bars, riffles, and pools are all present through this section. A clear-span footbridge crosses the river in the middle of this reach, but does not influence the river hydraulics. The river bed through this reach is also coarse-grained (gravel, cobbles and a few small boulders, with some bricks). The area upstream of the Main Street bridge exhibits depositional features in response to backwater during high flows.

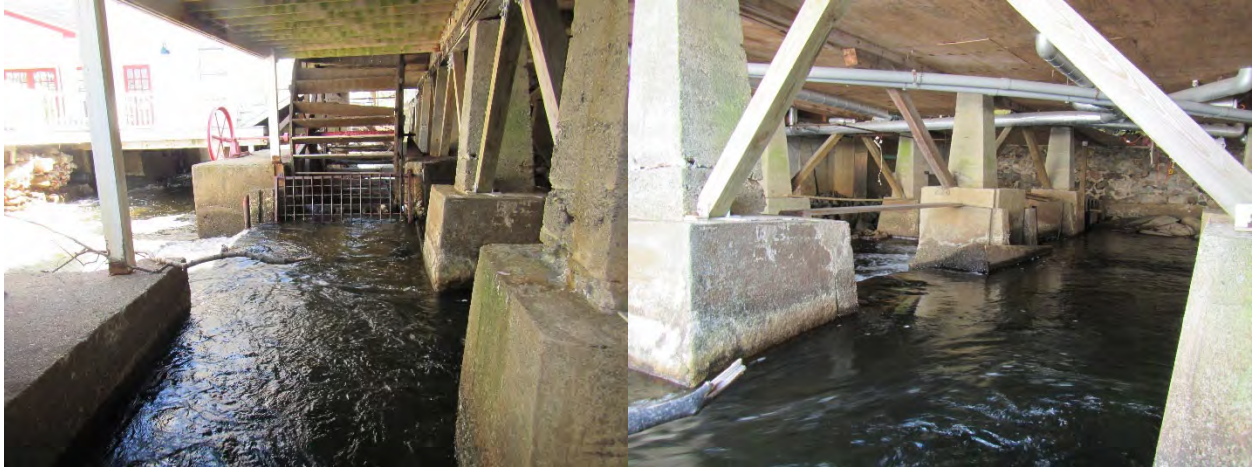
Figure 31. Looking downstream beneath the Brewster building, May 8, 2018. Relict water wheels and weirs between pier footings visible in images.

The upper end of the Montgomery dam impoundment is located approximately 350 feet upstream of the bridge and 525 feet upstream of the dam. From this point upstream to Washington Street, the river again flows under residential and commercial buildings, including the Brewster building, the site of a former shirt factory. A relict water wheel and a line of weirs extend across the channel beneath this building, creating a hydraulic drop of approximately 1 to 2 feet (Figure 31). These features are not a full fish passage barrier, but modest management of the conditions beneath the building would enhance fish passage potential. Additionally, analysis for the current study demonstrates that these legacy features influence peak flood water surface elevations near Washington Street.

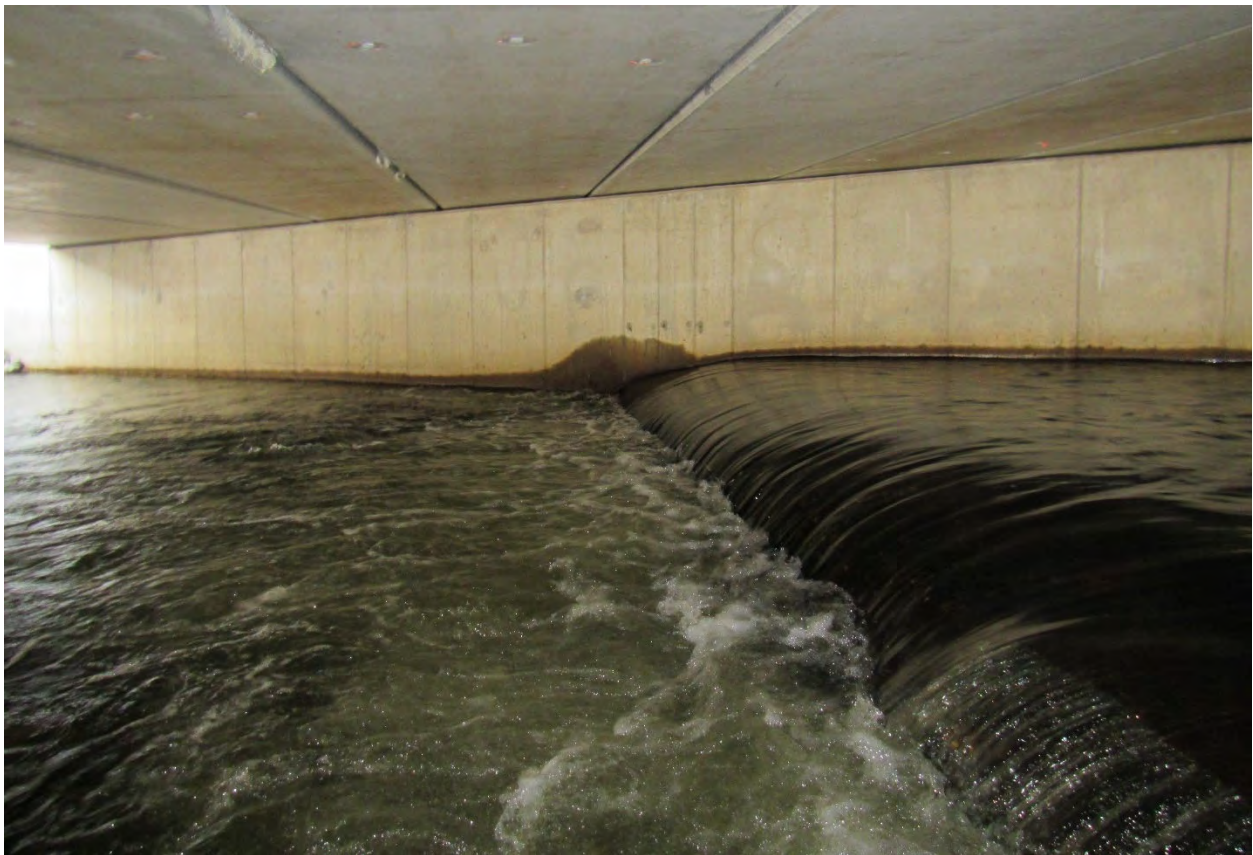
Figure 32. View across channel beneath Washington Street bridge, May 8, 2018. Concrete sewer line encasement creates hydraulic drop of approximately 9 inches.

Lastly, the river flows under the Washington Street ('Bakery') Bridge (MEDOT# 2981) approximately 500 feet upstream of Main Street. The super structure of the clearspan bridge was replaced in 2017. Beneath the bridge, a concrete-encased sewer pipe creates an approximate 9-inch to 12-inch hydraulic drop, assessed to not be a full fish passage barrier (Figure 32), but should be monitored for passage efficiency associated with future restoration activity.

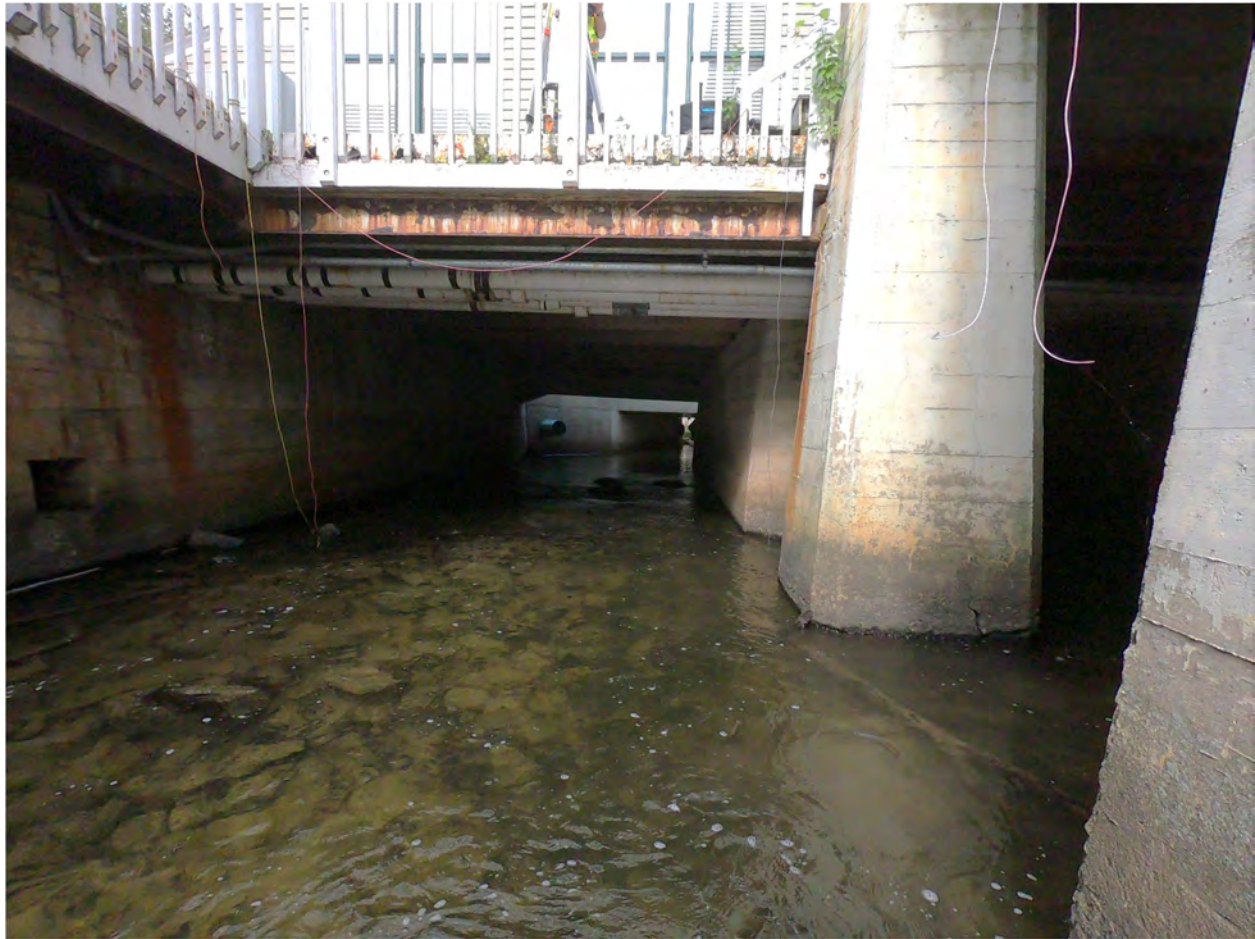
Figure 33. Looking downstream from below The Jack restaurant. The channel is walled on both sides, with numerous building footings present in the channel. The coarse bed substrate is visible in the center of the channel.

The subreach between the Washington Street crossing and the Knox Mill Dam is flanked by walls and much of it is below buildings (Figure 33). Limited complexity plane-bed morphology (devoid of pools or bedforms) dominates this portion of the reach, which would naturally exhibit pool-riffle morphology. The bed is armored with cobbles and gravel, depleted of fines. The plane-bed morphology and armoring are due to urbanization of the channel and a sediment transport regime disrupted by upstream dams.

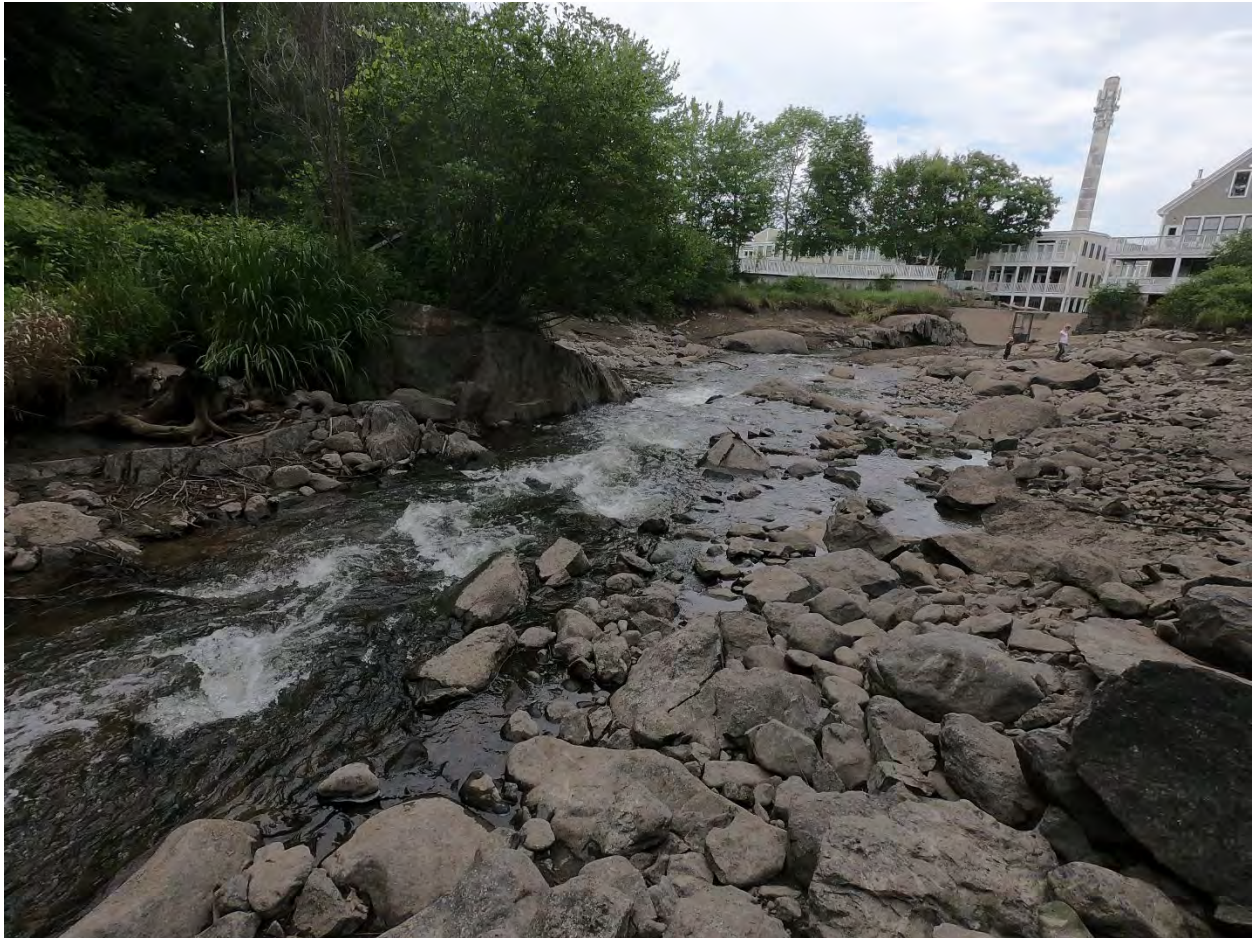
Figure 34. Looking downstream at the Knox Mill impoundment in a drawn down condition. The coarse bed material and relatively modest amount of impounded sediment are evident.

The impoundment was drawn down during the field investigation, affording a close look at its bed (Figure 34). The impoundment bed is notably rocky, with several outcroppings of ledge along the left bank, and contains only a modest volume of fines. A single-threaded channel emerged

immediately upon draw down. This channel likely represents the natural alignment, as it follows a distinct low point in the valley and exhibits a steep slope and well-developed pool-riffle morphology similar to the channel upstream of the impoundment.
