Megunticook River Feasibility Report

Camden, ME

July 31, 2021

Town of Camden,
Maine

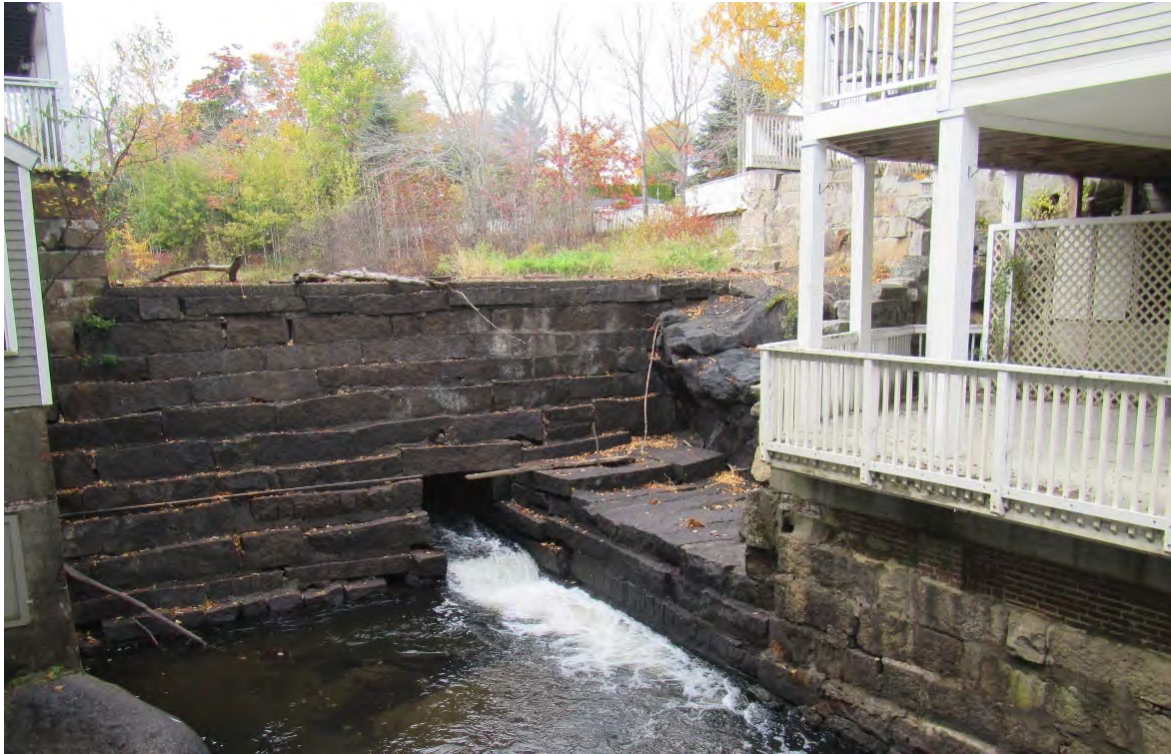
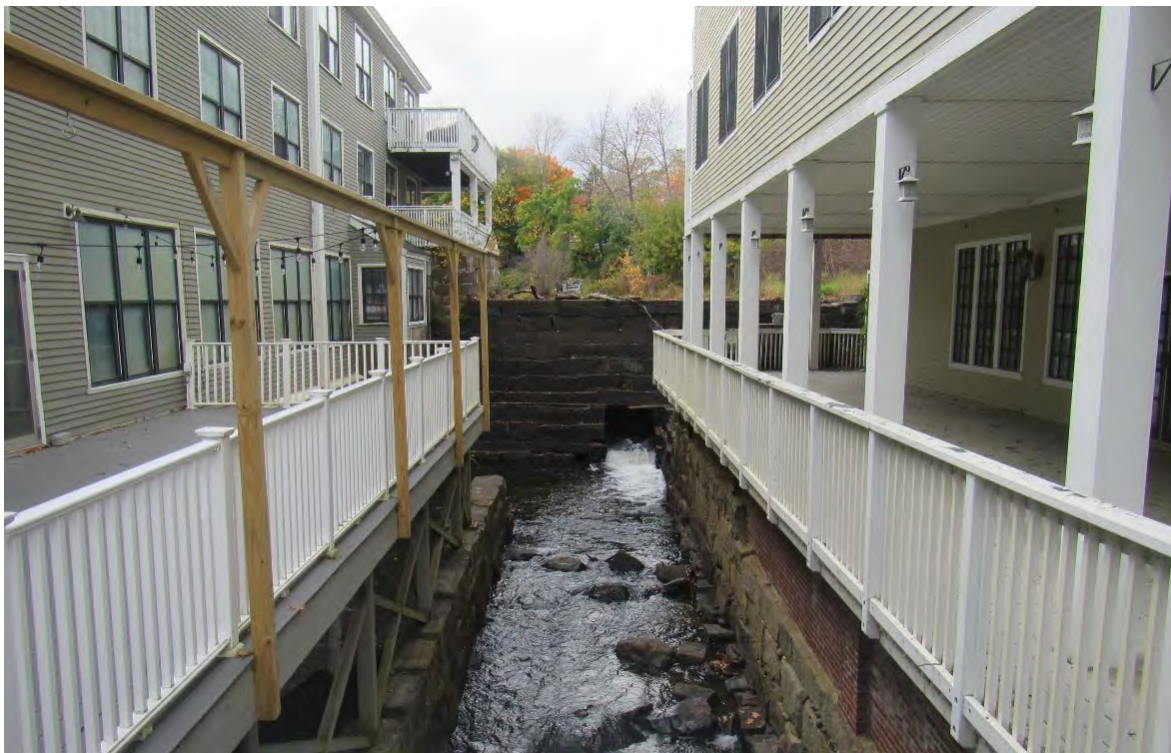
Figure 35. Downstream view of Knox Mill Dam. Previously mill buildings extended completely across the river.

Figure 36. Downstream view of Knox Mill Dam. Previously mill buildings extended completely across the river.

Knox Mill Dam is a stone masonry dam with a 54 foot-long concrete spillway. Its abutments are founded on bedrock, and the dam intersects bedrock on the north end and a granite retaining wall on the south end. Vegetation in the retaining wall suggests mortar loss between stones. Downstream of the dam, buildings directly abutting the river have granite foundation walls and wooden decks extending over approximately half the river. See also Appendix A.

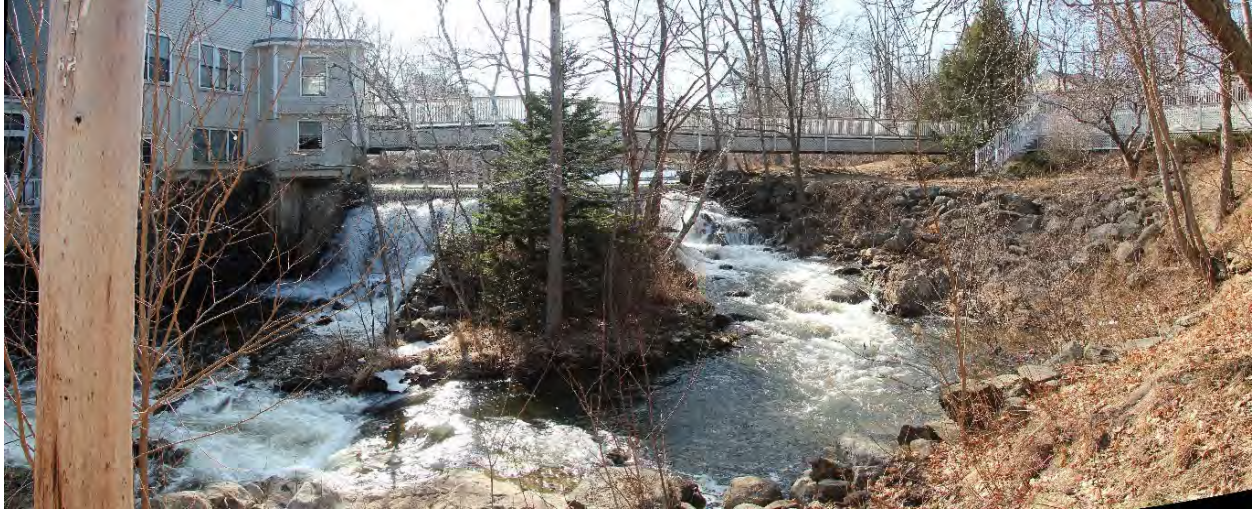
Figure 38. Split flow downstream of Knowlton Street dam, with assisted living facility on river right.

In the downstream segment of this reach, immediately downstream of the Knowlton Street dam, flow is split around a bedrock knoll that the dam is founded on (Figure 38). The left channel is a step-pool sequence with several outcroppings of ledge and a stone wall constructed along the left bank (Figure 39). To the right of the bedrock knob, flow cascades over a steep section of ledge before plunging into a deep pool. Flow merges with the left channel just upstream of the Knowlton Street crossing. A wall forms the right bank of the channel through this section.

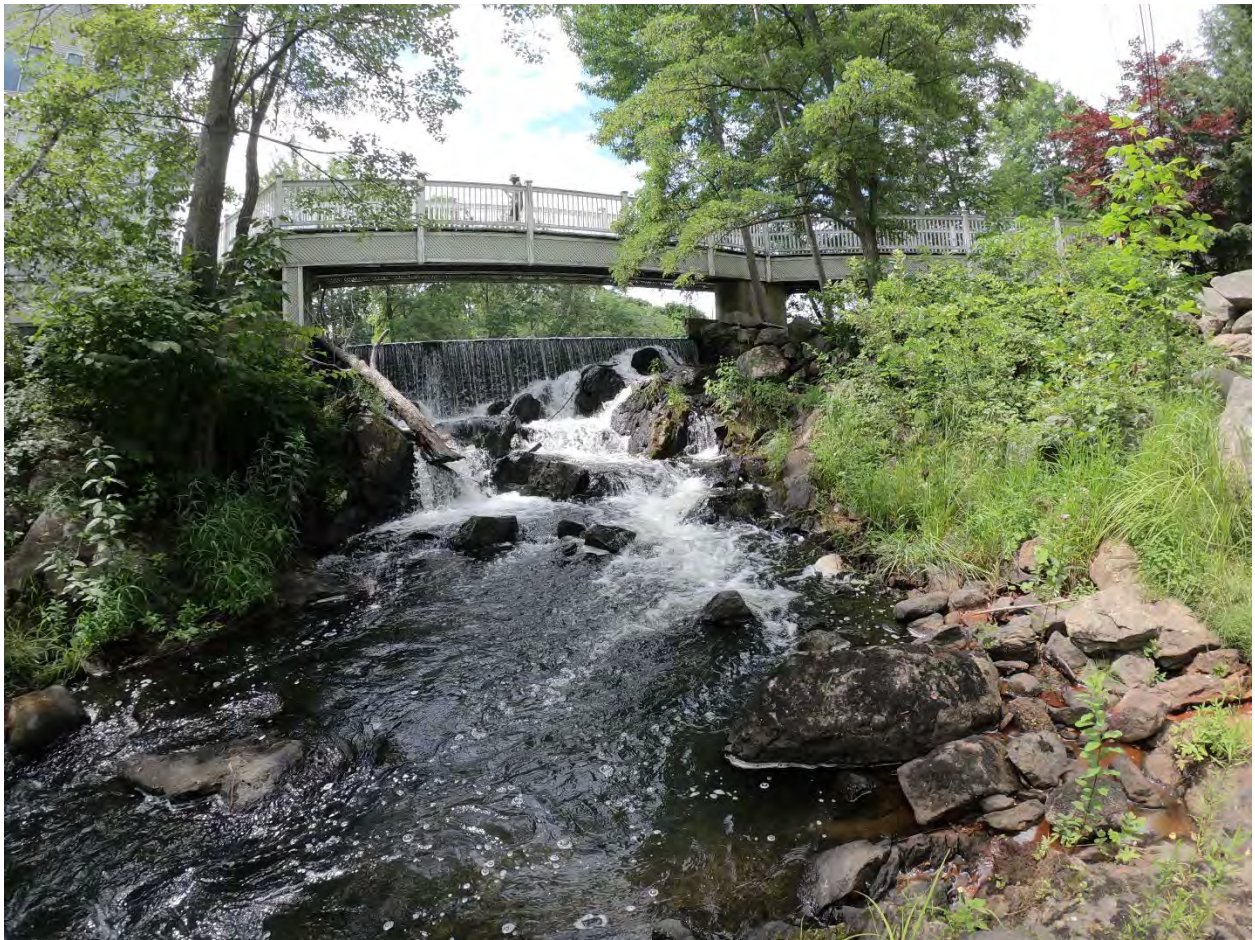
Figure 39. Looking upstream towards the Knowlton Street dam at the left fork of the split channel.

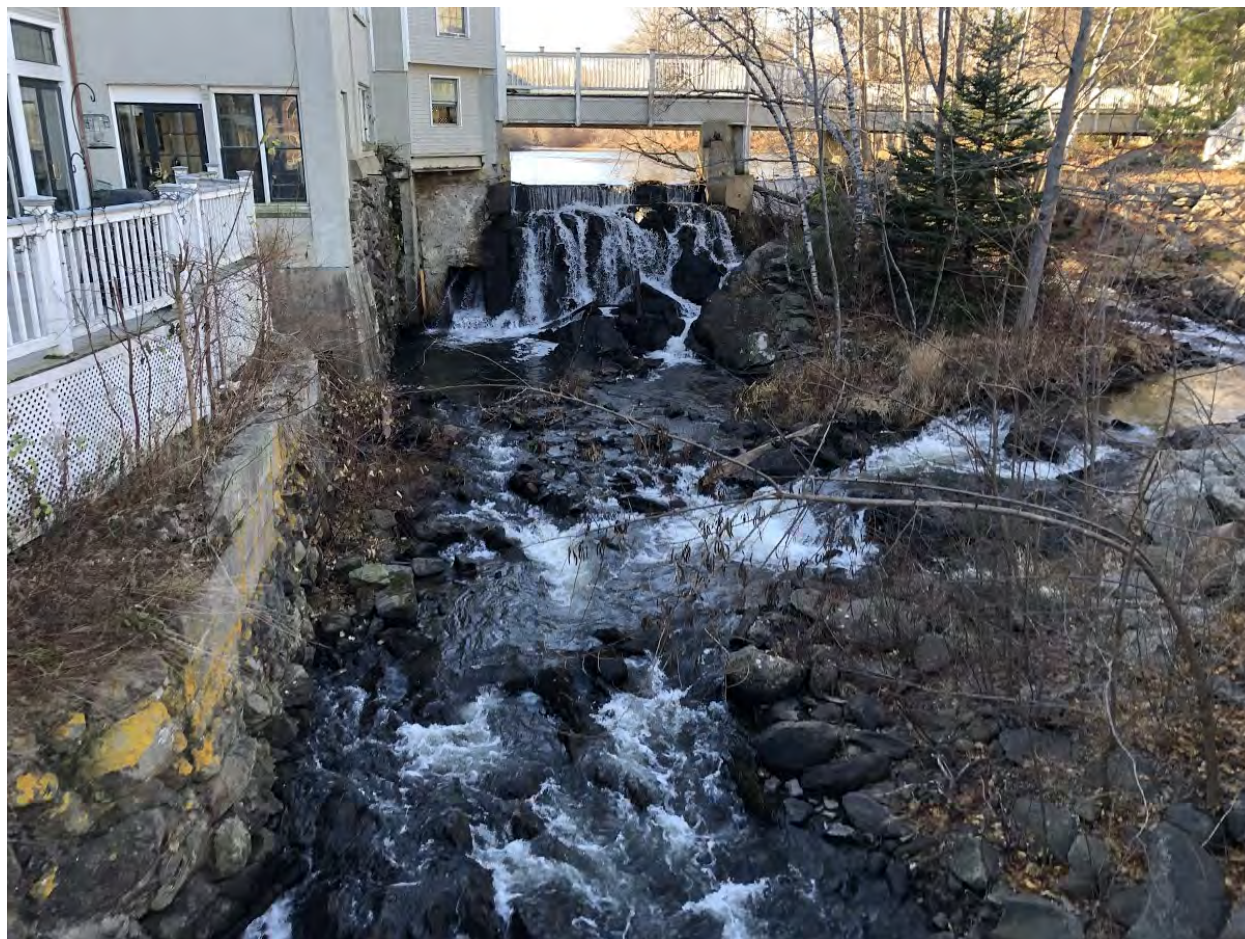
Figure 40. Looking upstream from the Knowlton Street Crossing at the river right channel and confluence with the river left channel downstream of the dam.

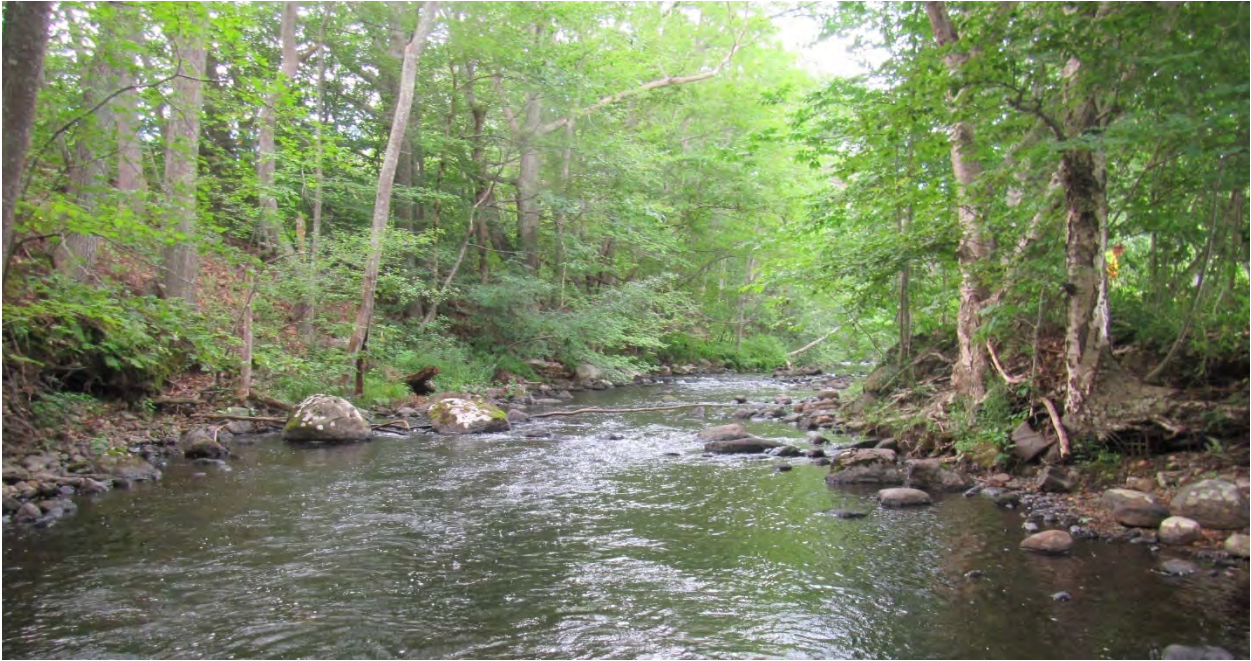
Figure 43. Looking upstream at the reach between the Rawson Street and Washington Street crossings.

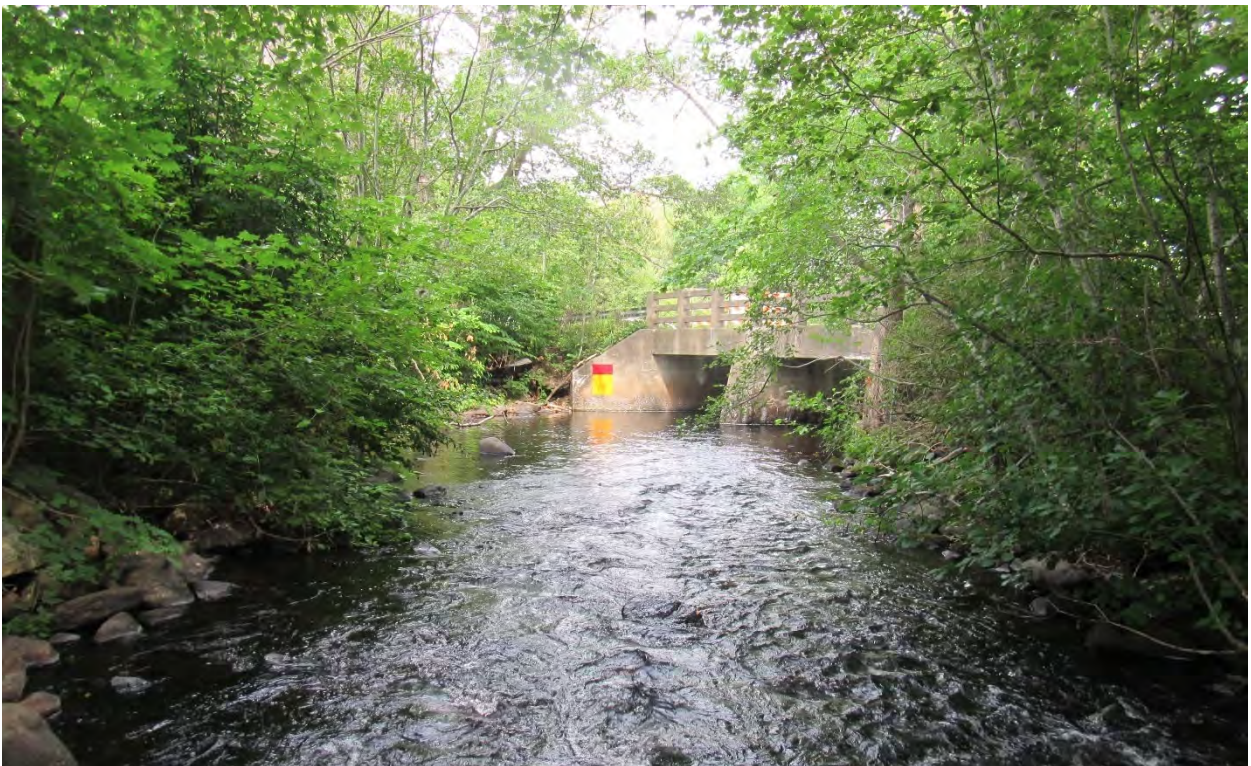
Figure 44. Looking downstream at the Rawson Street crossing.

The Rawson Street crossing at the downstream end of the reach is identified in this report as a fish passage consideration. Though the crossing itself does not present a significant obstacle to fish passage, it does constrict flow and impact instream habitat conditions, and has been prone to periodic debris accumulation including logs. The bridge also poses a navigation hazard for recreational paddlers at certain flow conditions. Because the crossing is condemned and no longer used for vehicle traffic, it presents an opportunity to improve fish passage by removing the

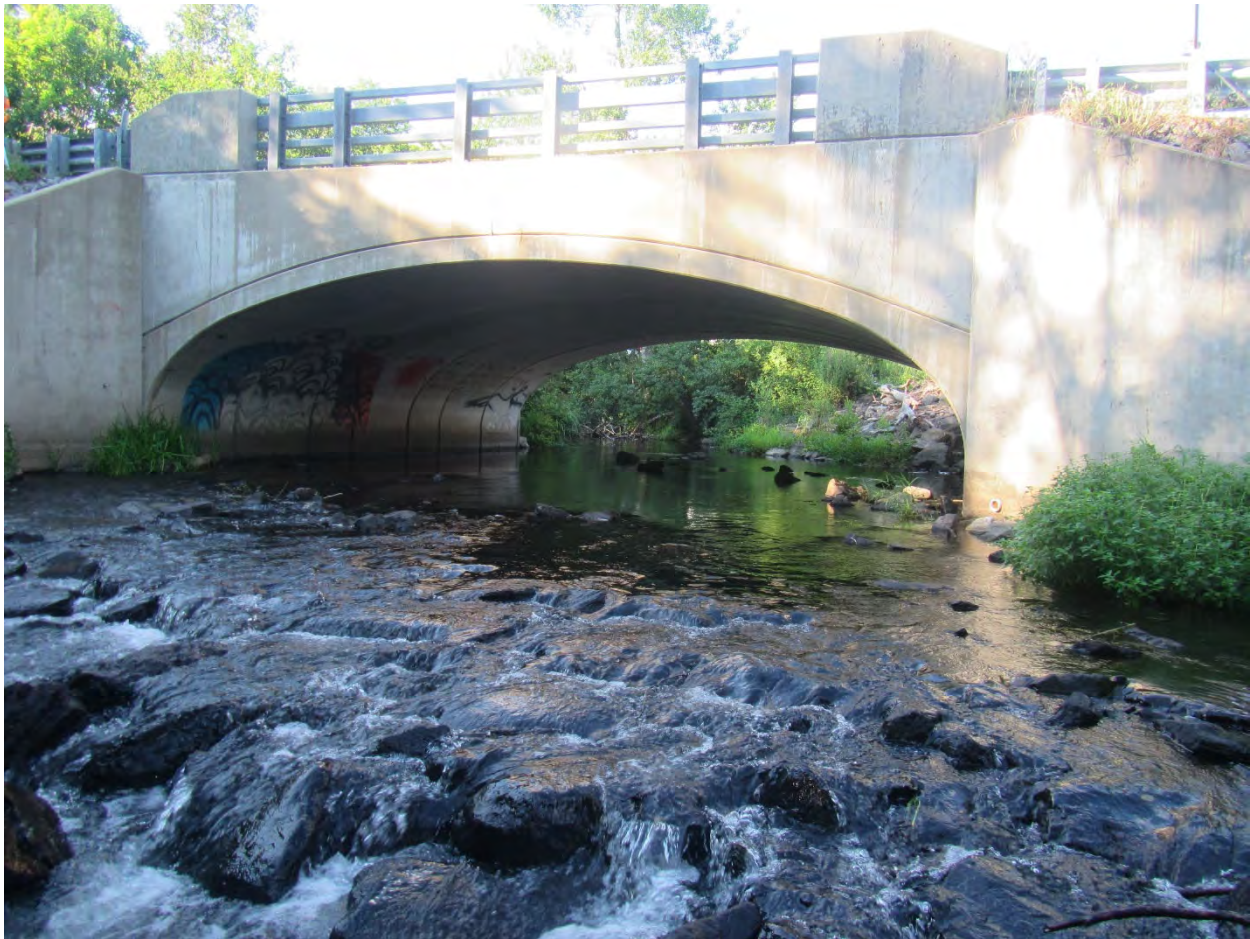
Figure 45. Looking upstream at the Washington Street crossing, A constructed grade control riffle is visible in the foreground.

The Washington Street crossing at the upstream end of the reach is also identified in this report as a fish passage consideration. The crossing is a clear span bridge with a grade control riffle constructed immediately downstream of the crossing to protect the bridge from scour. The slope and roughness of the riffle create a section of shallow, high velocity flow that may influence fish passage potential at some flows. Directly downstream of this location a historical dam was located which impoundment water and backwatered flow upstream to the Powder Mill dam area.

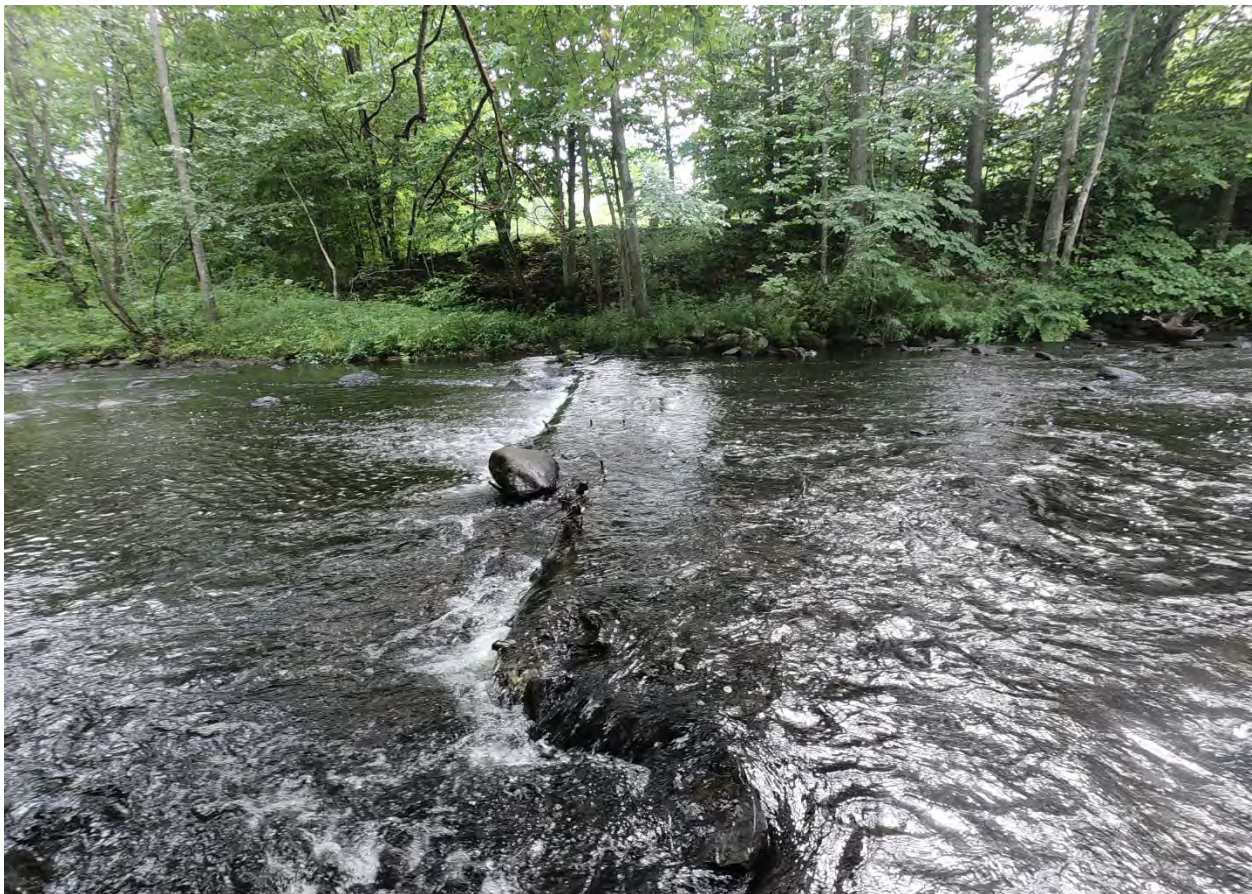
Figure 47. The remnants of a wooden crib dam approximately 330 feet downstream of the Powder Mill Dam.

The downstream portion of the reach exhibits similar characteristics to the Tannery Reach, with pool-riffle sequences and alternating bars. Approximately 330 feet downstream of the Powder Mill Dam are the remnants of a small timber crib dam (Figure 47). The crib structure is what remains of the lower of two dams associated with the D.H. Bisbee powder mills, described as 20 rods (330 feet) downstream of the upper dam in the Maine Hydrographic Survey's inventory of dams on the Megunticook (Wells 1868). The cribbing is nearly flush with the bed, causing a modest hydraulic step and does not present a serious fish passage concern.

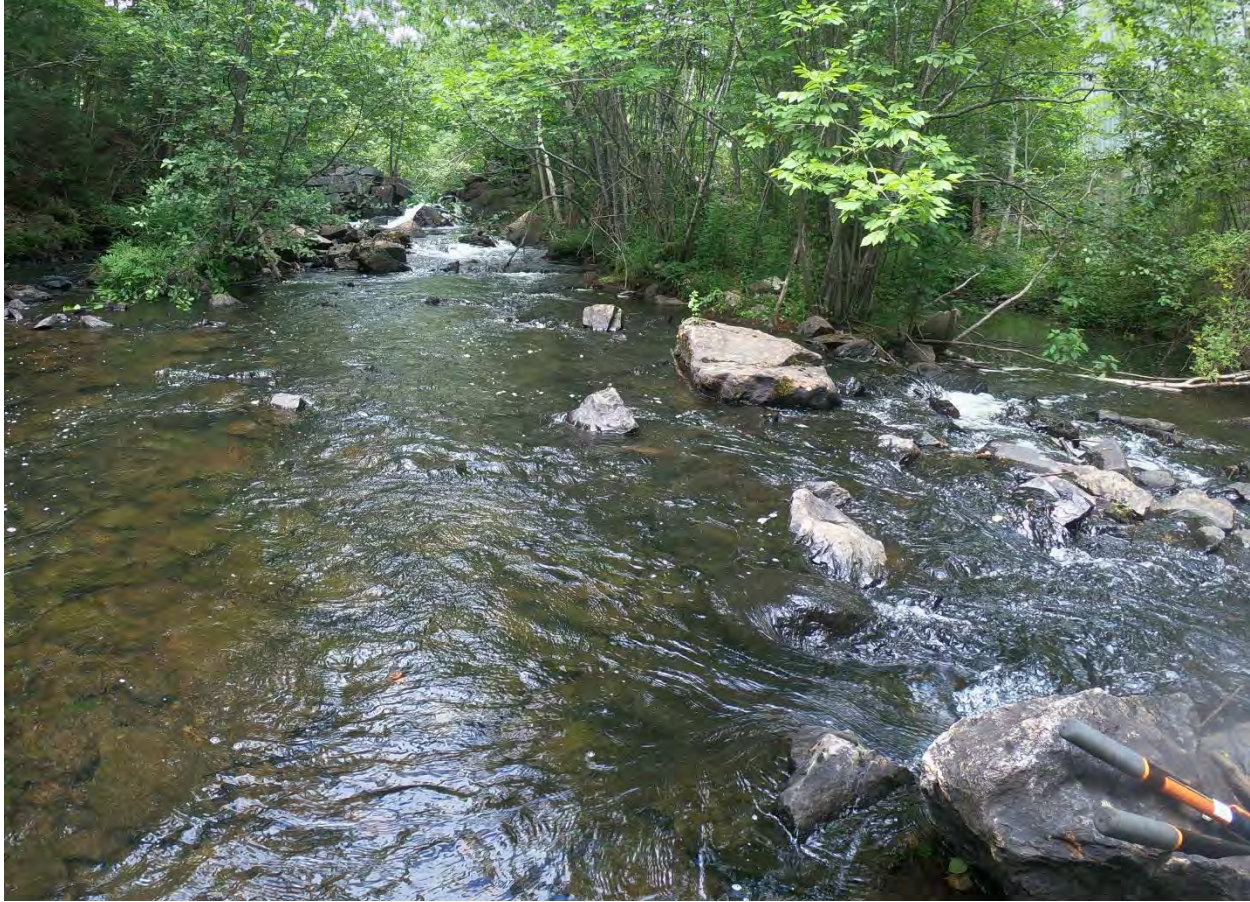
Figure 48. Looking upstream at the remains of the Powder Mill Dam. The break in the mid-channel island is in the foreground, with water flowing towards the river left channel and the alcove visible upstream of the break.

slight narrowing of the channel width. Immediately downstream of the dam there is a mid-channel island that extends from the dam face. A break in the island allows flow to split around it with an alcove extending back towards the dam on river left. A building wall forms the left bank of the channel through this section. The dam itself is partially breached and passes flow through the low point (Figure 49). Large granite blocks that have fallen from the dam structure make up much of the bed immediately downstream of the dam.

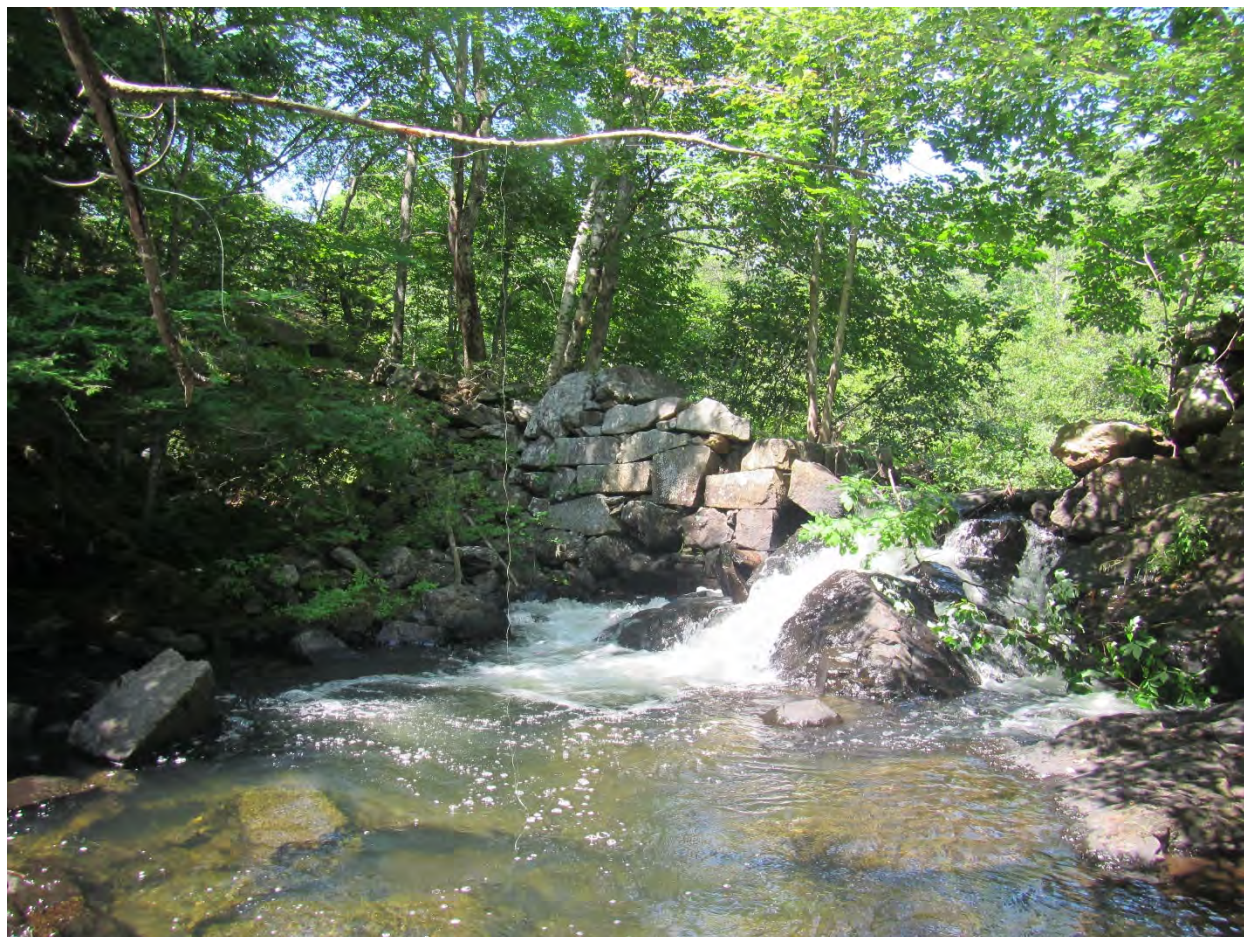
Figure 49. The Powder Mill Dam ruins. Granite blocks dislodged from the dam are visible in the channel in the foreground.

The Powder Mill dam breached many years ago. The structure is subject to progressive incremental failure in the years to come. The structure does not retain a large volume of water, and hence poses limited hazard in its present state.

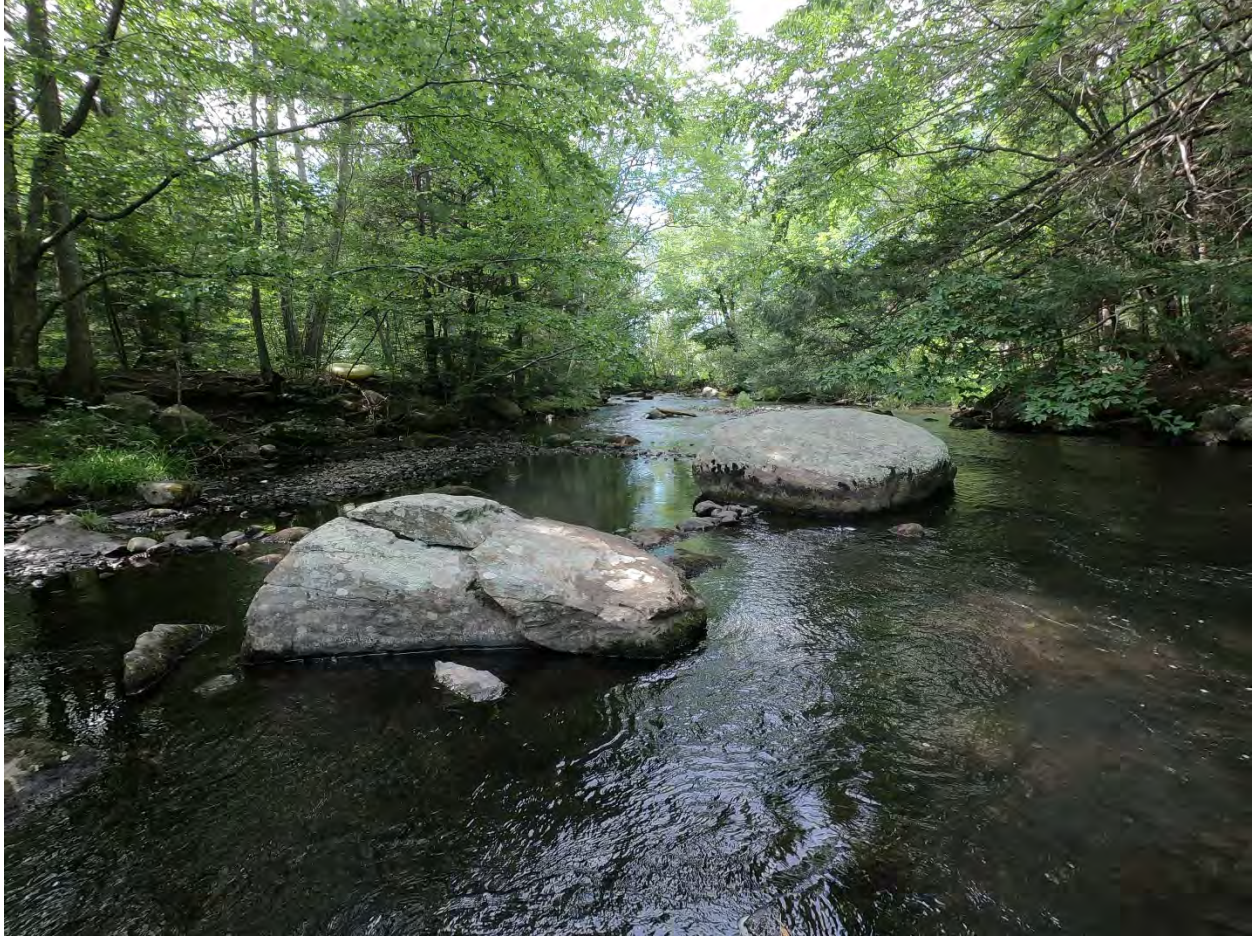
Figure 51. Boulders in the channel between Mount Battie Street and Seabright Dam.

Upstream of this confluence, the channel is split by a small island. The left channel has more flow than the right, though both are active at low flow. Additional complexity is added to the channel by large boulders and bedrock, which are both increasingly present in the subreach.

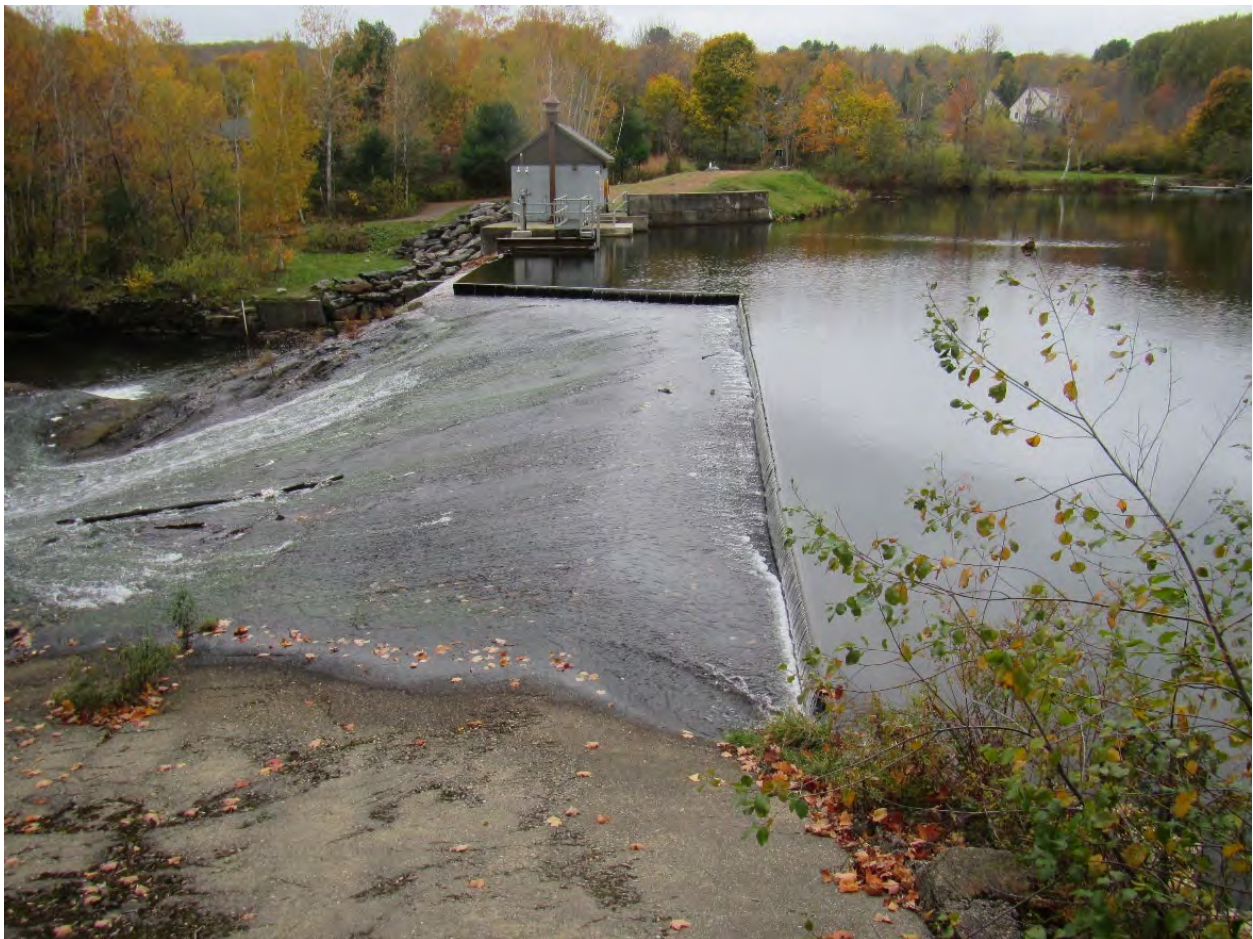
Figure 52. Seabright dam in 2020.

Seabright Dam is composed of stone masonry and concrete, and includes earth embankment wing walls. The dam features a 90-foot-long primary spillway and a 55-foot-long overflow spillway, and is classified as a high hazard dam. The most recent dam inspection report found a need for significant repairs in coming years, including remediation of a leaking joint in the concrete spillway that flows through the large rocks underneath and emerging in the sluiceway, resurfacing the spillway, and addressing the failed retaining wall downstream of the dam. Notable repair work was also completed in 2019 on the upstream face of the dam. See also Appendix A.

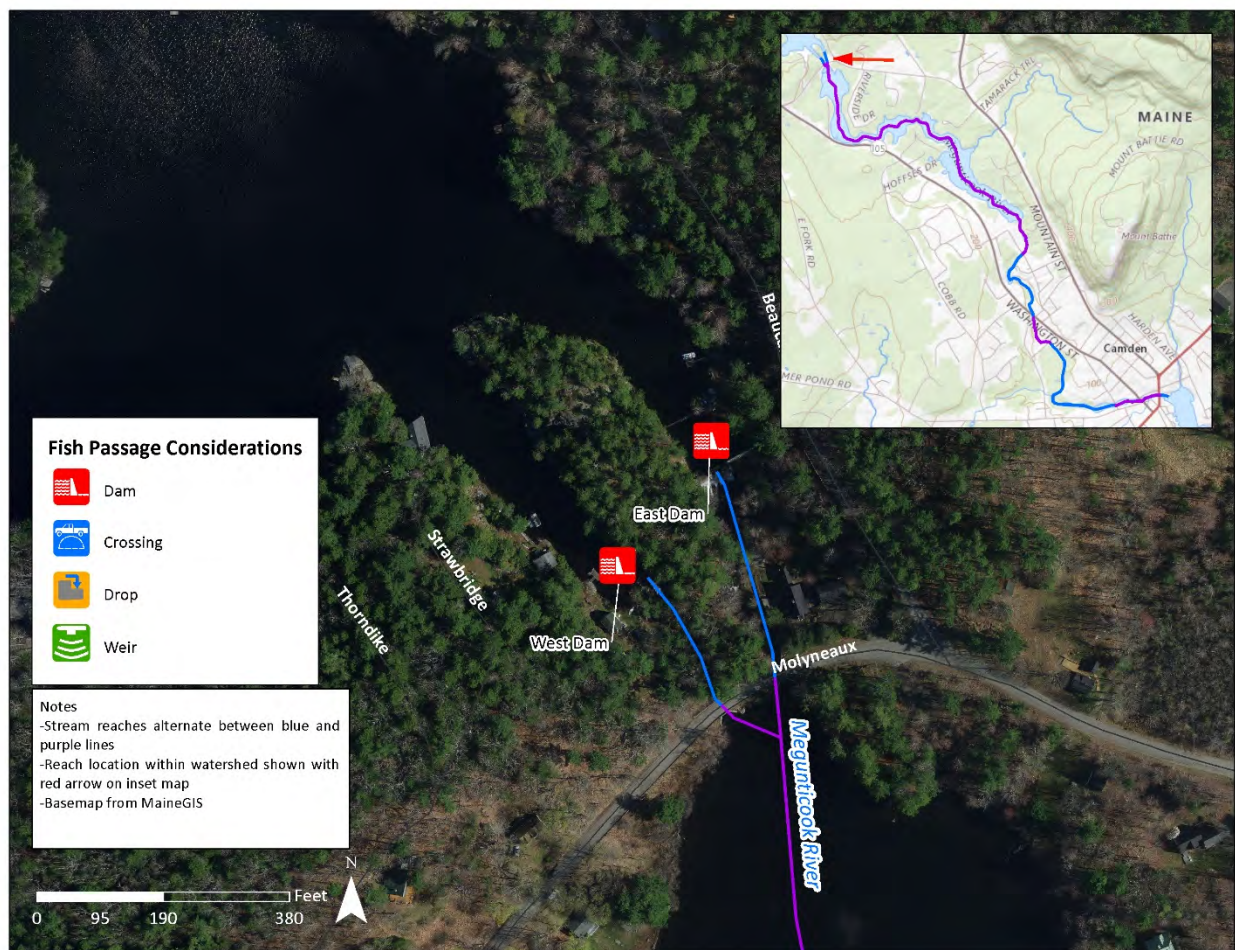
Figure 53. Overview of the Molyneaux Road to Megunticook Lake reach (blue line). Fish passage considerations are shown along the reach.

The reach from the Molyneaux Road crossing to Megunticook Lake is approximately 325 feet long. Over this reach, the Megunticook falls 18 feet, from an elevation of 140 feet to 122 feet, with an average slope of 5.5%. This reach is defined by the split flow around the bedrock knoll at the outlet of Megunticook Lake. The two channels enter the backwater of Seabright Pond and cross under Molyneaux Road through separate crossing structures. Below the West Dam, the west channel flows through a tight bedrock gorge before entering the backwater of the Seabright Pond upstream of Molyneaux Road. The east channel flows from the East Dam through a pool-riffle sequence and over west-dipping bedrock before entering the Seabright Pond backwater upstream of Molyneaux Road.

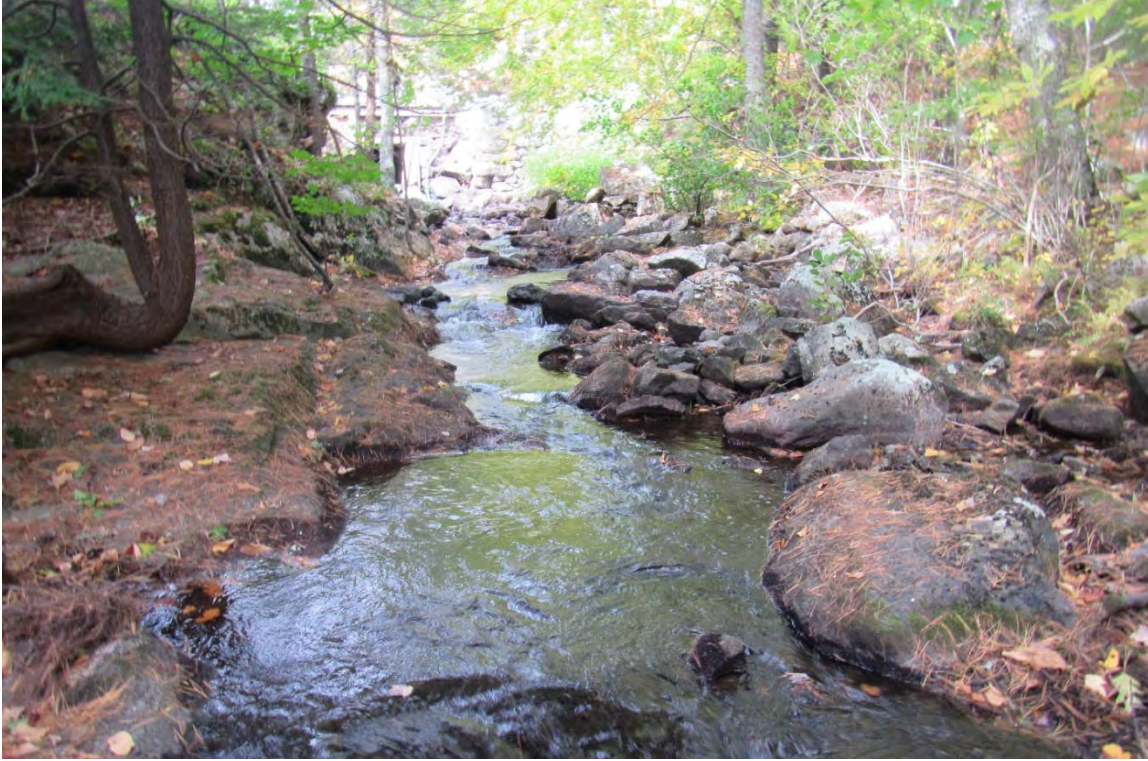
Figure 54. Looking upstream at the channel flowing from the West Dam. Steep bedrock forms the right bank of the channel.

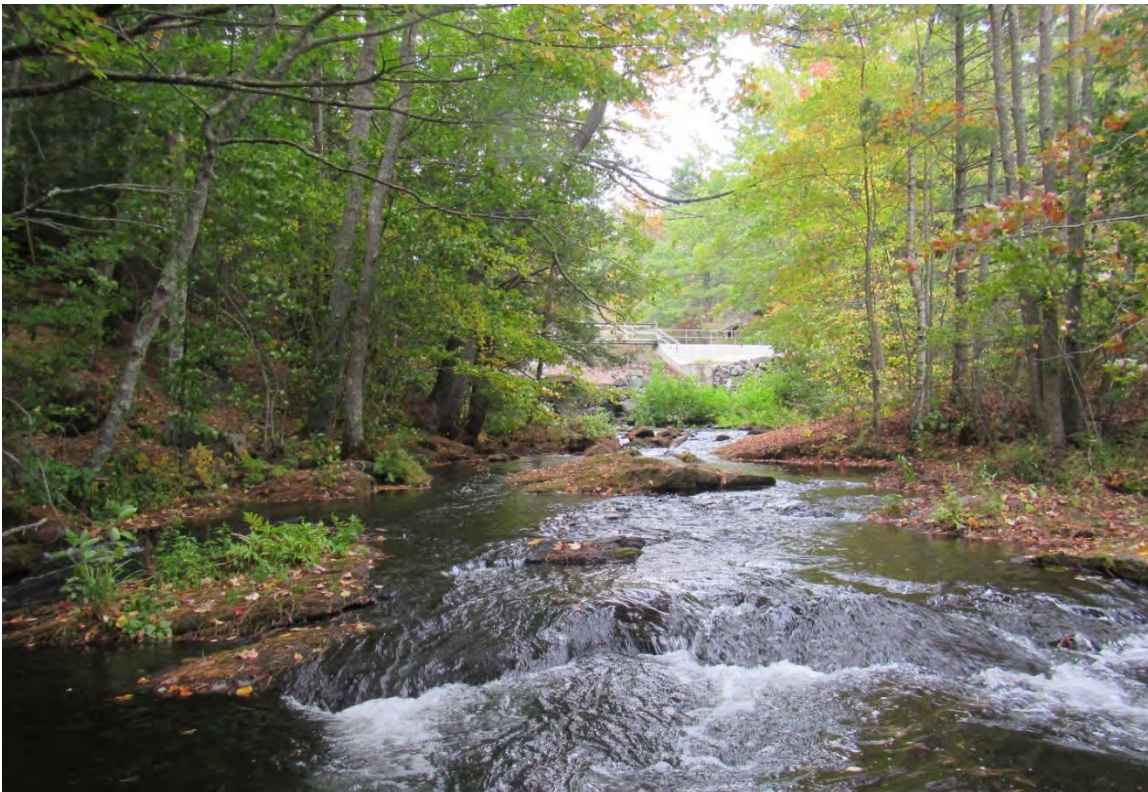
Figure 55. Looking upstream towards the East Dam. From the dam, the stream flows over bedrock and enters the backwater of Seabright Pond in the foreground.

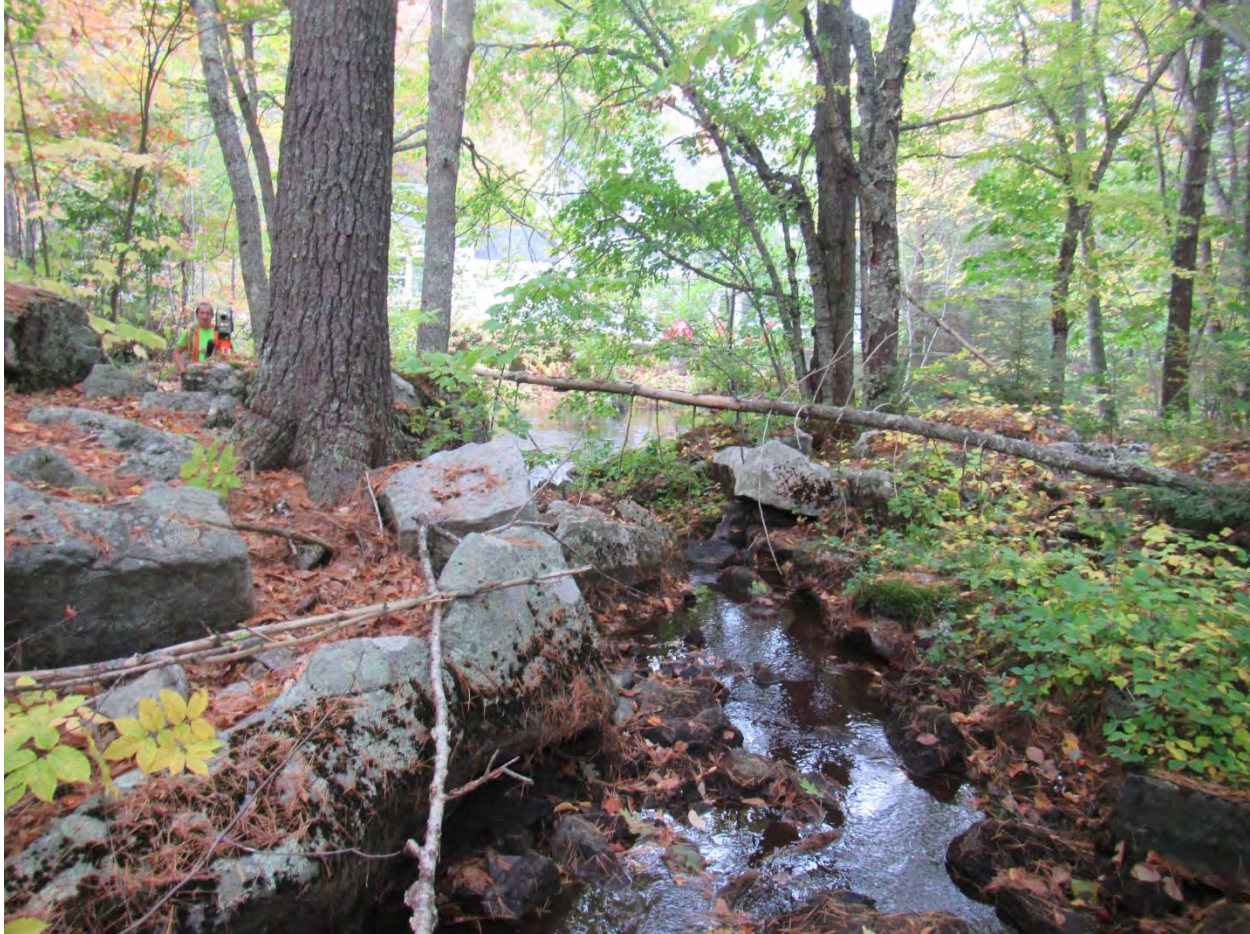
Figure 56. Looking downstream at the connector channel, flowing towards the east channel.

Approximately 125 feet downstream of the West dam, a small channel flows from the west channel to the east channel, crossing the forested area between the two channels. The channel is mix of step-pool and pool-riffle sequences and appears to convey perennial flow, being full at the time of the field assessment, conducted during drought conditions.

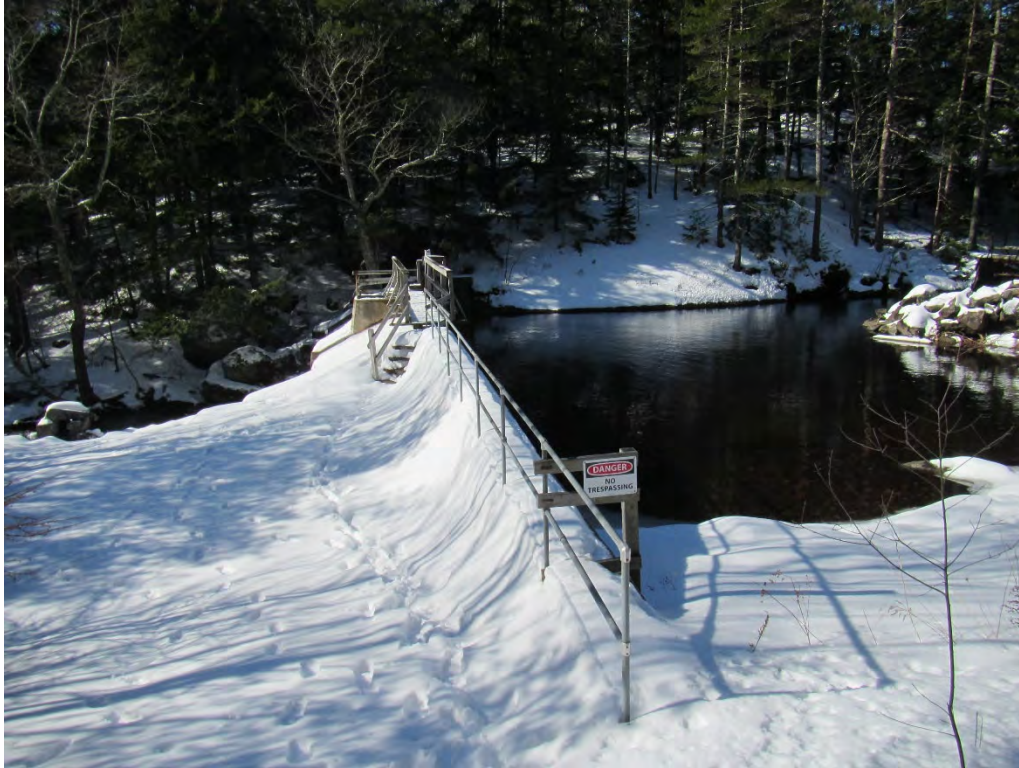
Figure 57. The East Dam in 2019.

East Dam is a gravity dam with two spillways, a gated sluice, and a trash rack structure, and is classified as a high hazard dam. The spillways are dry-laid masonry overlain with concrete. Past dam inspection reports conflict somewhat on the overall condition of the dam, with 2011 and 2019 reports prepared by Kleinschmidt reporting the dam to be in good condition, while a 2015 report from GEI found the dam to be in fair to poor condition.

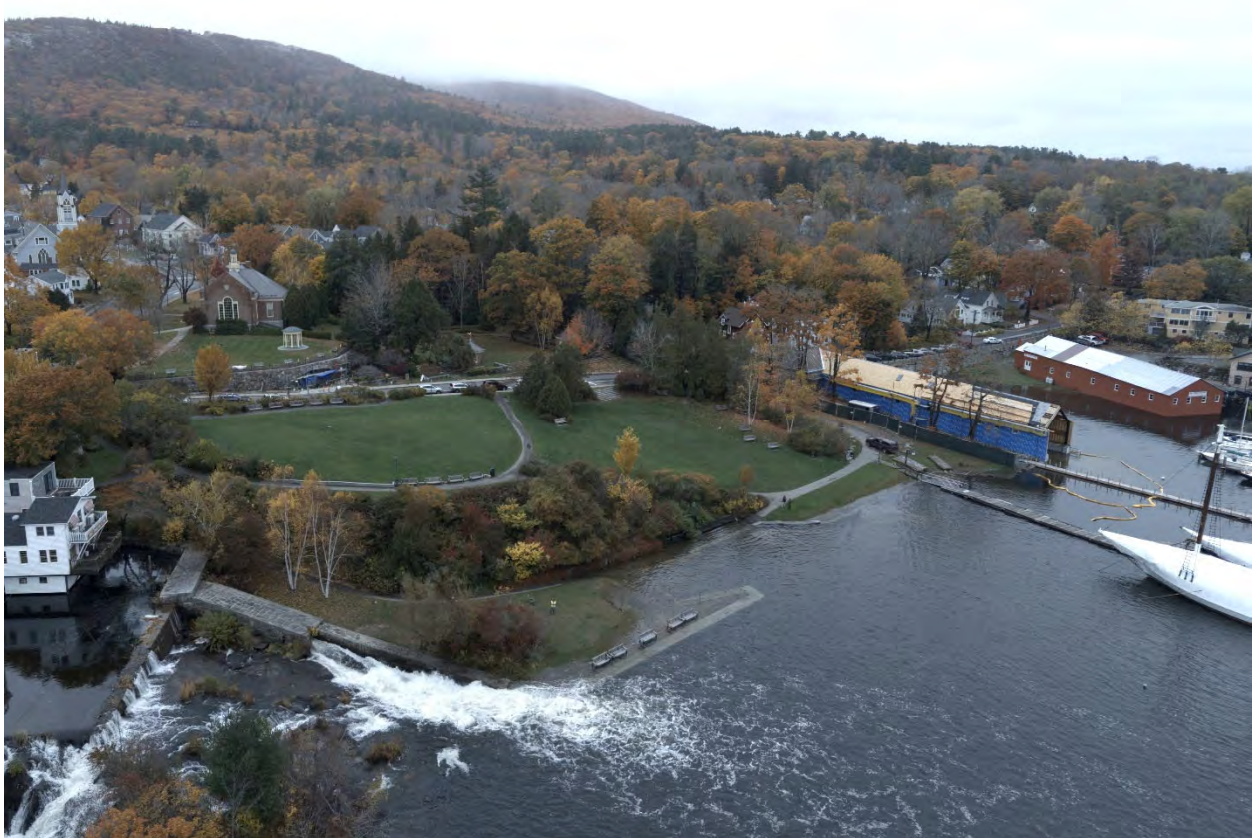
Figure 66. Tidal inundation of Harbor Park area in October 2019. Image credit: Jeff Senders.

Near the mouth of the Megunticook River, spring tides (high tide when the sun and moon are in alignment) and storm tides (high tide combined with storm surge) commonly overtop the sea wall and inundate portions of the Harbor Park area. The Town of Camden has initiated vulnerability assessment and resilience planning for the inner harbor and working waterfront area along with the Maine Department of Marine Resources and others (Wood 2019), including integrating specific planning targets in the Town’s comprehensive plan.
