Megunticook River Feasibility Report

Camden, ME

July 31, 2021

Town of Camden,
Maine

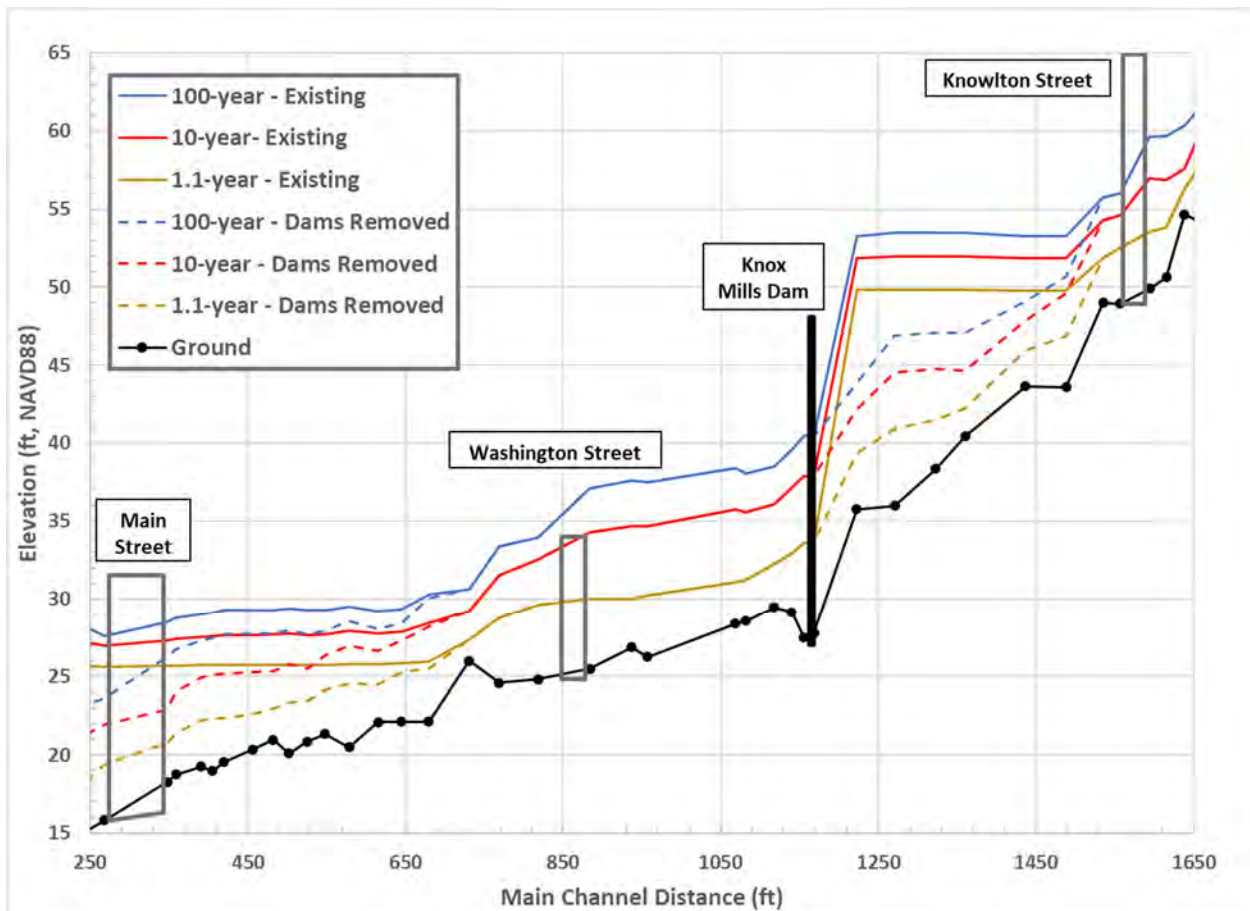
Figure 73. Simulated flood water surface profiles for the reach from Main Street to Knowlton Street. Solid lines denote existing condition profiles; dashed lines denote water surface profiles associated with the long term restored river model scenarios. Flow events shown include the 100-year, 10-year, and 1.1-year events.

Flood flow hydraulic conditions in the reach between Main Street and Knowlton Street are heavily influenced by Knox Mill Dam, numerous road crossings, and the constricted channel geometry. Backwater effects of hydraulic structures are localized due to the steep slope of the reach. Demonstrated reductions in the flood profile at Main Street and at the footbridge are caused by the removal of Montgomery Dam. Flood profile changes are limited in the subreach reach between the footbridge and Knox Mill Dam solely due to removal of Montgomery Dam and Knox Mill Dam. (Table 10; Figure 73).

The estimated reduction in water surface resulting from dam removal is 9.4 feet for the 100-year flow immediately upstream of Knox Mill Dam, and ranges from approximately 5 to 10 feet throughout most of the Knox Mill impoundment (Figure 73). No change in the flood profile is expected at Knowlton Street, as the bridge crossing lies outside the Knox Mill Dam impoundment. Inundation extents of the 10-year flood flow would be reduced and confined within the existing Knox Mill Dam impoundment. Between Knox Mill Dam and Main Street, modeling demonstrates a slight narrowing during the 10-year and 100-year events relative to existing conditions (Figure 74 and Figure 75).

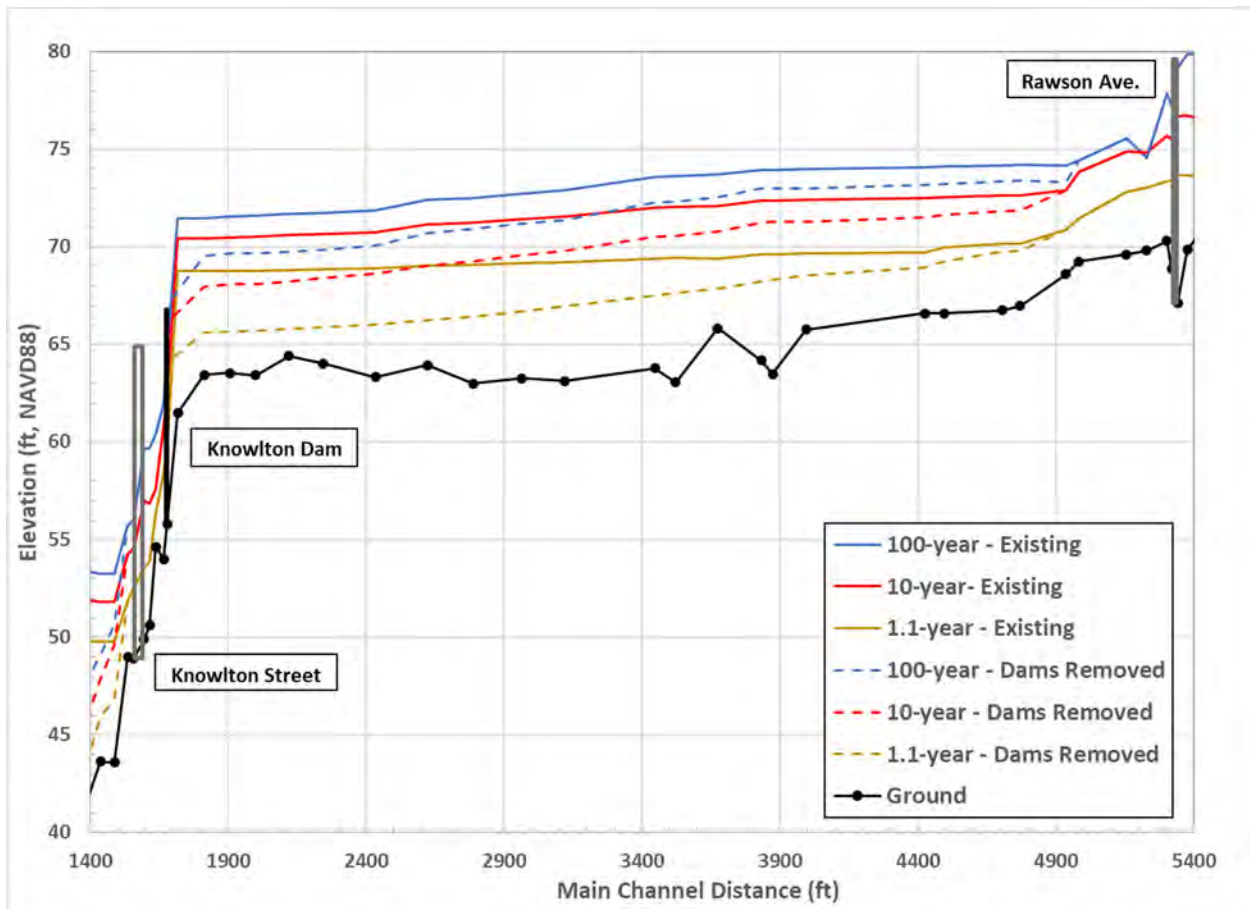
Figure 76. Simulated flood water surface profiles for the reach from Knowlton Street to Rawson Avenue. Solid lines denote existing condition profiles; dashed lines denote water surface profiles associated with the long term restored river model scenarios. Flow events shown include the 100-year, 10-year, and 1.1-year events.

Flood profiles between Knowlton Street and Rawson Avenue are chiefly controlled by Knowlton Street Dam, which is constructed on top of a bedrock outcrop. The reach downstream of Knowlton Street Dam is a steep bedrock and boulder channel with a slope of approximately 10%. Hydraulic modeling demonstrates that this area would not experience changes in water surface elevations up following dam removal for the 100-year flow event (Table 11; Figure 76). At Knowlton Street Dam, a reduction in water surface elevation of 4.1 feet is predicted for the 100-year flow event, and a reduction of 0.8-4.1 feet is expected throughout the impoundment following either restoration or long-term evolution of the channel within the impoundment, assuming the channel's geometric characteristics eventually take the form of the reach upstream of the impoundment. The Rawson Avenue bridge is upstream of the impoundment and no change to flood profiles is predicted at this location. Modeling suggests inundation extents of the 10-year and 100-year flow will be confined within the existing impoundment in the downstream half of the Knowlton Street Dam impoundment, and will occupy a broader low-lying area in the upper half of the impoundment (Figure 77 and Figure 78).

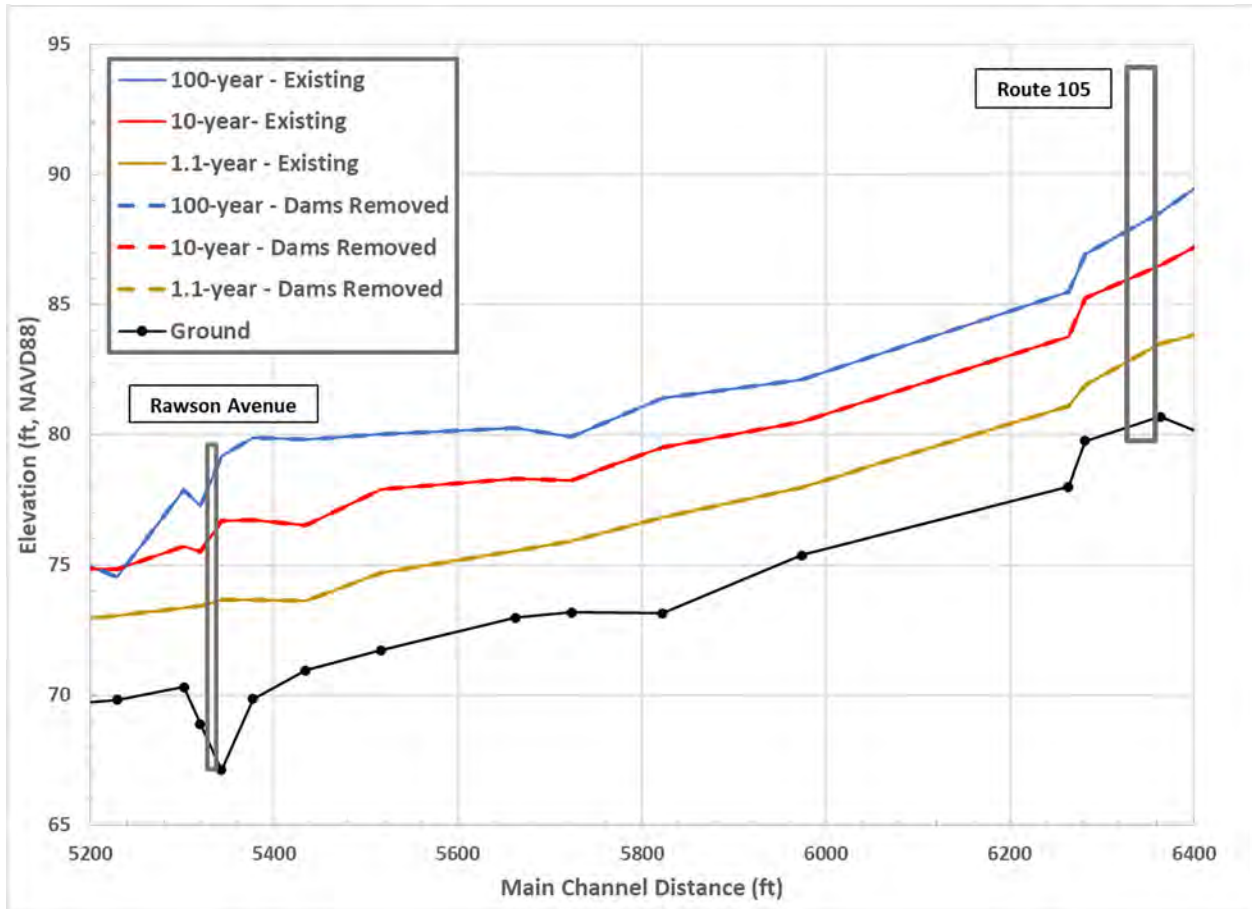
Figure 79. Simulated flood water surface profiles for the reach from Rawson Avenue to Route 105. Solid lines denote existing condition profiles; dashed lines denote water surface profiles associated with the long-term dam removal model scenarios. Note the lines overlap in this figure as there is no change in water surface profile. Flow events shown include the 100-year, 10-year, and 1.1-year events.

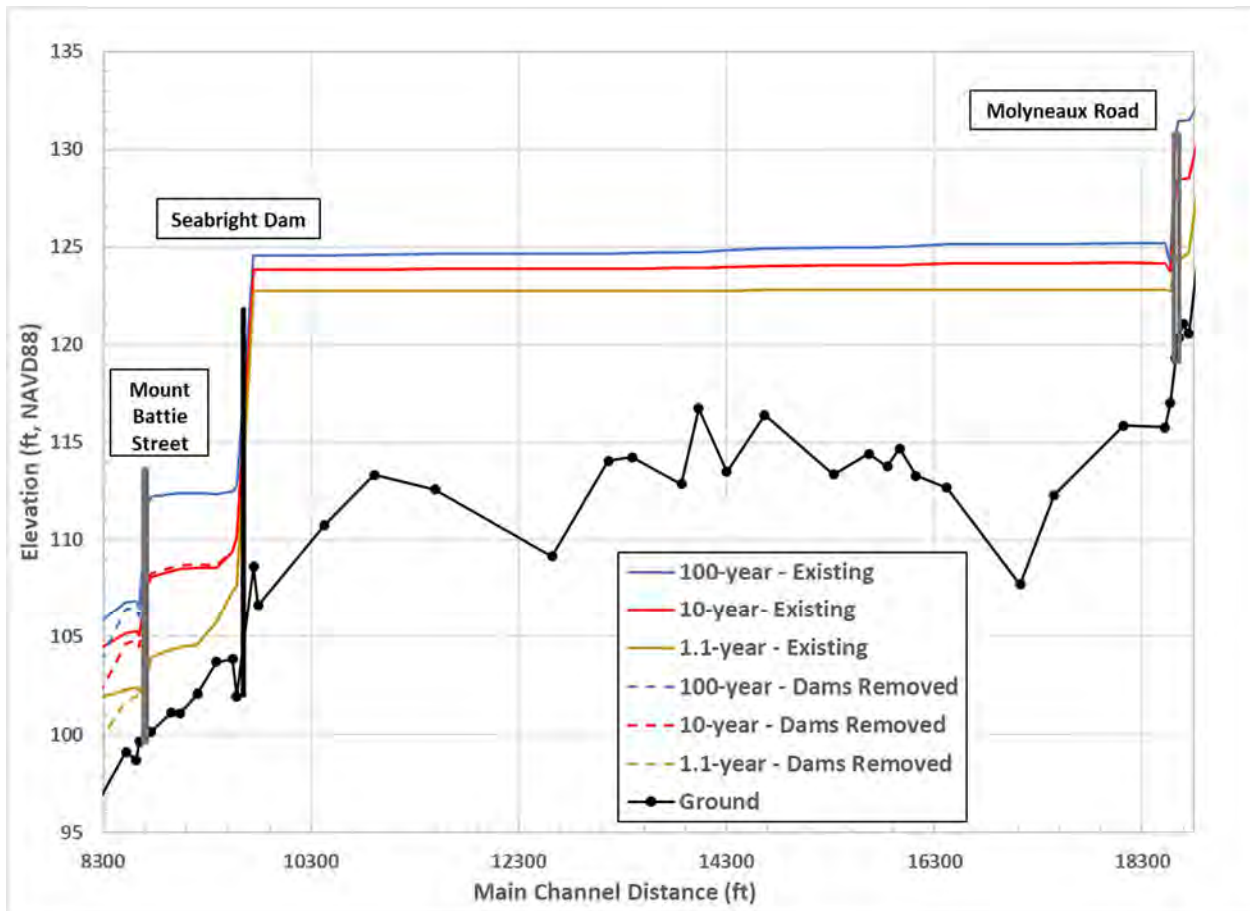
Figure 85. Simulated flood water surface profiles for the reach from Mount Battie Street to Molyneaux Road. Solid lines denote existing condition profiles; dashed lines denote water surface profiles associated with the long-term dam removal model scenarios. Note the lines overlap in portions of this figure as there is no change in water surface profile. Flow events shown include the 100-year, 10-year, and 1.1-year events.

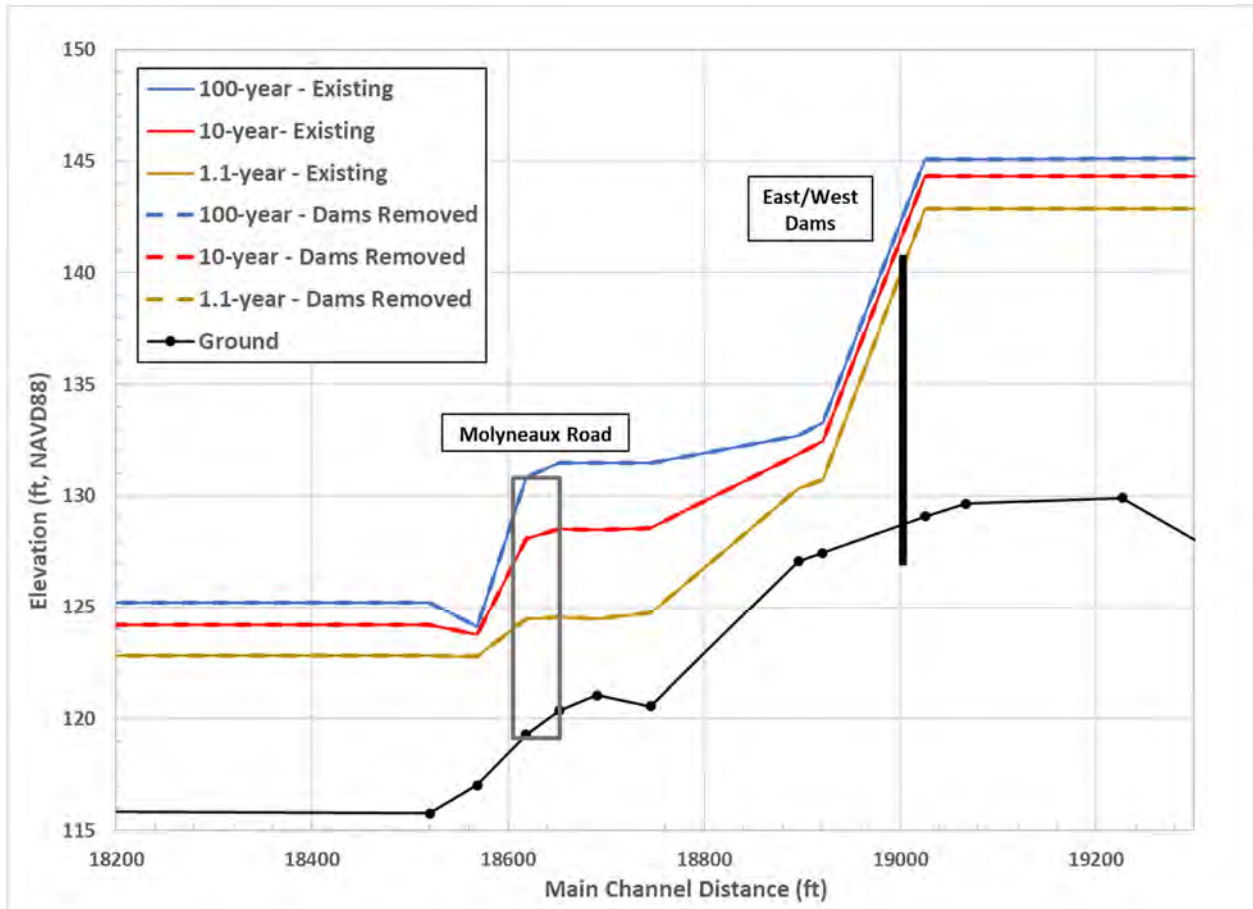
Figure 88. Simulated flood water surface profiles for the reach from Molyneaux Road to Megunticook Lake. Solid lines denote existing condition profiles; dashed lines denote water surface profiles associated with the long-term dam removal model scenarios. Note the lines overlap in this figure as there is no change in water surface profile. Flow events shown include the 100-year, 10-year, and 1.1-year events.

Flood profiles between Molyneaux Road and Megunticook Lake are influenced by East and West Dams and the Molyneaux Road crossing. There are no predicted changes in flood water surface profiles in the reach. (Table 15; Figure 88). Inundation extents of flood flows, including the 10-year and 100-year flows, will not change in the reach under the long-term river restoration scenario (Figure 89 and Figure 90).

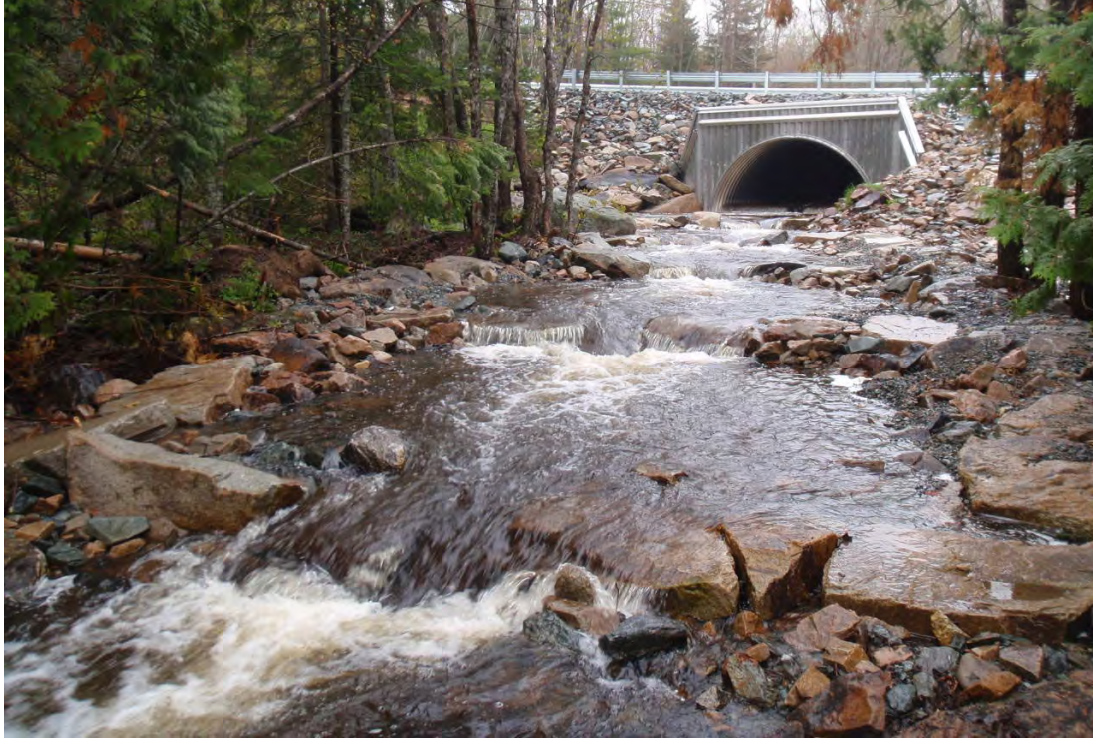
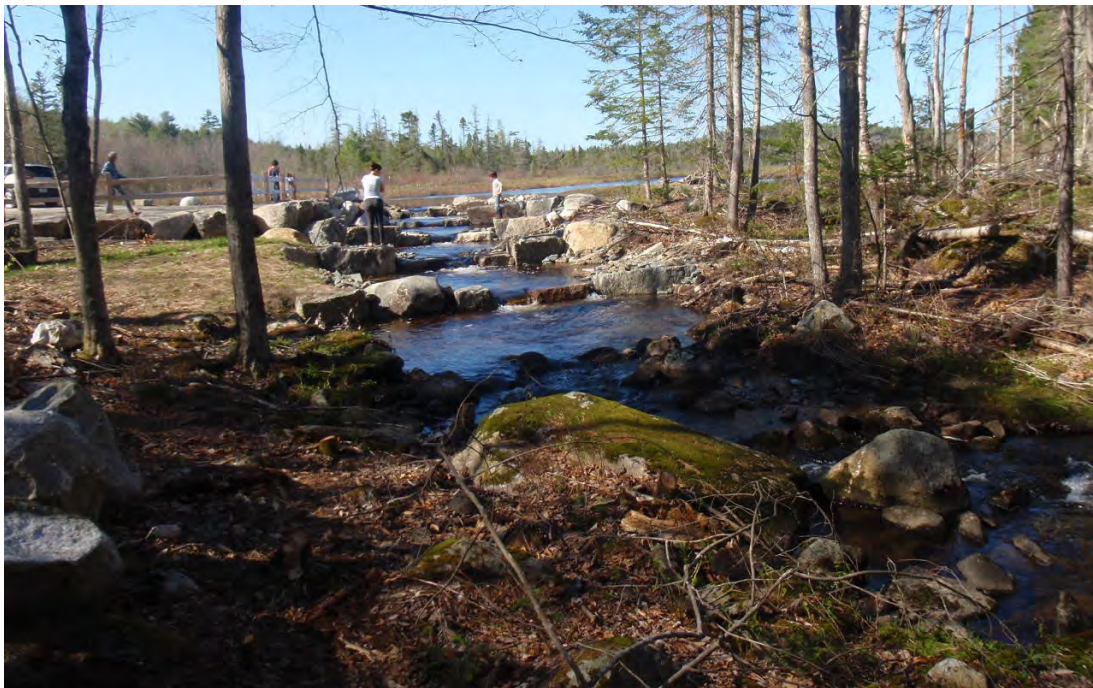
Figure 91. Examples of constructed nature-like fish passage (photo credits: Matt Bernier).

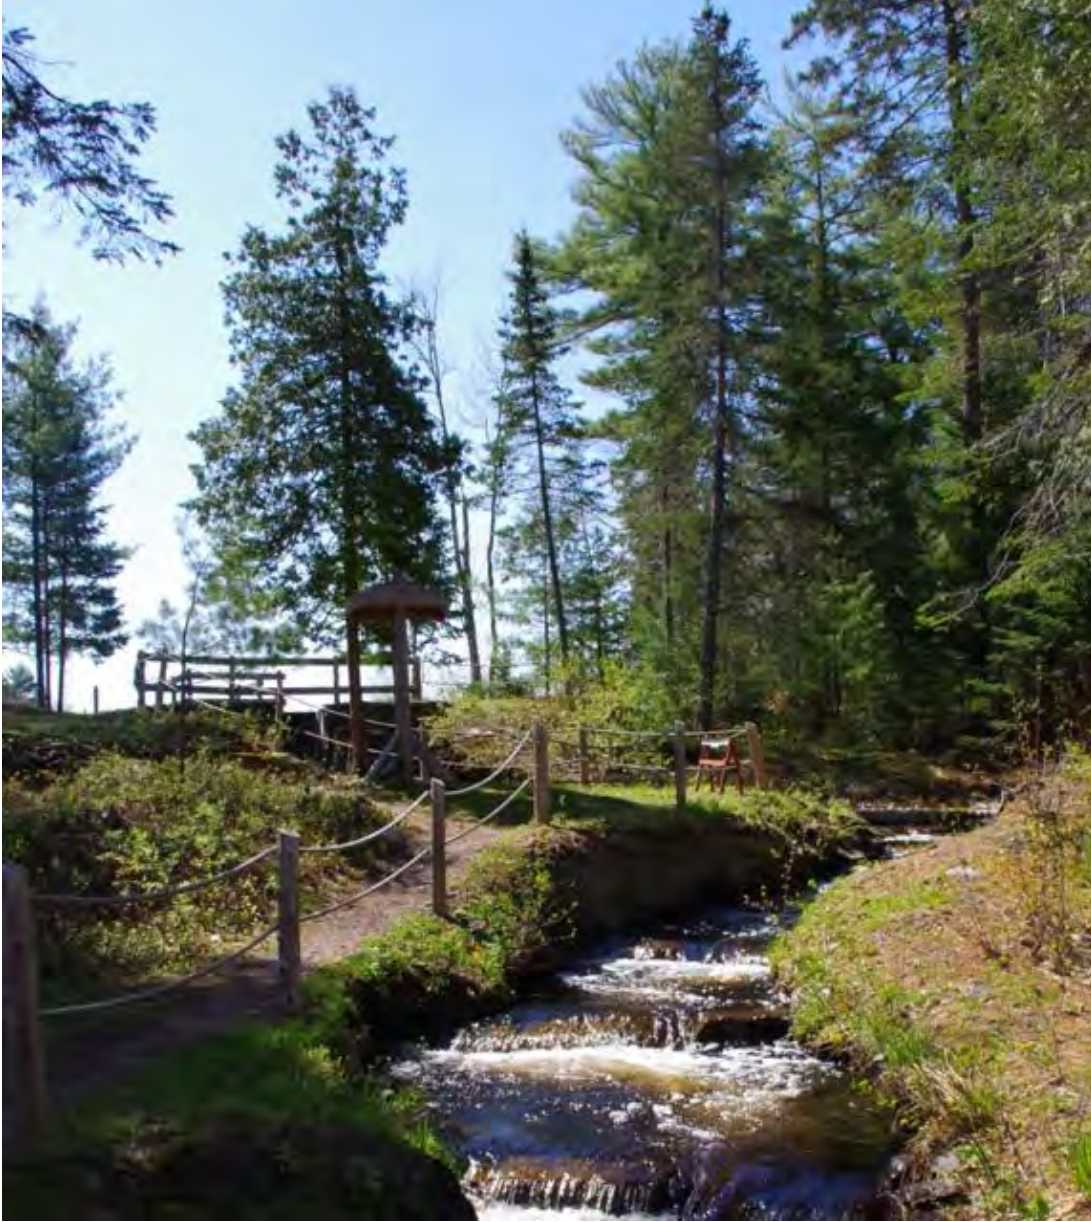
Figure 92. Pool and weir fishway at Blackman Stream (photo credit: Maine Sea Grant).

Among the technical passage approaches, the pool and weir approach is generally favored on the basis of performance and reduced constraints relative to Denil fishways. Pool and weir ladders are typically also easier to add aesthetic enhancements too. However, pool and weir fishways are more expensive than Denil ladders.

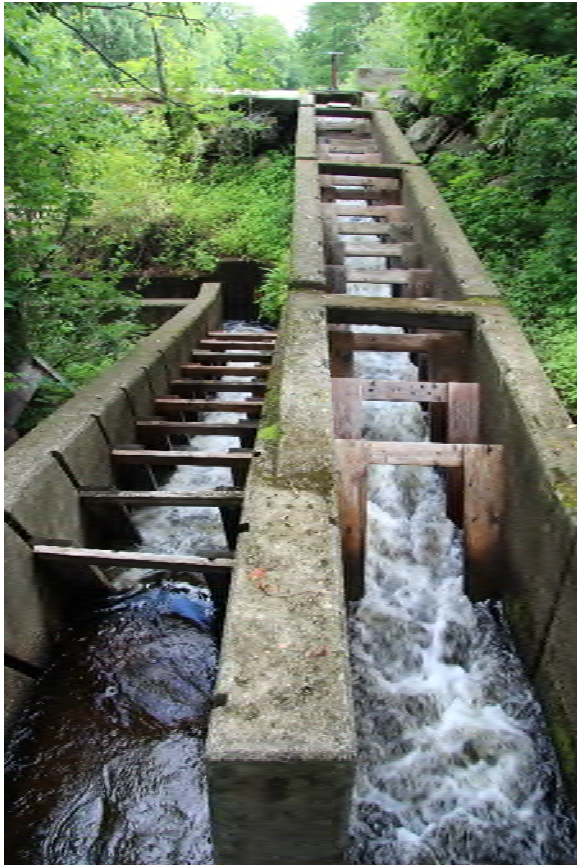
Figure 93. Example of a Denil fishway.

Lastly, Denil fishways are typically the least preferred approach. Although they can be very effective for river herring and salmonids including resident brook trout if sited and designed properly, they can be constrained by biological and flow capacity. Typically, standard Denil fish passage designs are considered to have biological capacity for approximately 200,000 to 300,000 river herring. They possess greater sensitivity to operating conditions, particularly flow conditions at the entrance and exit, can be susceptible to debris clogging, and the flow limitation may limit the attraction signal in some instances. This is especially true at locations where competing flow signals may occur, such as dispersed flow over ledge outcrops. Operation and maintenance costs for Denil fishways are typically high, especially those that use wooden baffles.

Yet, Denil fishways are often the technical fishway option with the lowest initial construction cost due to simpler construction and relatively smaller footprint. They are more utilitarian in nature, and although it is possible to add flourishes such as masonry veneer, they tend to be less pleasing aesthetically. There are many Denil fishways in Maine, with varying degrees of performance and success, from sites with highly efficient passage for river herring and trout, to sites that perform poorly and are presently subject to removal. With Denil fish passage facilities, typically a separate eel passage structure is required, although eel may be able to partially ascend sites with exposed ledge outcrops if suitable flow exists.

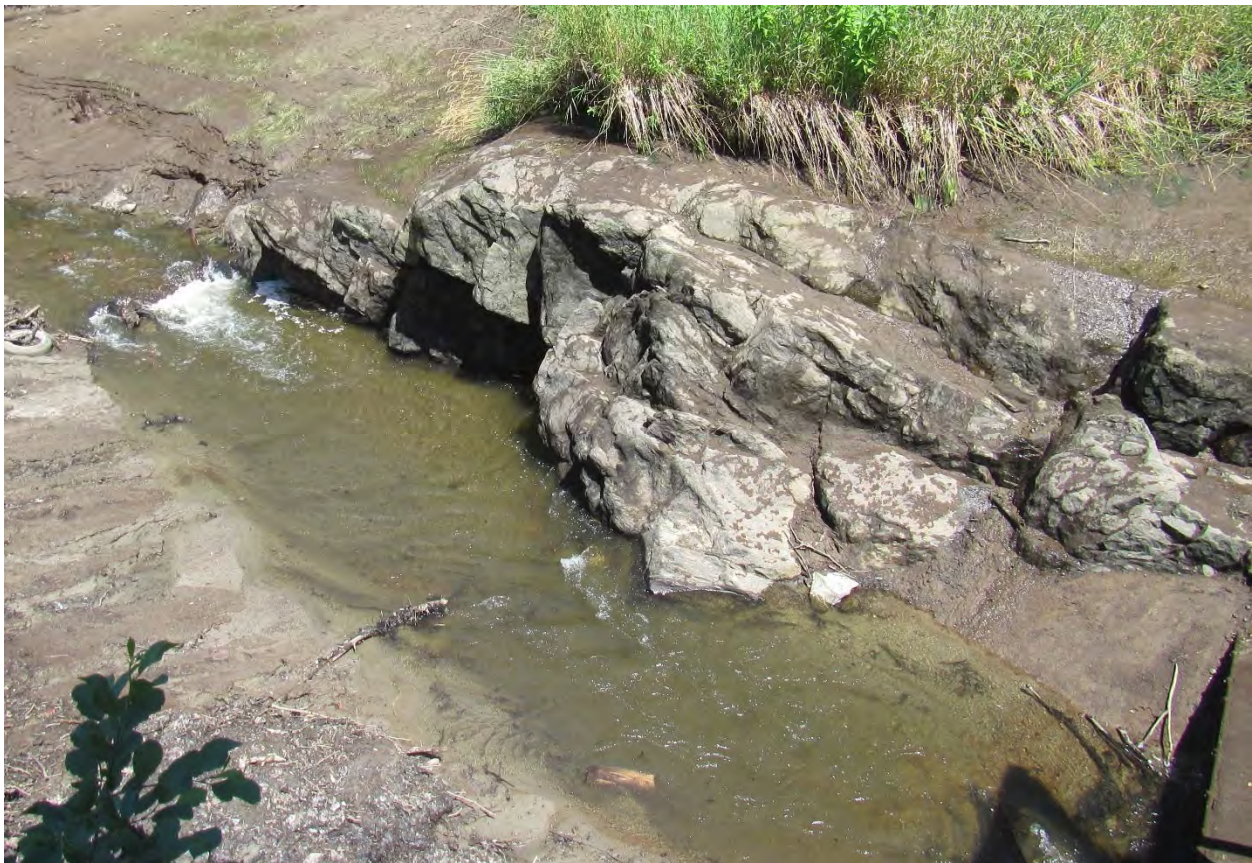
Figure 94. *Photo of the channel immediately upstream of Knox Mill Dam in a drawn-down condition. The shadow of the open gate structure is visible in the bottom right corner.*

Following removal of the structure, the newly exposed bedrock channel may require modest proactive management to provide safe, timely, and effective fish passage conditions because the channel corridor is modified from the historical condition. Assessment of the impoundment after the summer 2020 drawdown suggests a relatively narrow channel would be present at the site of the dam with an effective gradient of 4.5% through the footprint of the dam (Table 17, Figure 94). The condition of the river bed beneath the dam spillway is not known. In the detailed design phase,

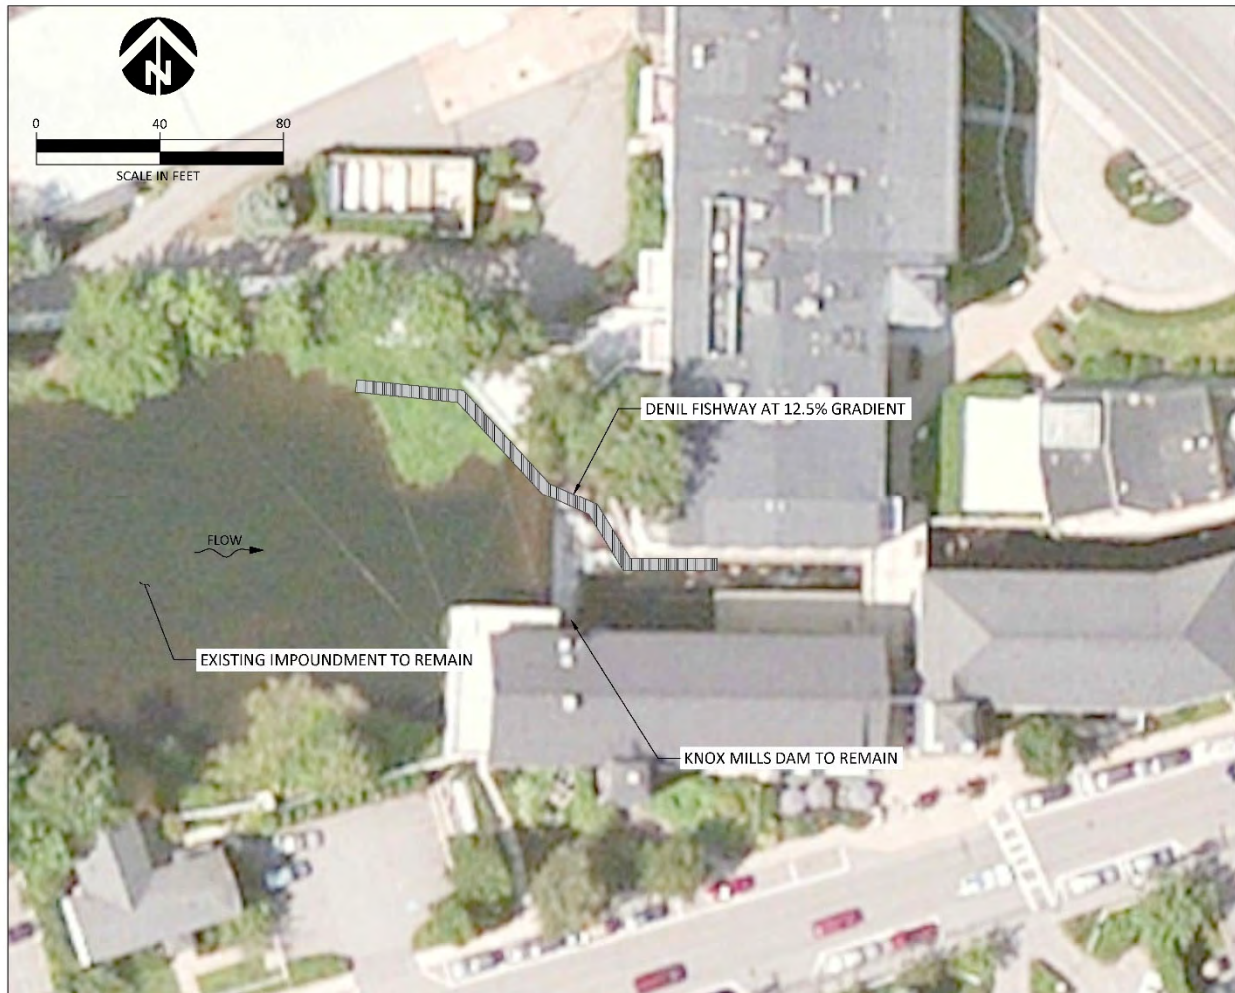
Figure 95. Schematic layout of a Denil fishway at Knox Mill Dam.

A Denil fishway option would need to extend upstream of the dam to avoid excessive downstream length or switchbacks. The alignment shown in Figure 95 displays a potential configuration of a Denil fishway. Turning pools at fishway bends would need to be incorporated, and resting pools would be needed for every 6 to 9 feet of elevation gain not featuring a turning pool.

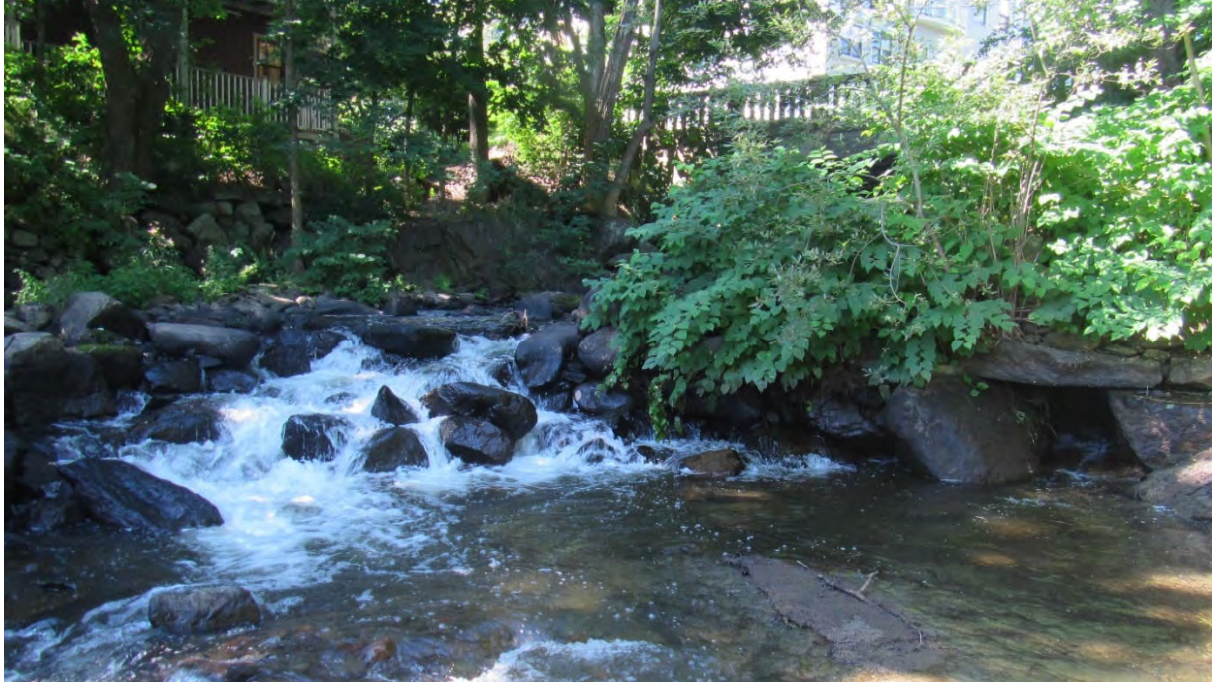
Figure 96. Photo of the remnant dam upstream of Knox Mill Dam.

Although Knox Mill Dam presents the primary constraint to fish passage in the surrounding reach, a remnant boulder dam is located just below the upstream end of the impoundment, and will influence flow if Knox Mill dam were removed. When the impoundment is full, the relict dam is submerged. This feature creates a drop of approximately 2-4 feet, depending on flow (Figure 96). This relict dam may be a passage barrier to non-leaping fish such as river herring at many flows. Fish passage at the feature would be restored by manipulating the boulders to manage the vertical drop along a more gradual gradient. Boulders could be moved to nearby areas where they would disperse flow, creating velocity refugia and habitat variability within the main channel for migrating fish and aquatic species.

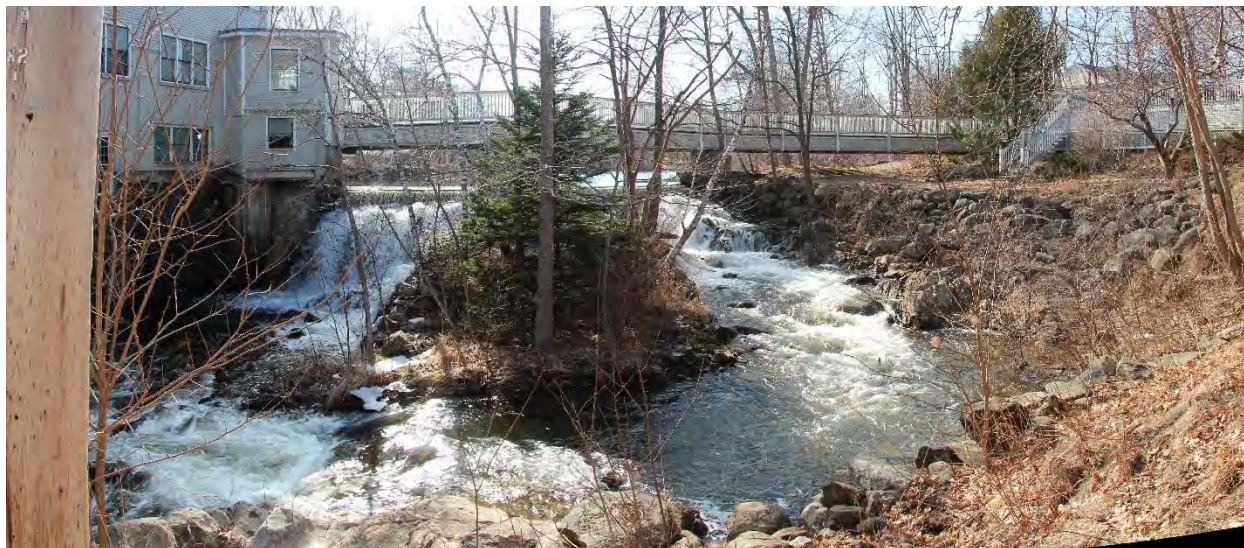
Figure 97. Composite photo of the existing side channel (right side of photo) through which fish passage could be attained under a dam removal scenario at Knowlton Street Dam.

Removal of Knowlton Street Dam would permit safe, effective, and timely fish passage. The dam is constructed on a bedrock ledge, which would be revealed following removal of the vertical dam structure. Following dam removal, flow would preferentially flow over the left side of the bedrock ledge, and through the channel on the left side of the island. This channel is composed of a series of three bedrock/boulder steps and pools and has a slope of approximately 6.3% from the downstream ledge to the exposed bedrock at the dam (Table 18; Figure 97).

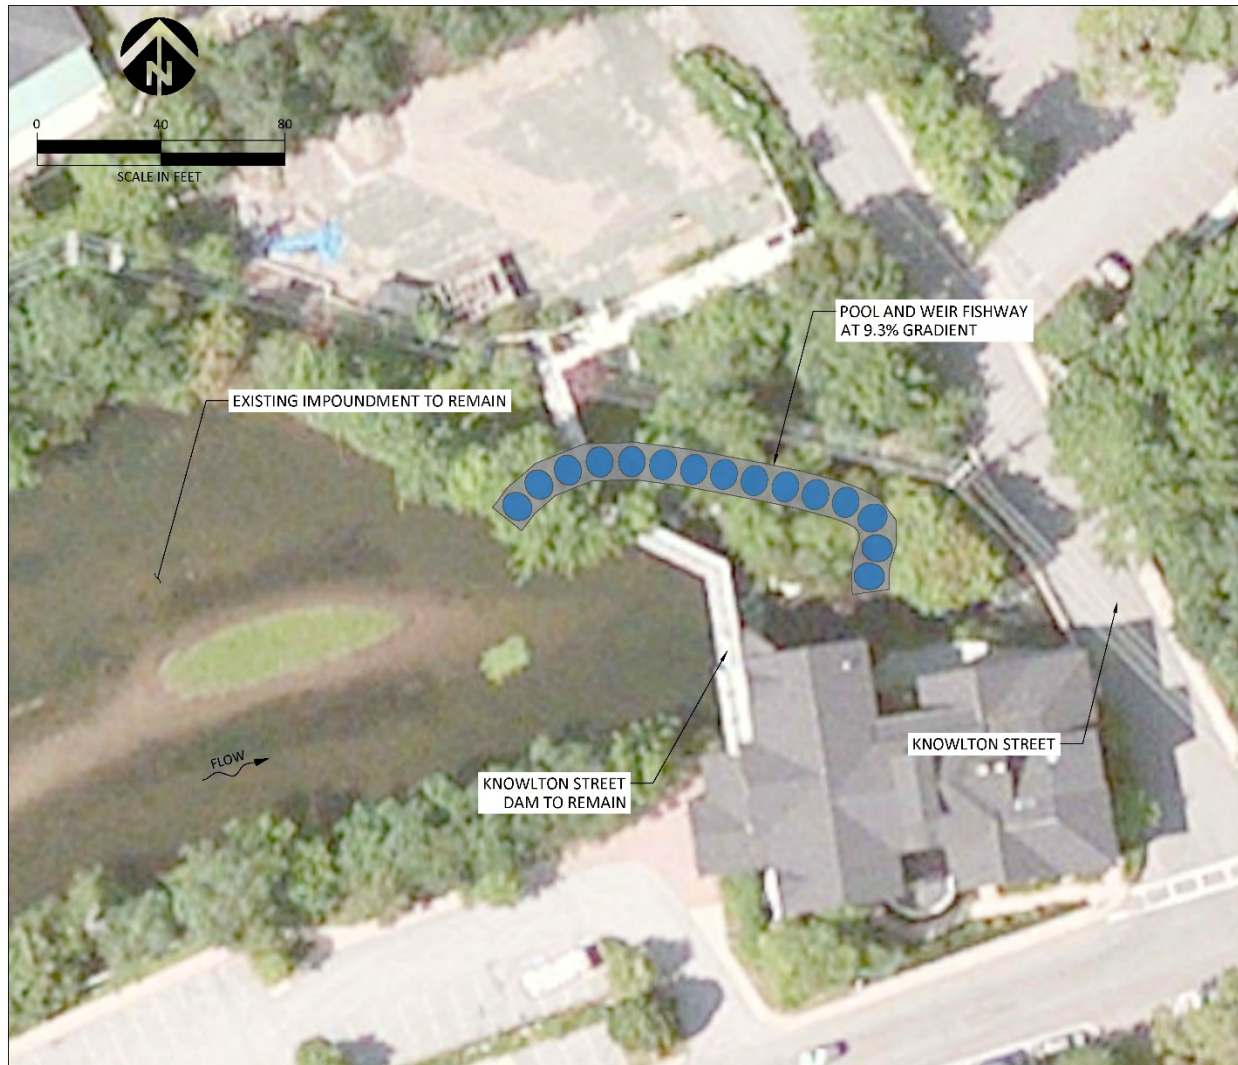
Figure 98. Schematic layout of a pool-and-weir fishway at Knowlton Street Dam.

A pool-and-weir fishway is a feasible option to provide safe, effective, and timely fish passage at Knowlton Street Dam (Table 18). The maximum allowable slope for a pool and weir fishway is 10%. To attain a slope passable to target species, the fishway entrance would be positioned at the small ledge currently defining the outlet of the left channel (Figure 98). This ledge would essentially serve as the first weir in the fishway. Approximately 50 feet upstream of the ledge, the fishway would adopt an alignment along the bank of the channel, and would pass through the left abutment of the dam underneath the pedestrian bridge. Depending on bedrock depths near the abutment, bedrock may need to be manipulated to attain fishway slopes.

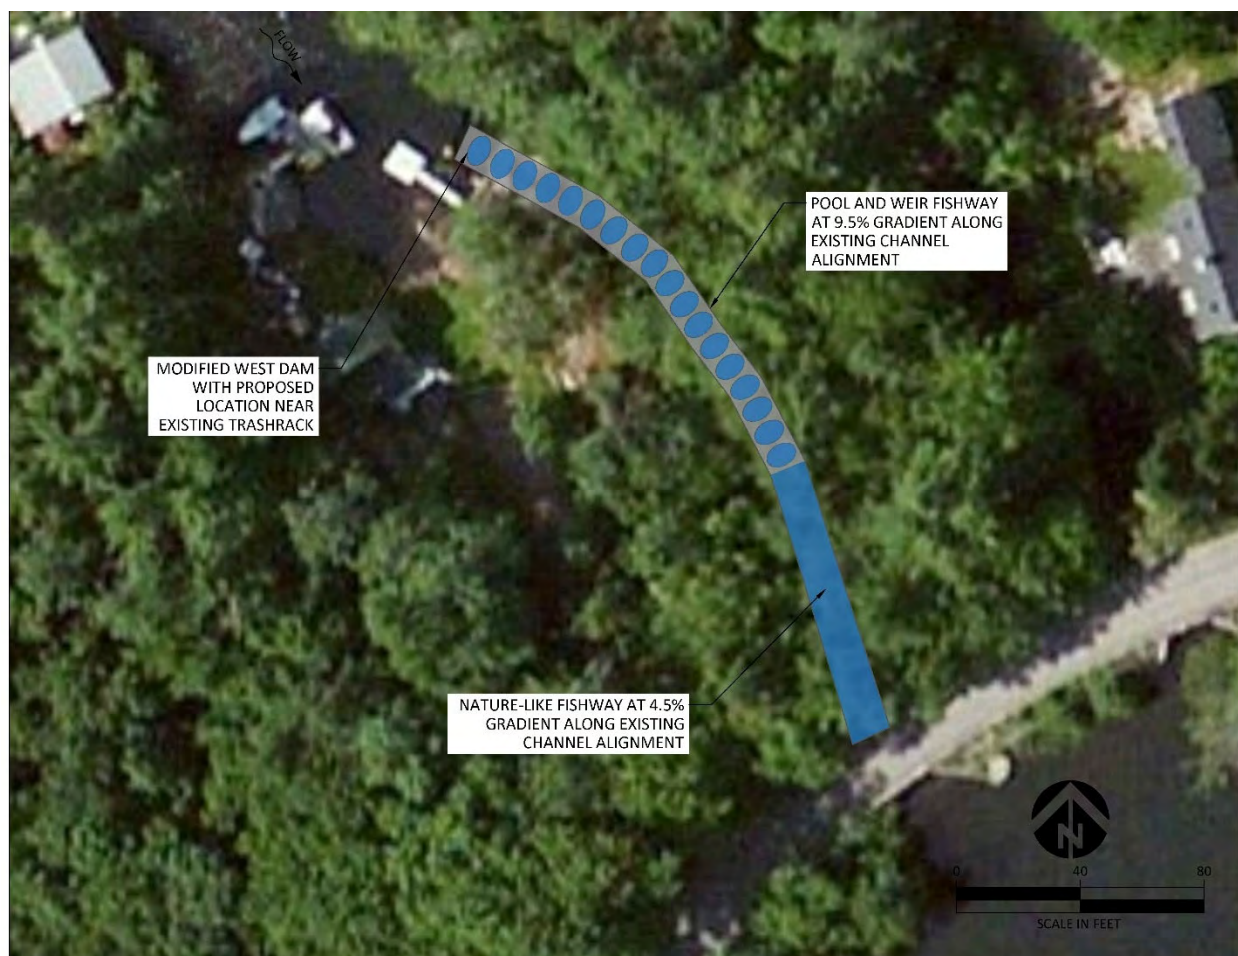
Figure 100. Schematic layout of a hybrid nature-like fishway and pool-and-weir fishway at West Dam.

A hybrid fishway would require modifications to West Dam to permit passage around the dam, including potential replacement in-kind, with new water control at the replacement dam crest. Possible manipulation of headwater elevations may be necessary to extend passage conditions in compliance with the dam's operational guidelines. See also Appendix A.

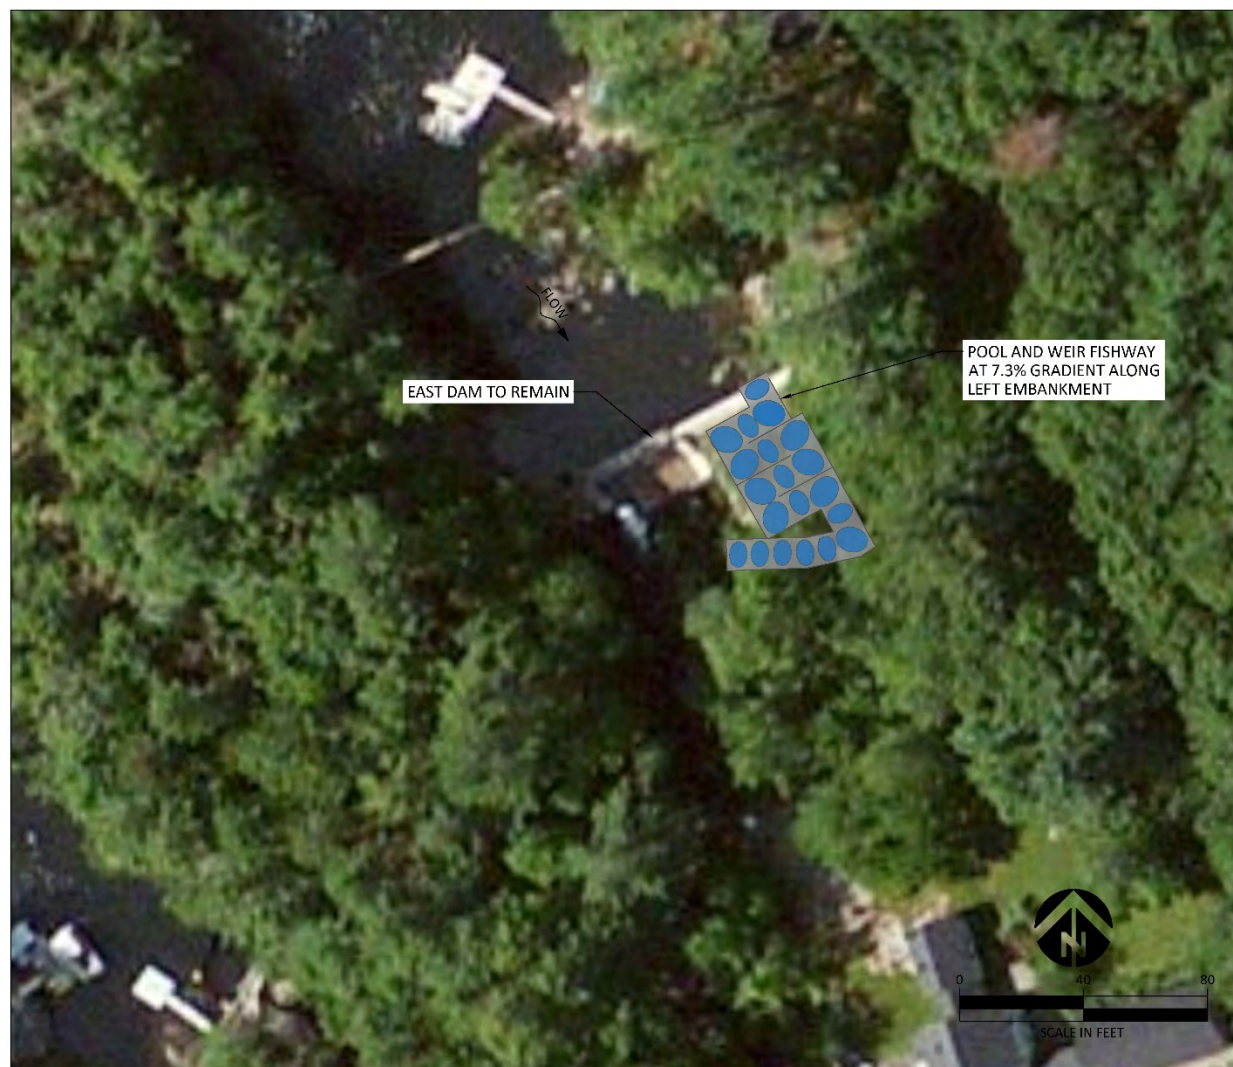
Figure 101. Schematic layout of a pool-and-weir fishway option at East Dam.

A pool-and-weir fishway is feasible at East Dam and would occupy a switchback alignment along the eastern spillway embankment downstream of the dam (Table 21; Figure 101). The alignment is located on private property adjacent to the dam, and will require ledge excavation (potentially substantial).

A pool-and-weir fishway option would have a slope of approximately 7%. Increased pool size, and sections of variable slope could be considered during detailed design to minimize energy requirements for fish to ascend the fishway. Alignments featuring a longer downstream extension were discarded, as those would feature weaker attraction signals compared to an alignment with the fishway entrance near the dam. Fairly shallow conditions are currently present at the fishway exit location.

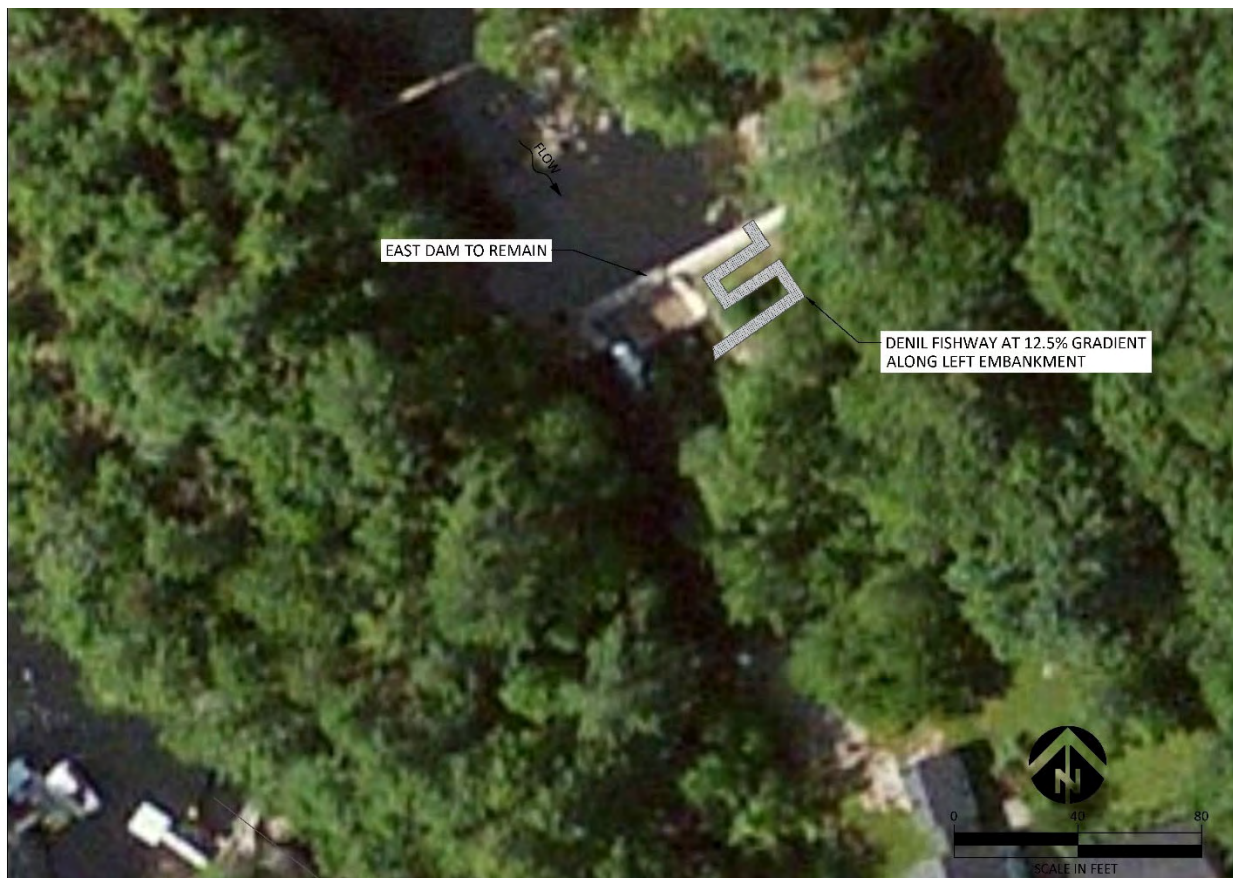
Figure 102. Schematic layout of a Denil fishway option at East Dam.

A Denil fishway option would adopt a switchback alignment along the left embankment of East Dam and maintain a slope of 12.5% (1V:8H) slope, which is recommended for weaker-swimming fish species (USFWS, 2019; Figure 102). The fishway would require resting pools at every 6-9 feet of elevation gain and at switchbacks. Entrance and exit conditions would be engineered during the detailed design phase of the project. Primary consideration would be given to ensuring acceptable water levels in Megunticook Lake correspond to the acceptable operating range of the fishway during the May-June migration period for river herring, as well as during other periods of the year

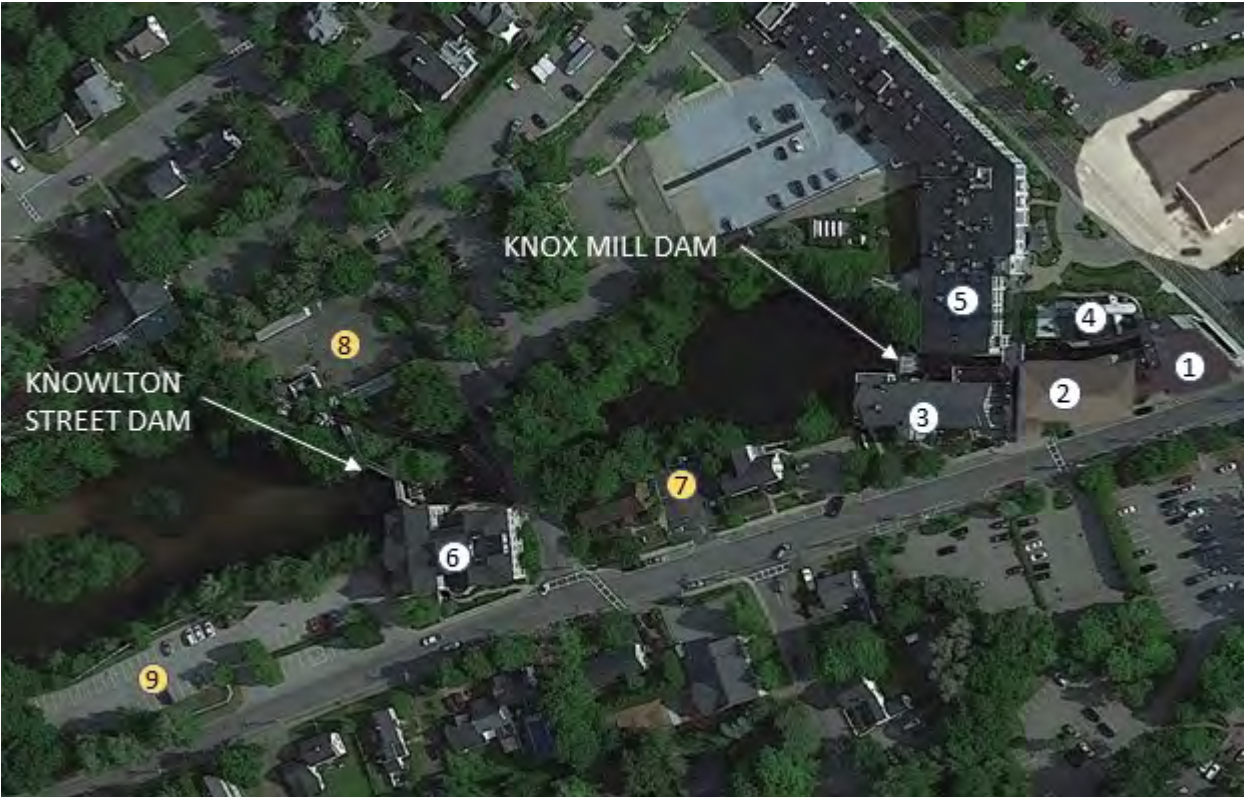
The assessment included observation of the following buildings and infrastructure elements at Knowlton Street Dam and Knox Mill Dam:

- ① 32 Mechanic Street (Buildings 1, 2 and 3 are contiguous; same address)
- ② 32 Mechanic Street (Buildings 1, 2 and 3 are contiguous; same address)
- ③ 32 Mechanic Street (Buildings 1, 2 and 3 are contiguous; same address)
- ④ 36 Washington Street
- ⑤ 40 Washington Street
- ⑥ 51 Mechanic Street
- ⑦ 49 Mechanic Street – Parking Lot
- ⑧ 2 Knowlton Street – Parking Lot
- ⑨ 51 Mechanic Street – Parking Lot

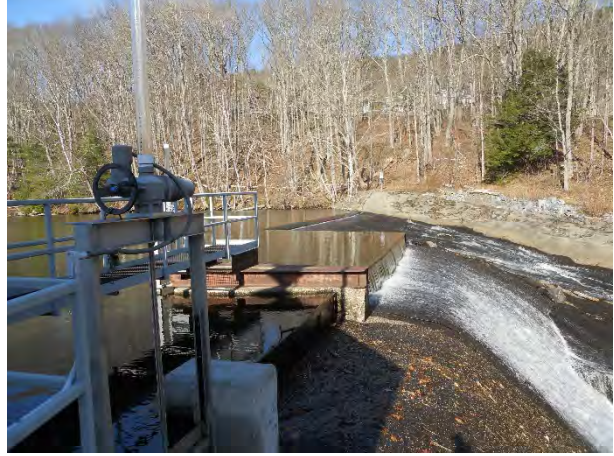
8) Seabright Dam spillway
