Megunticook River Feasibility Report

Camden, ME

July 31, 2021

Town of Camden,
Maine

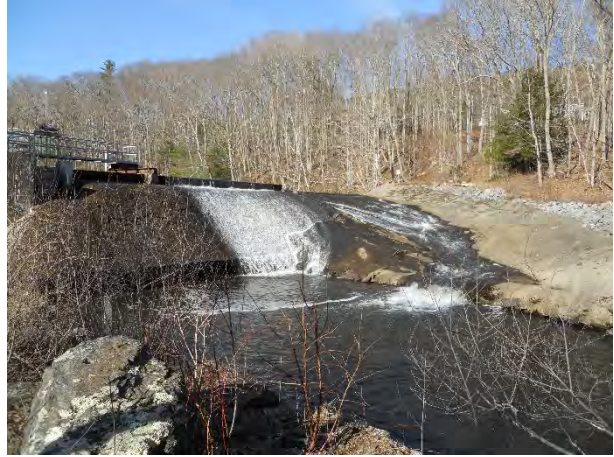
10) Seabright Dam – Recontoured area visible at right

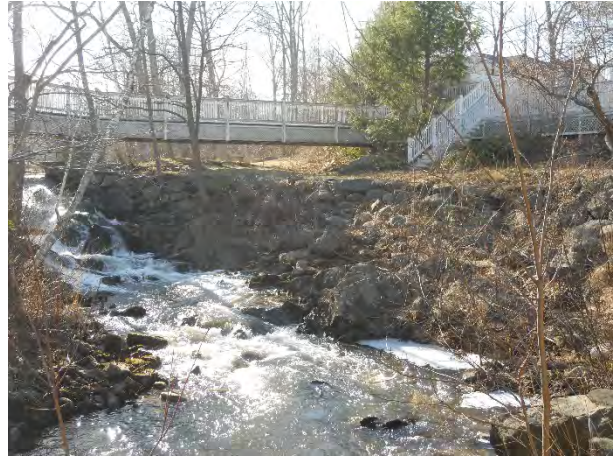
14) Knowlton Street Dam (north spillway), pedestrian bridge to 2 Knowlton Street, shoreline downstream river left (possible fish passage zone)

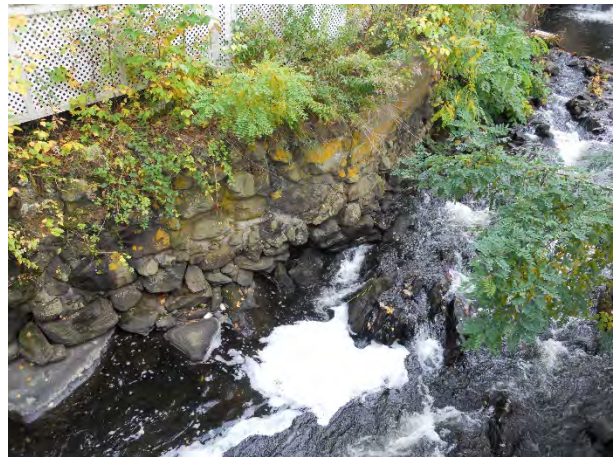
16) 51 Mechanic Street foundation – Repairs are needed; dam removal would change but not significantly worsen existing conditions

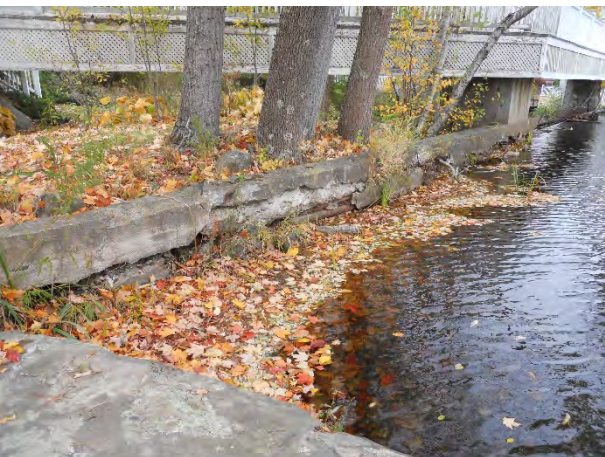
17) Knowlton Street Dam – North retaining wall (degraded)

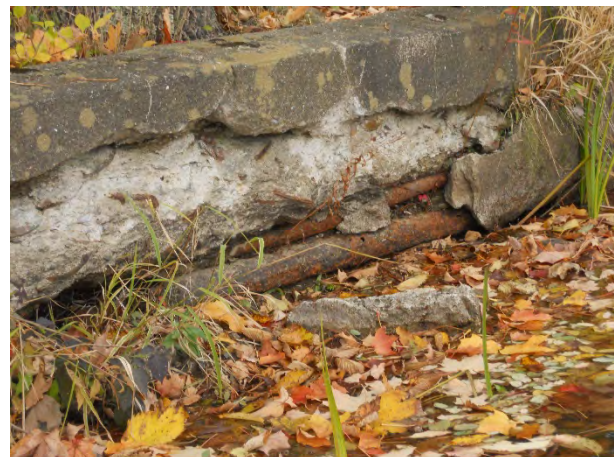
18) Knowlton Street Dam – North retaining wall (degraded)

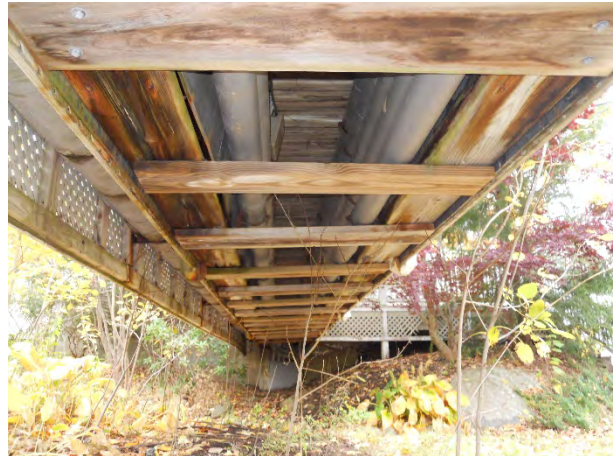
20) Knowlton Street Dam – Underside of pedestrian bridge with utility conduits

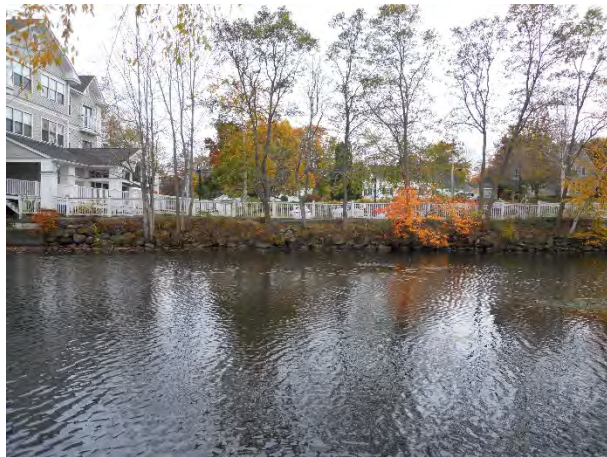
21) 51 Mechanic Street and parking lot – gravity retaining wall along shore

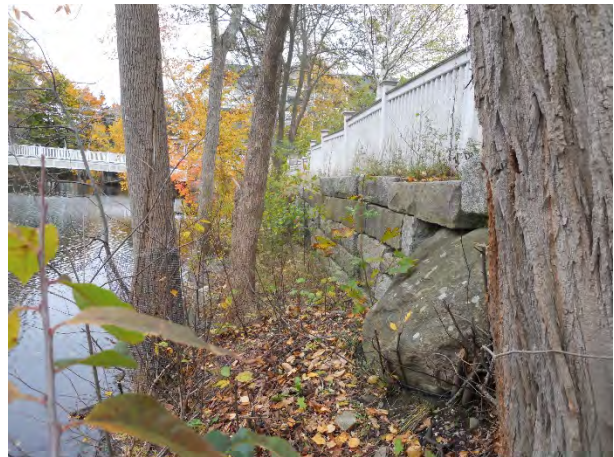
22) 51 Mechanic Street and parking lot – gravity retaining wall along shore is rotated with some misaligned elements

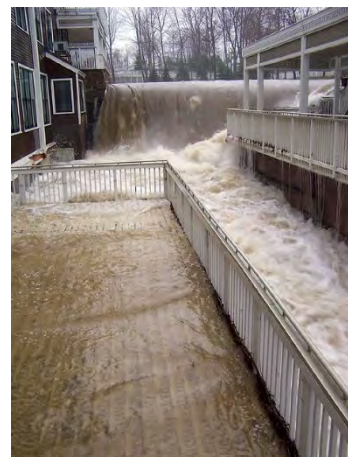
24) Knox Mill Dam – High water overtopping 32 Mechanic Street deck and impacting the upstream end of 40 Washington Street deck (Photo courtesy of Alison McKellar, Town of Camden)

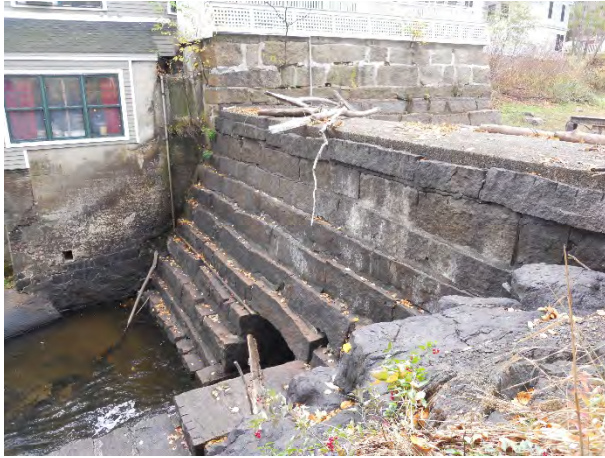
25) Knox Mill Dam and 32 Mechanic Street – Lowered water condition

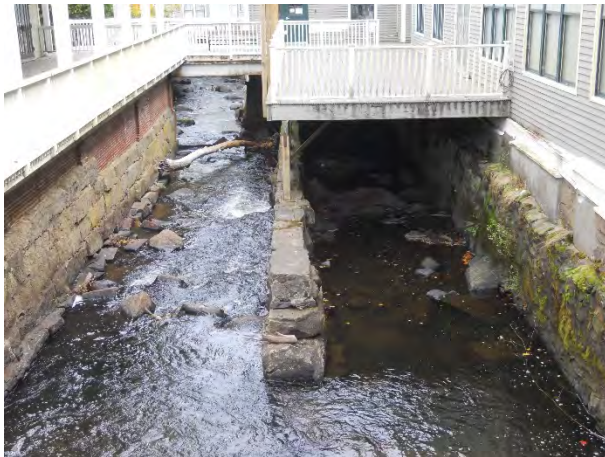
27) 40 Washington Street (left), 32 Mechanic Street (right) and connecting decks – Stone foundations

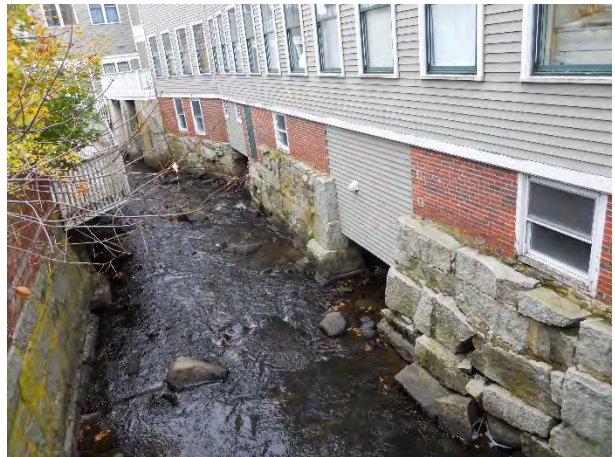
28) 36 Washington Street (left) and 32 Mechanic Street (right) – Stone foundations

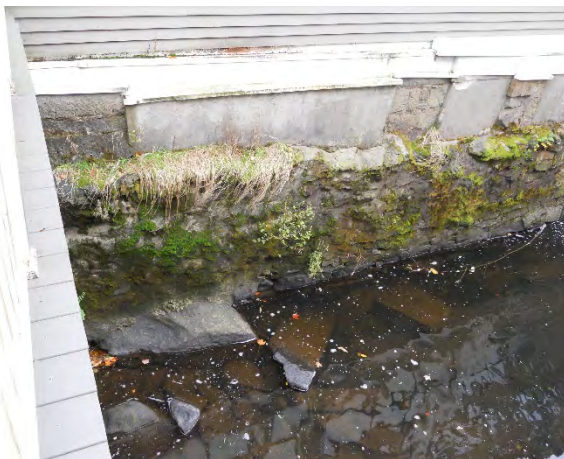
29) 32 Mechanic Street – Minor repairs are needed; dam removal may change but not significantly worsen existing conditions

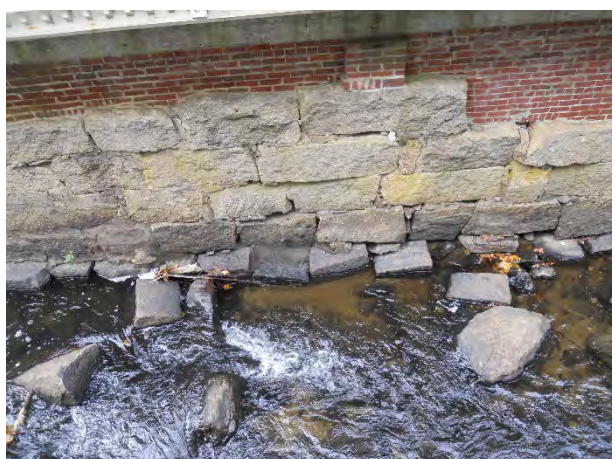
30) 32 Mechanic Street – Minor repairs are needed; dam removal may change but not significantly worsen existing conditions

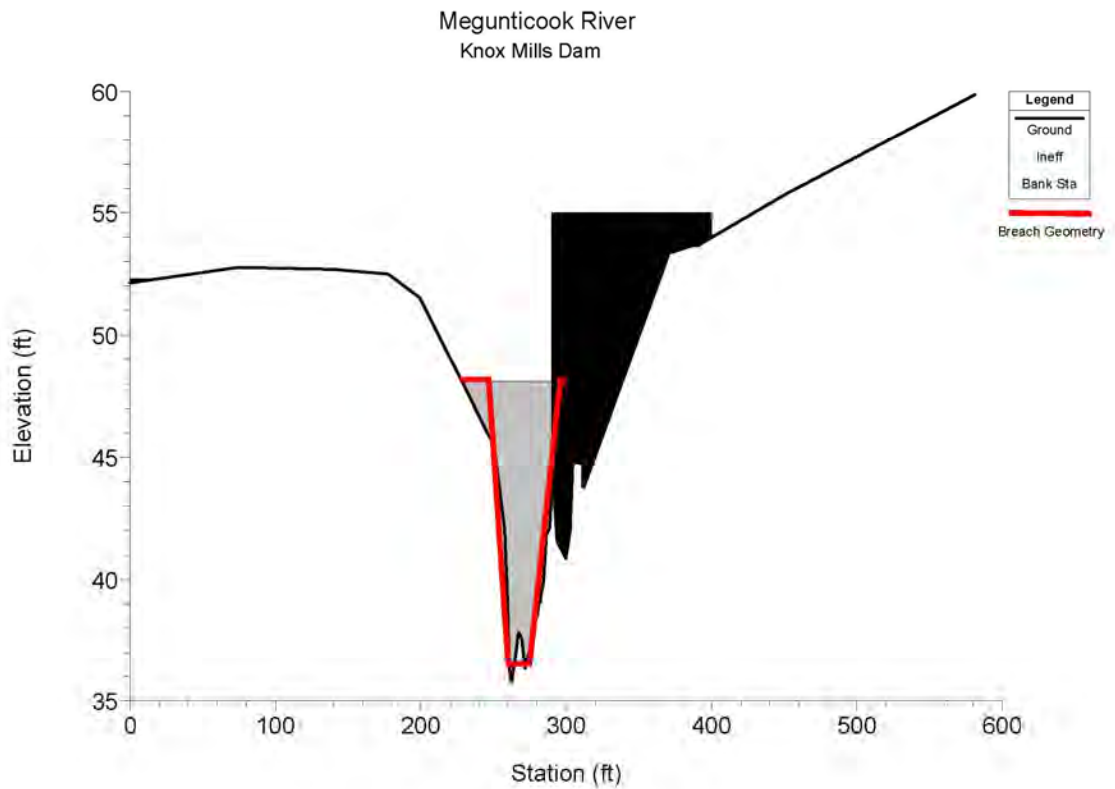
Breach Characteristic	Knox Mill Dam	Knowlton Street Dam
Final Bottom Width (feet)	14.0	20.0
Final Bottom Elevation (feet NAVD88)	37.0	63.4
Left Side Slope (H:V)	1.0	4.0
Right Side Slope (H:V)	2.0	0.0
Weir Coefficient	2.6	2.6
Time of Formation (hours)	0.5	0.1

Figure 2. Knox Mills Dam Breach Geometry

We used the methods described in “Breaching Parameters for Earth and Rockfill Dams²” to develop our assumptions for breach condition geometries at the Dams; Table 2 summarizes the assumptions. Figure 2 and Figure 3 illustrate the breach geometries as compared to the Knox Mill and Knowlton Street dam profiles, respectively.

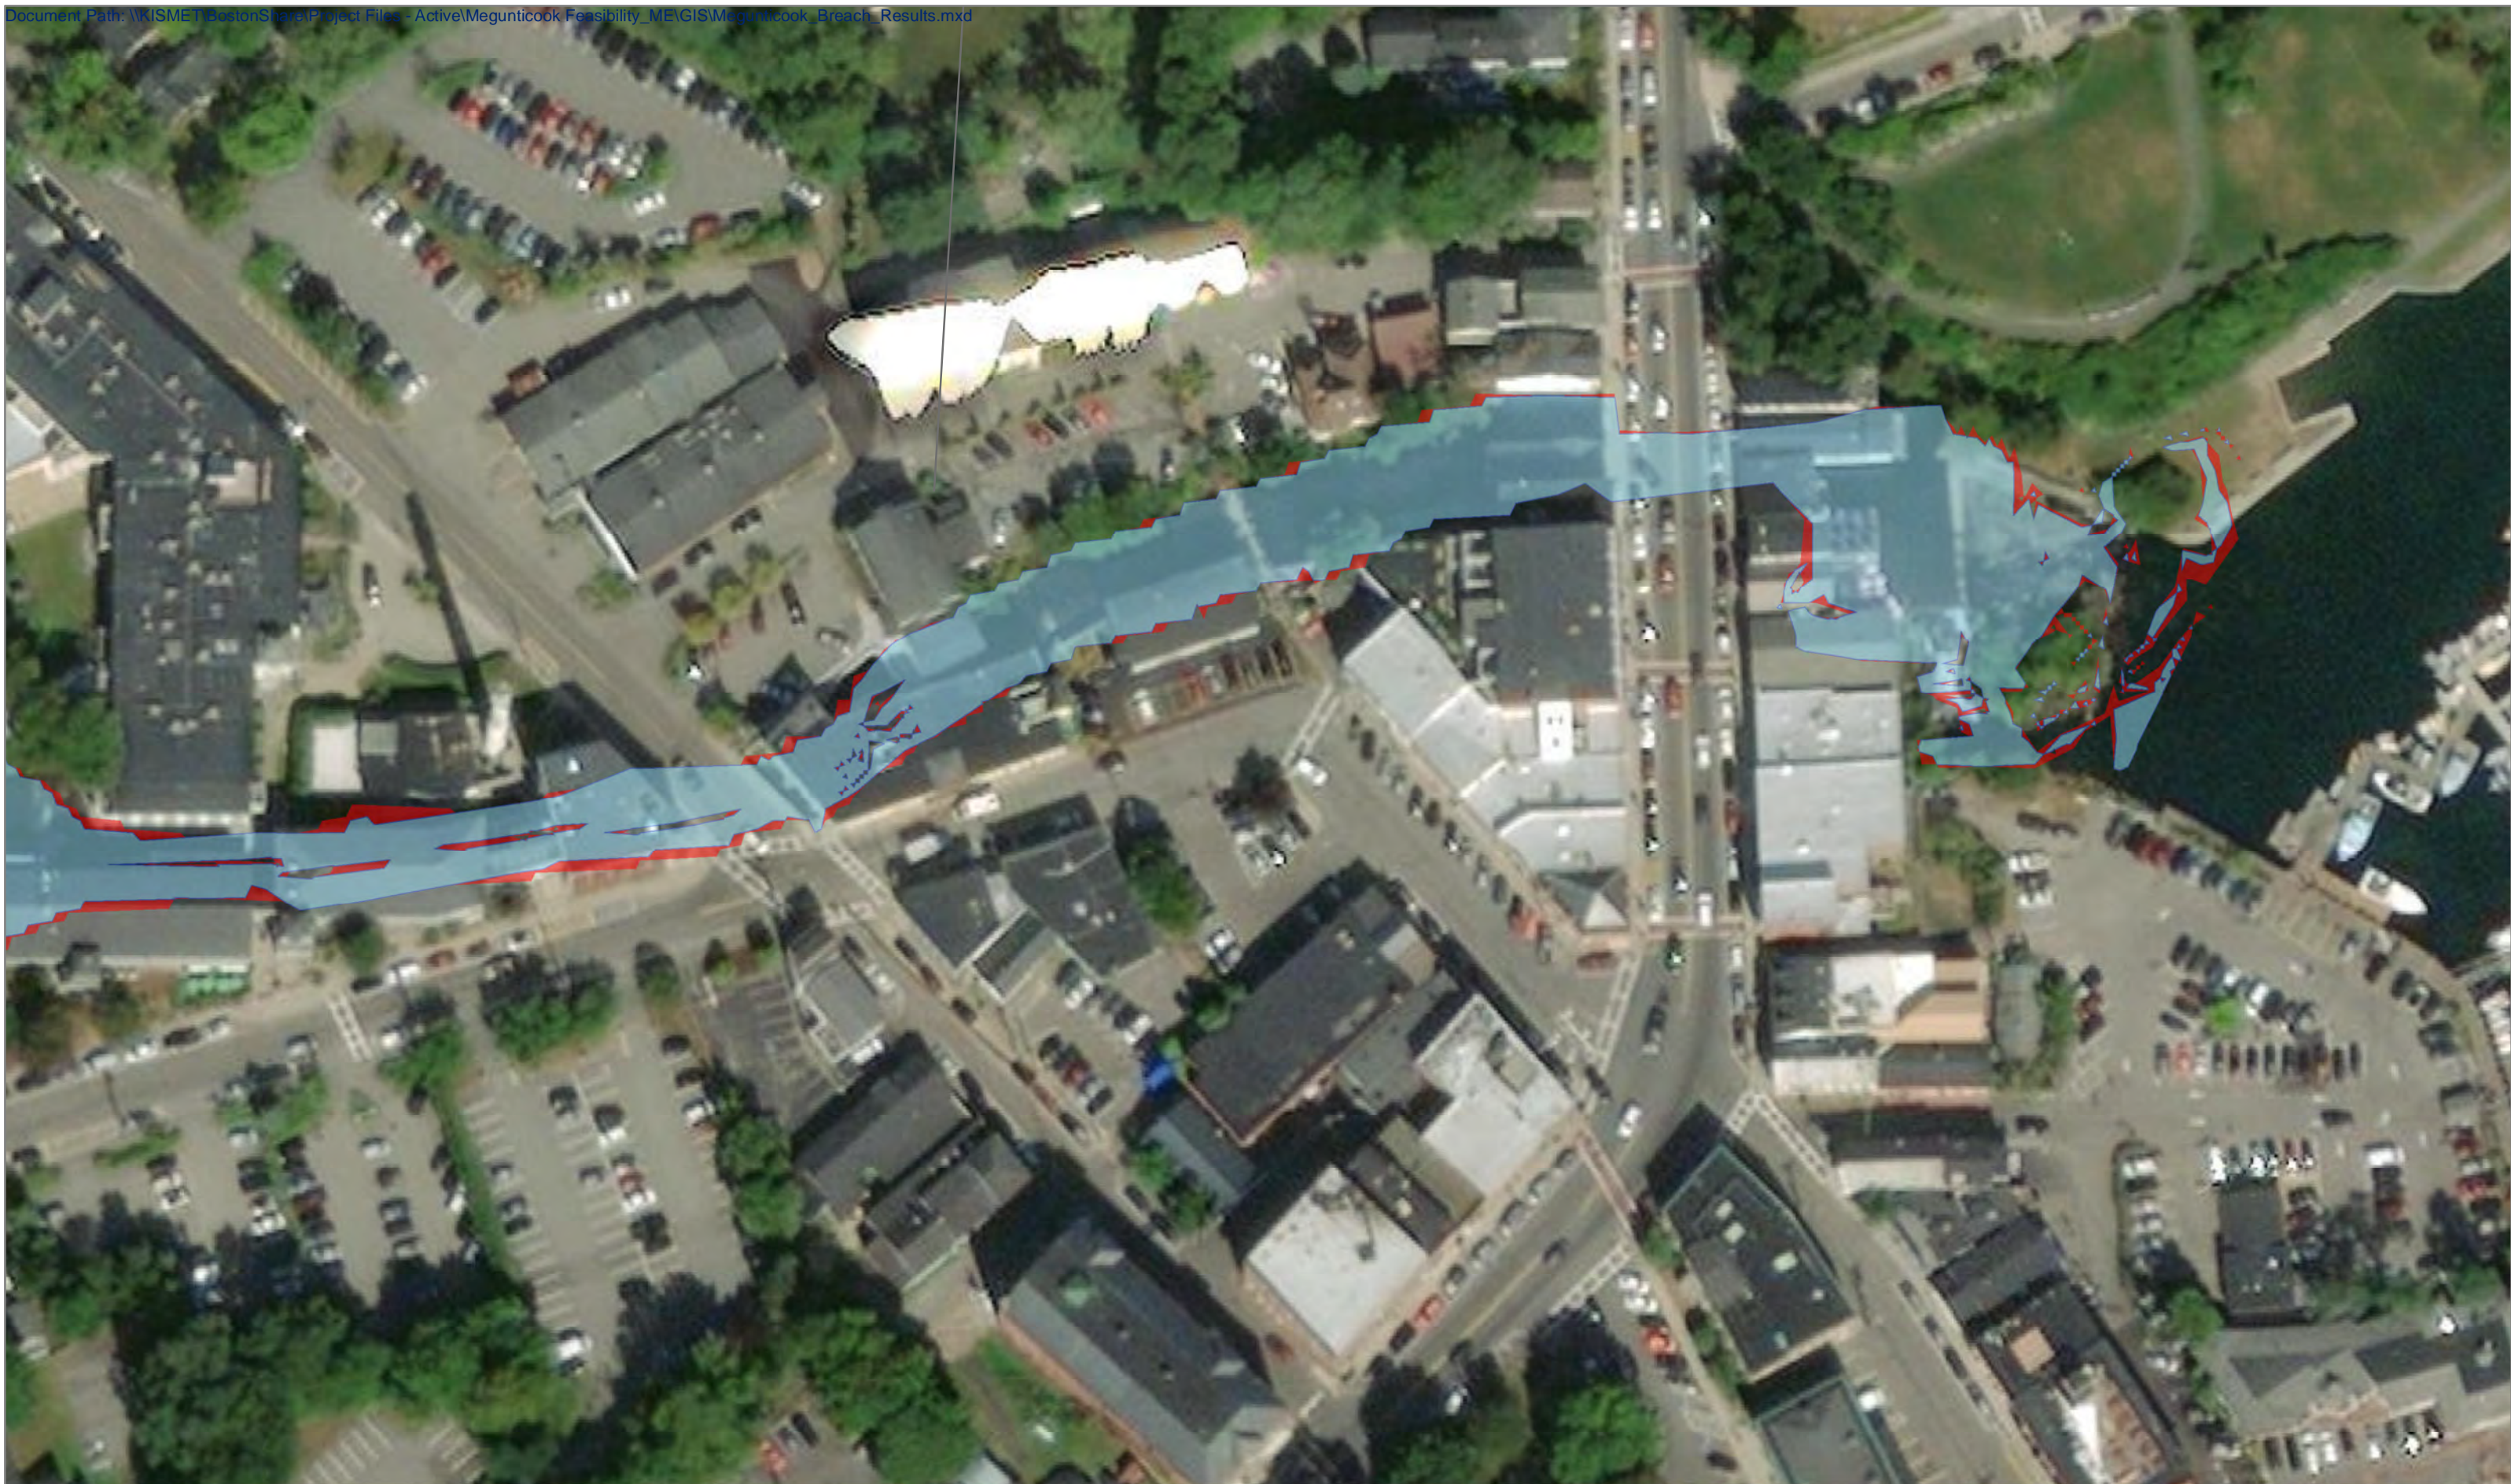
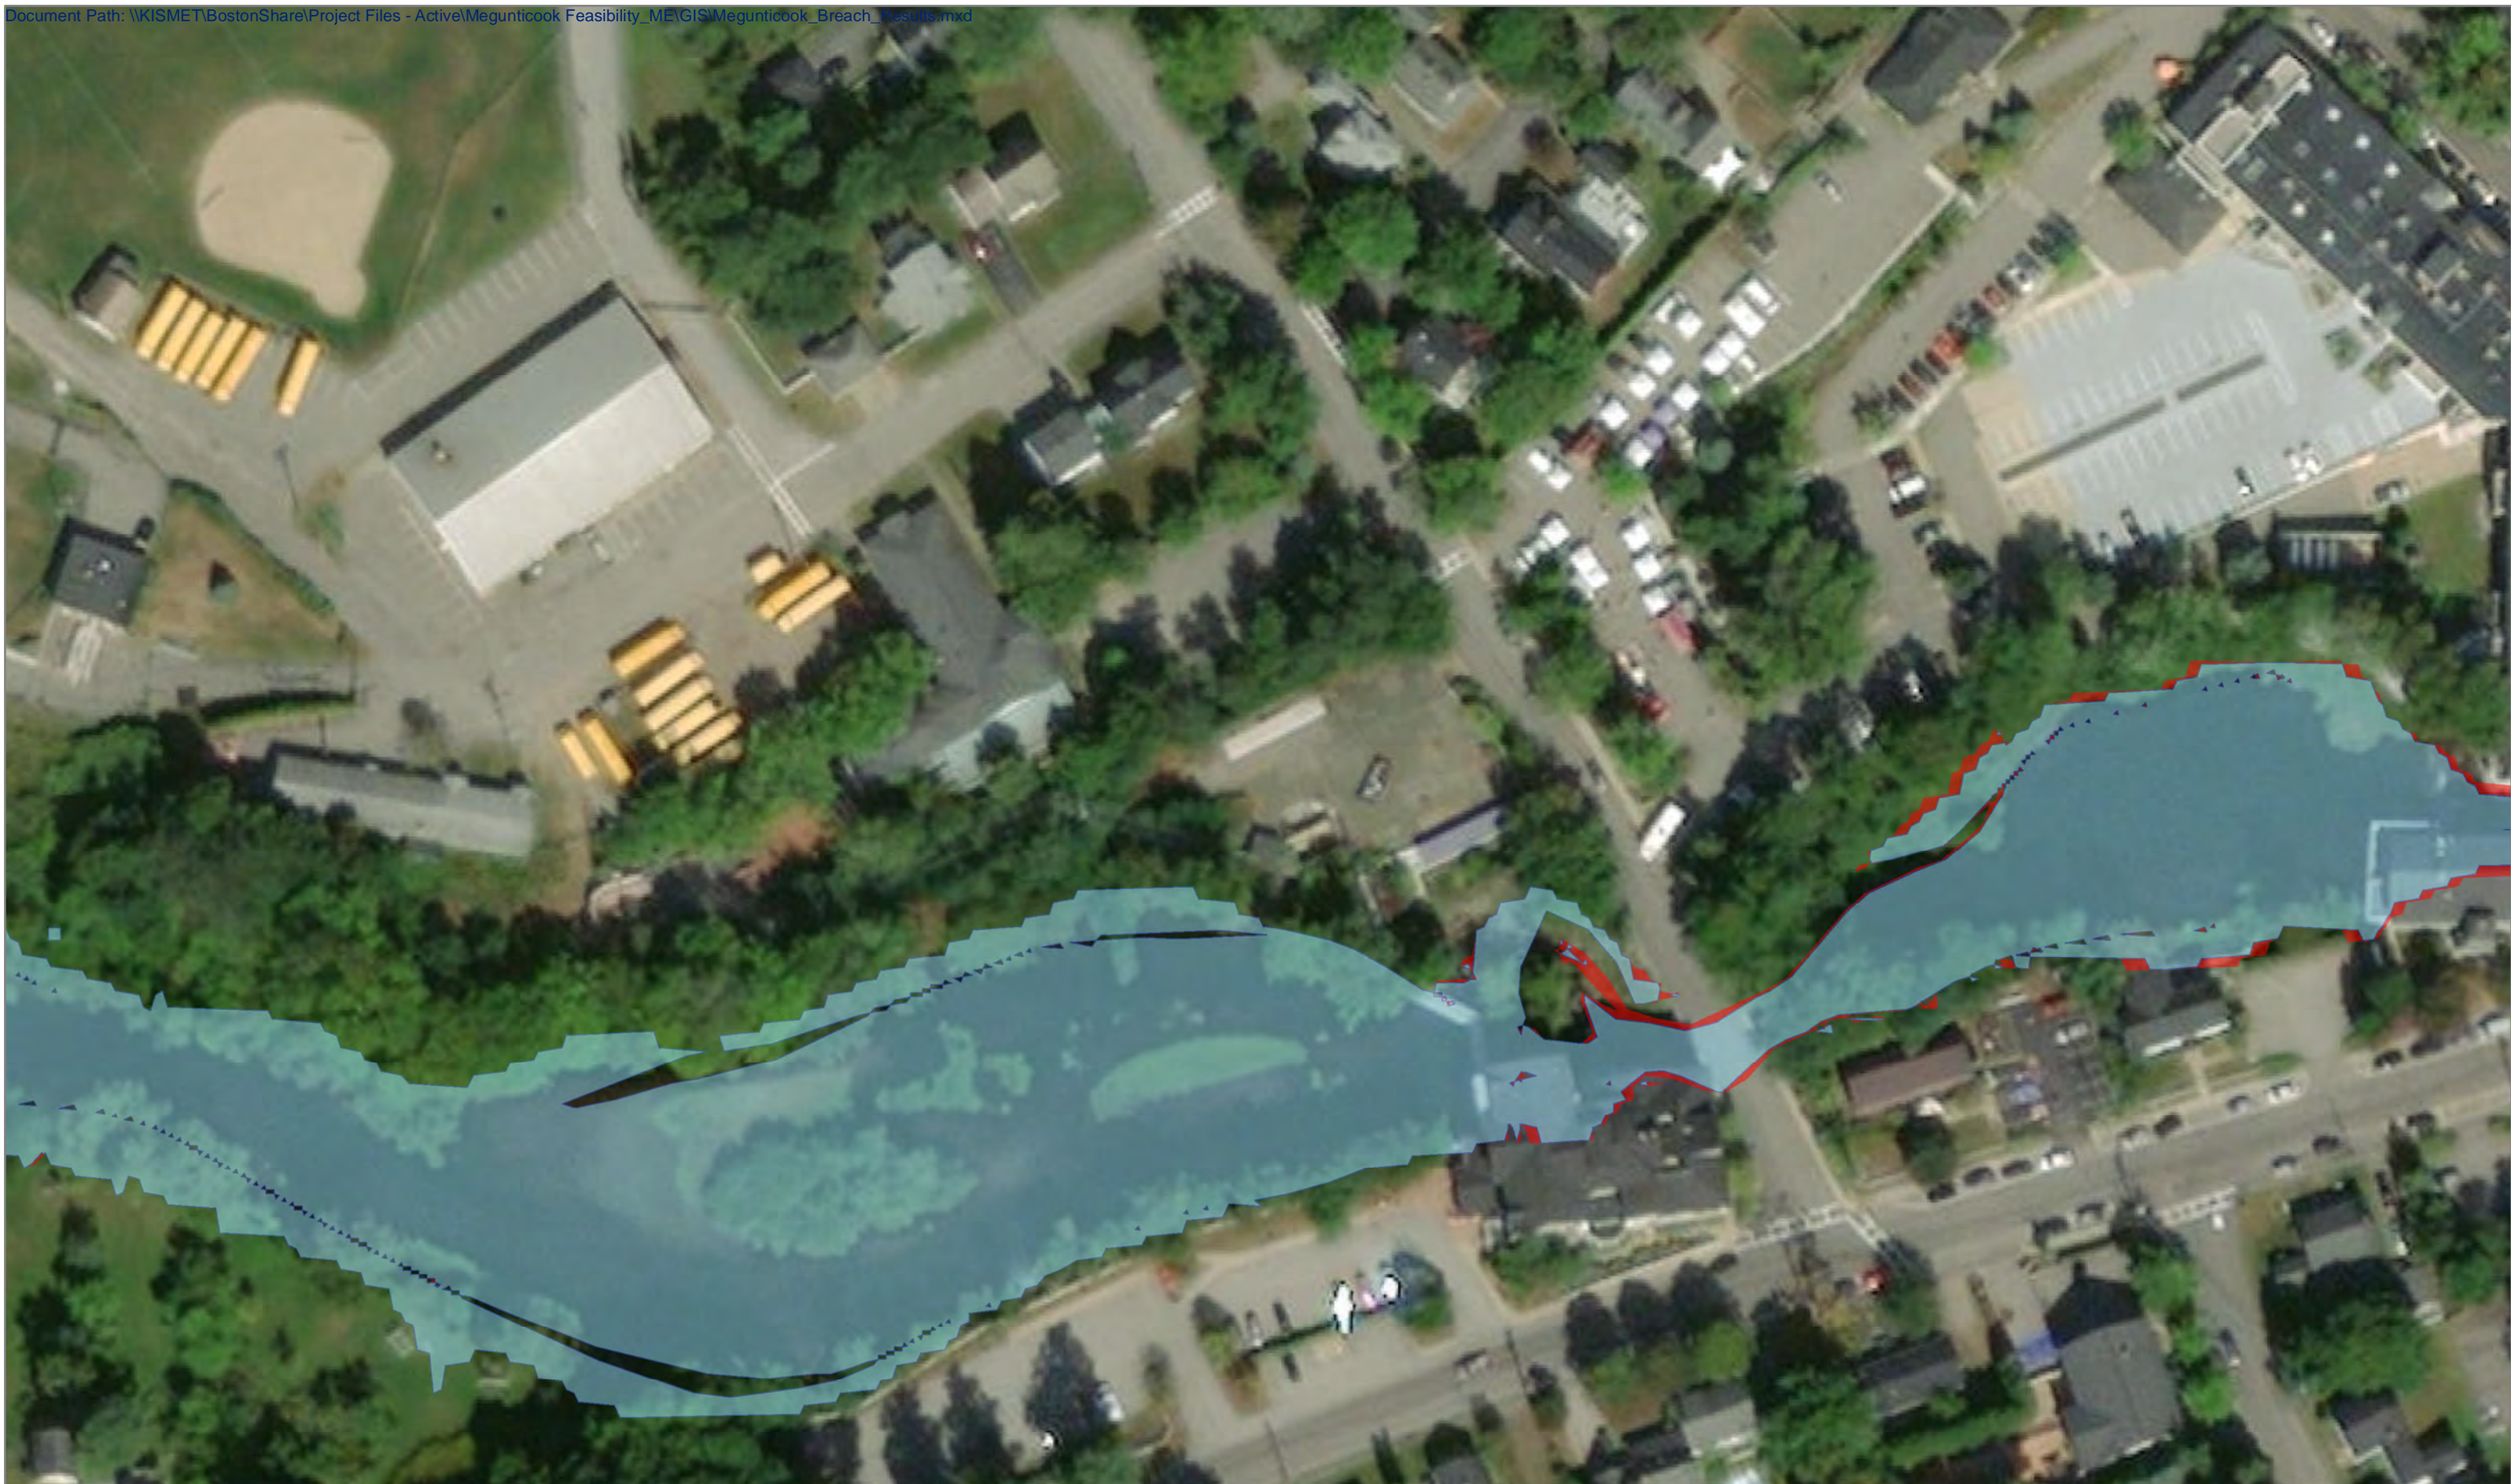
1-Year Event, Failure of Knowlton Dam
Impact of the Dam Breach
Inundation Area

- The breach wave will remain within the channel (Figure 10, Figure 11, Figure 12).
- The breach wave will not cause the water surface profile to rise more than 2 feet at any point along the river (Figure 4, Figure 5, Figure 6).

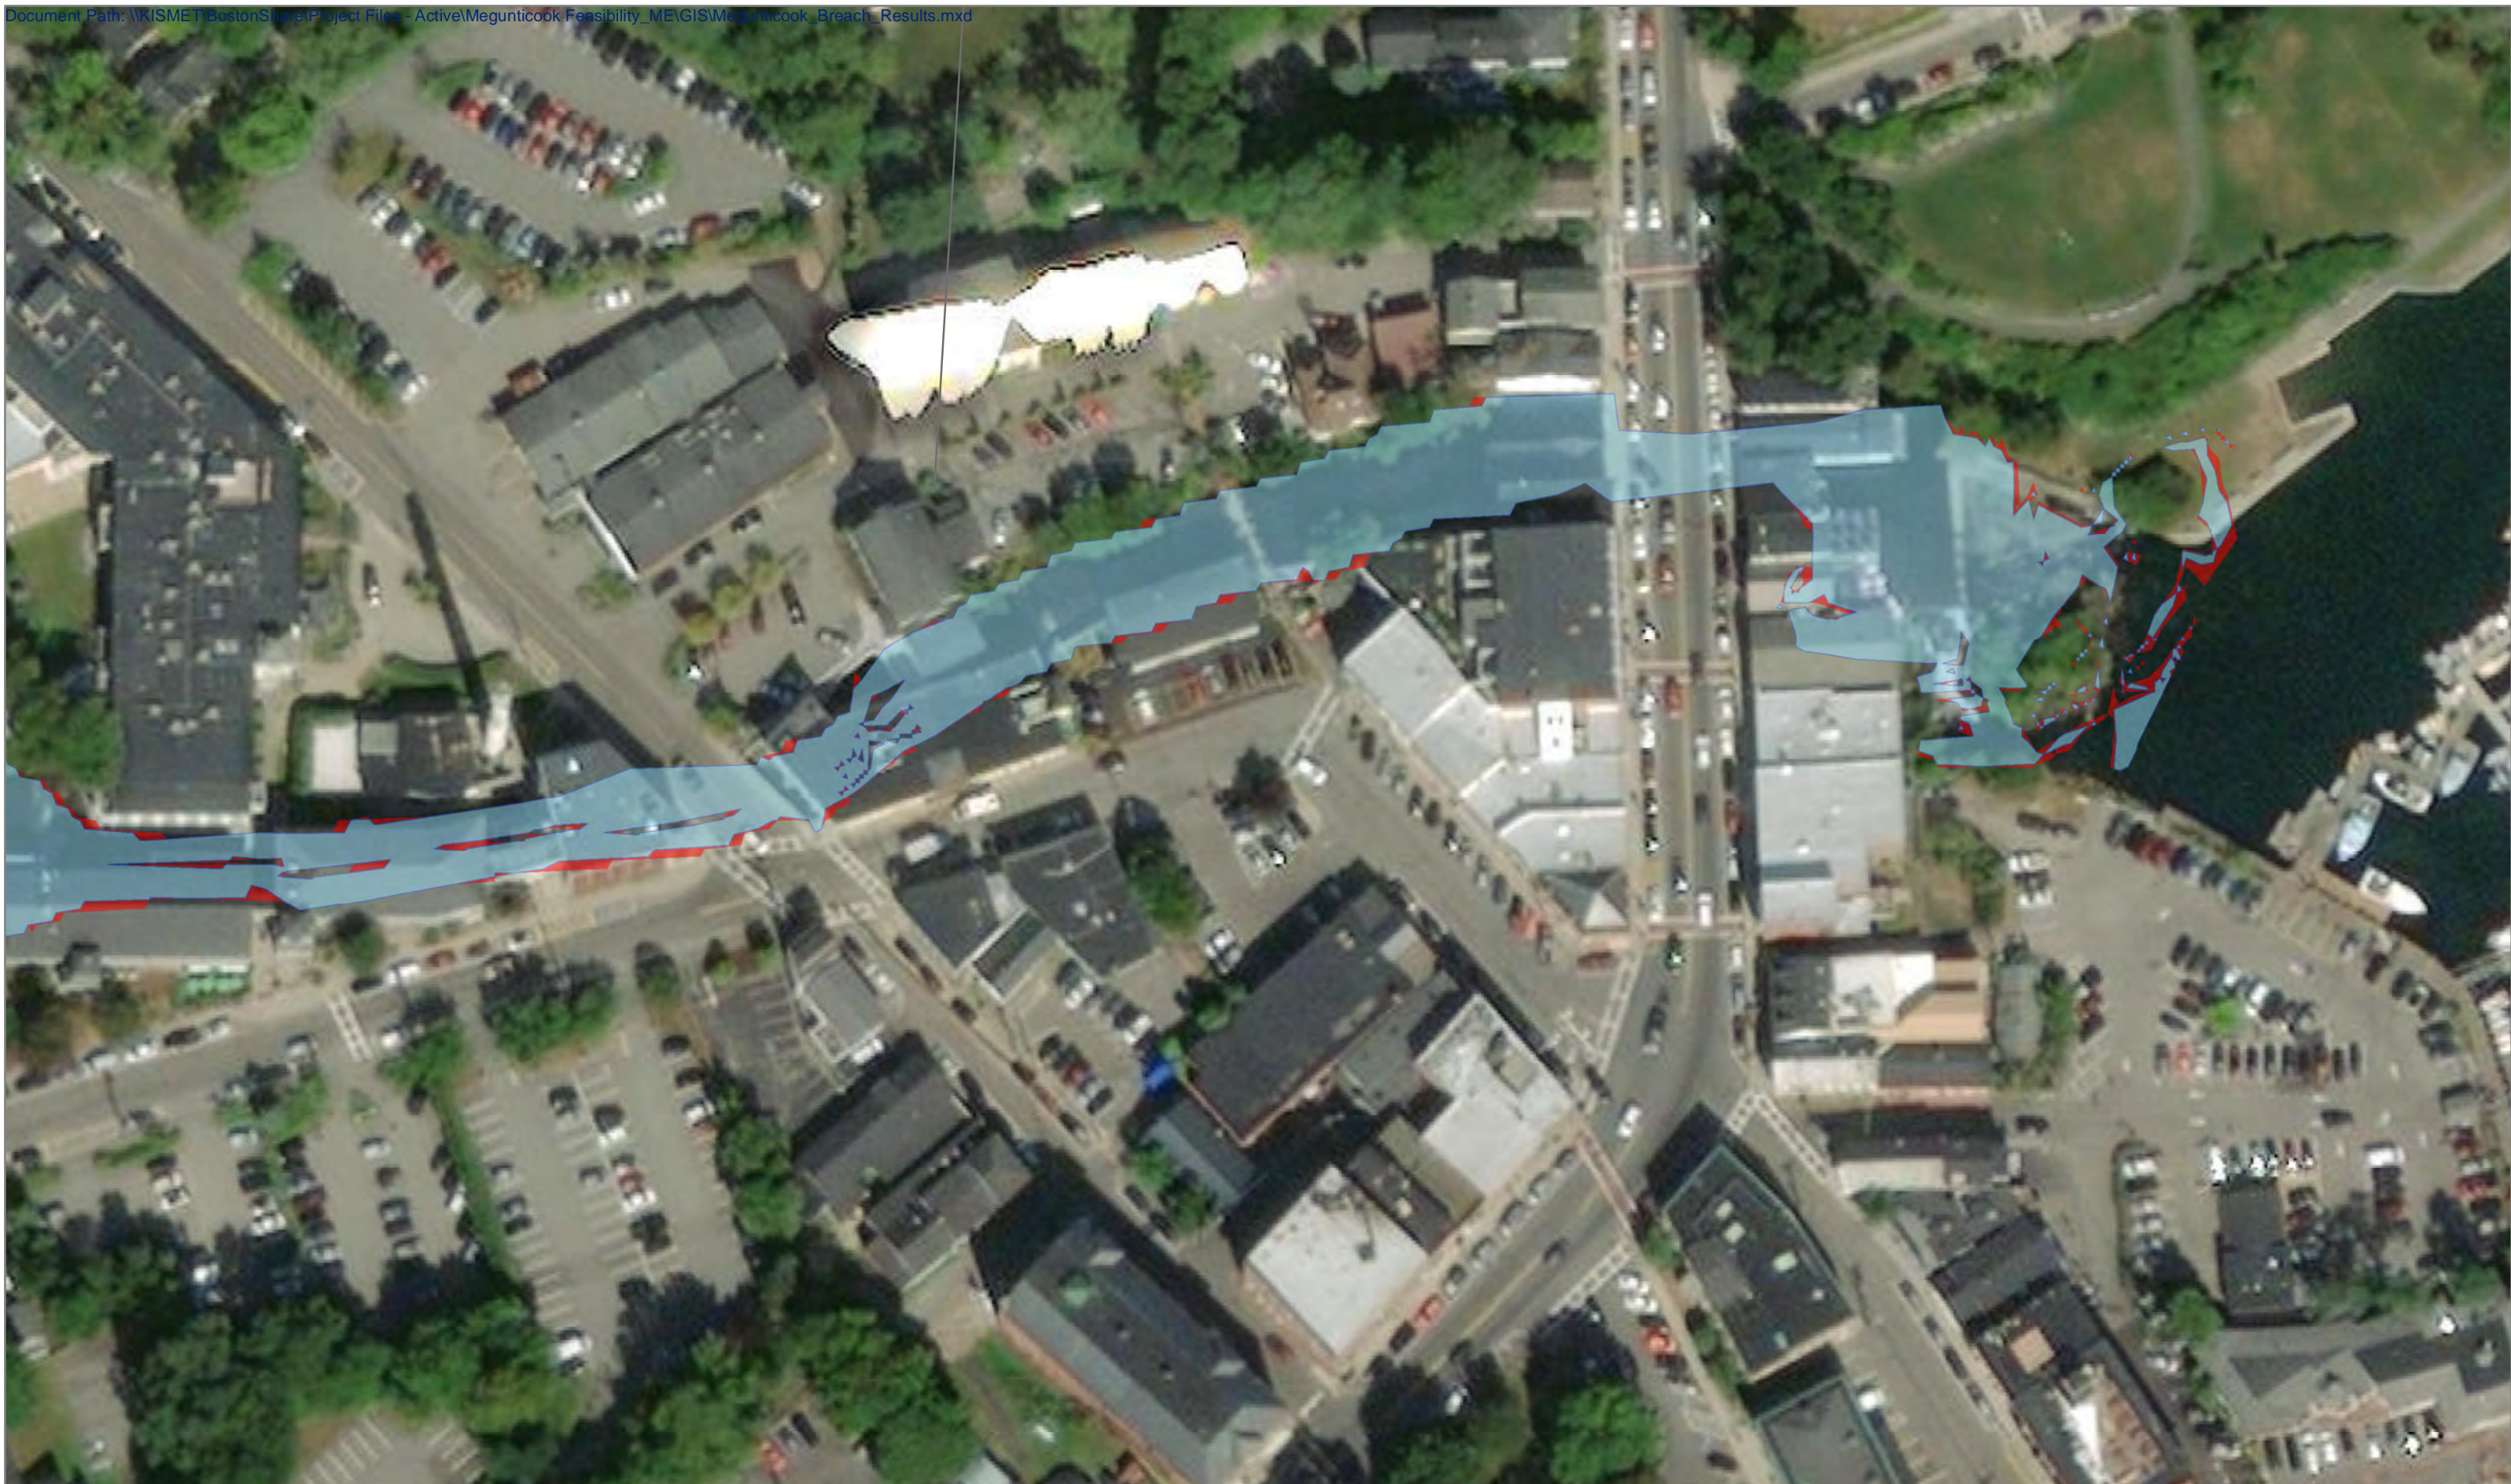
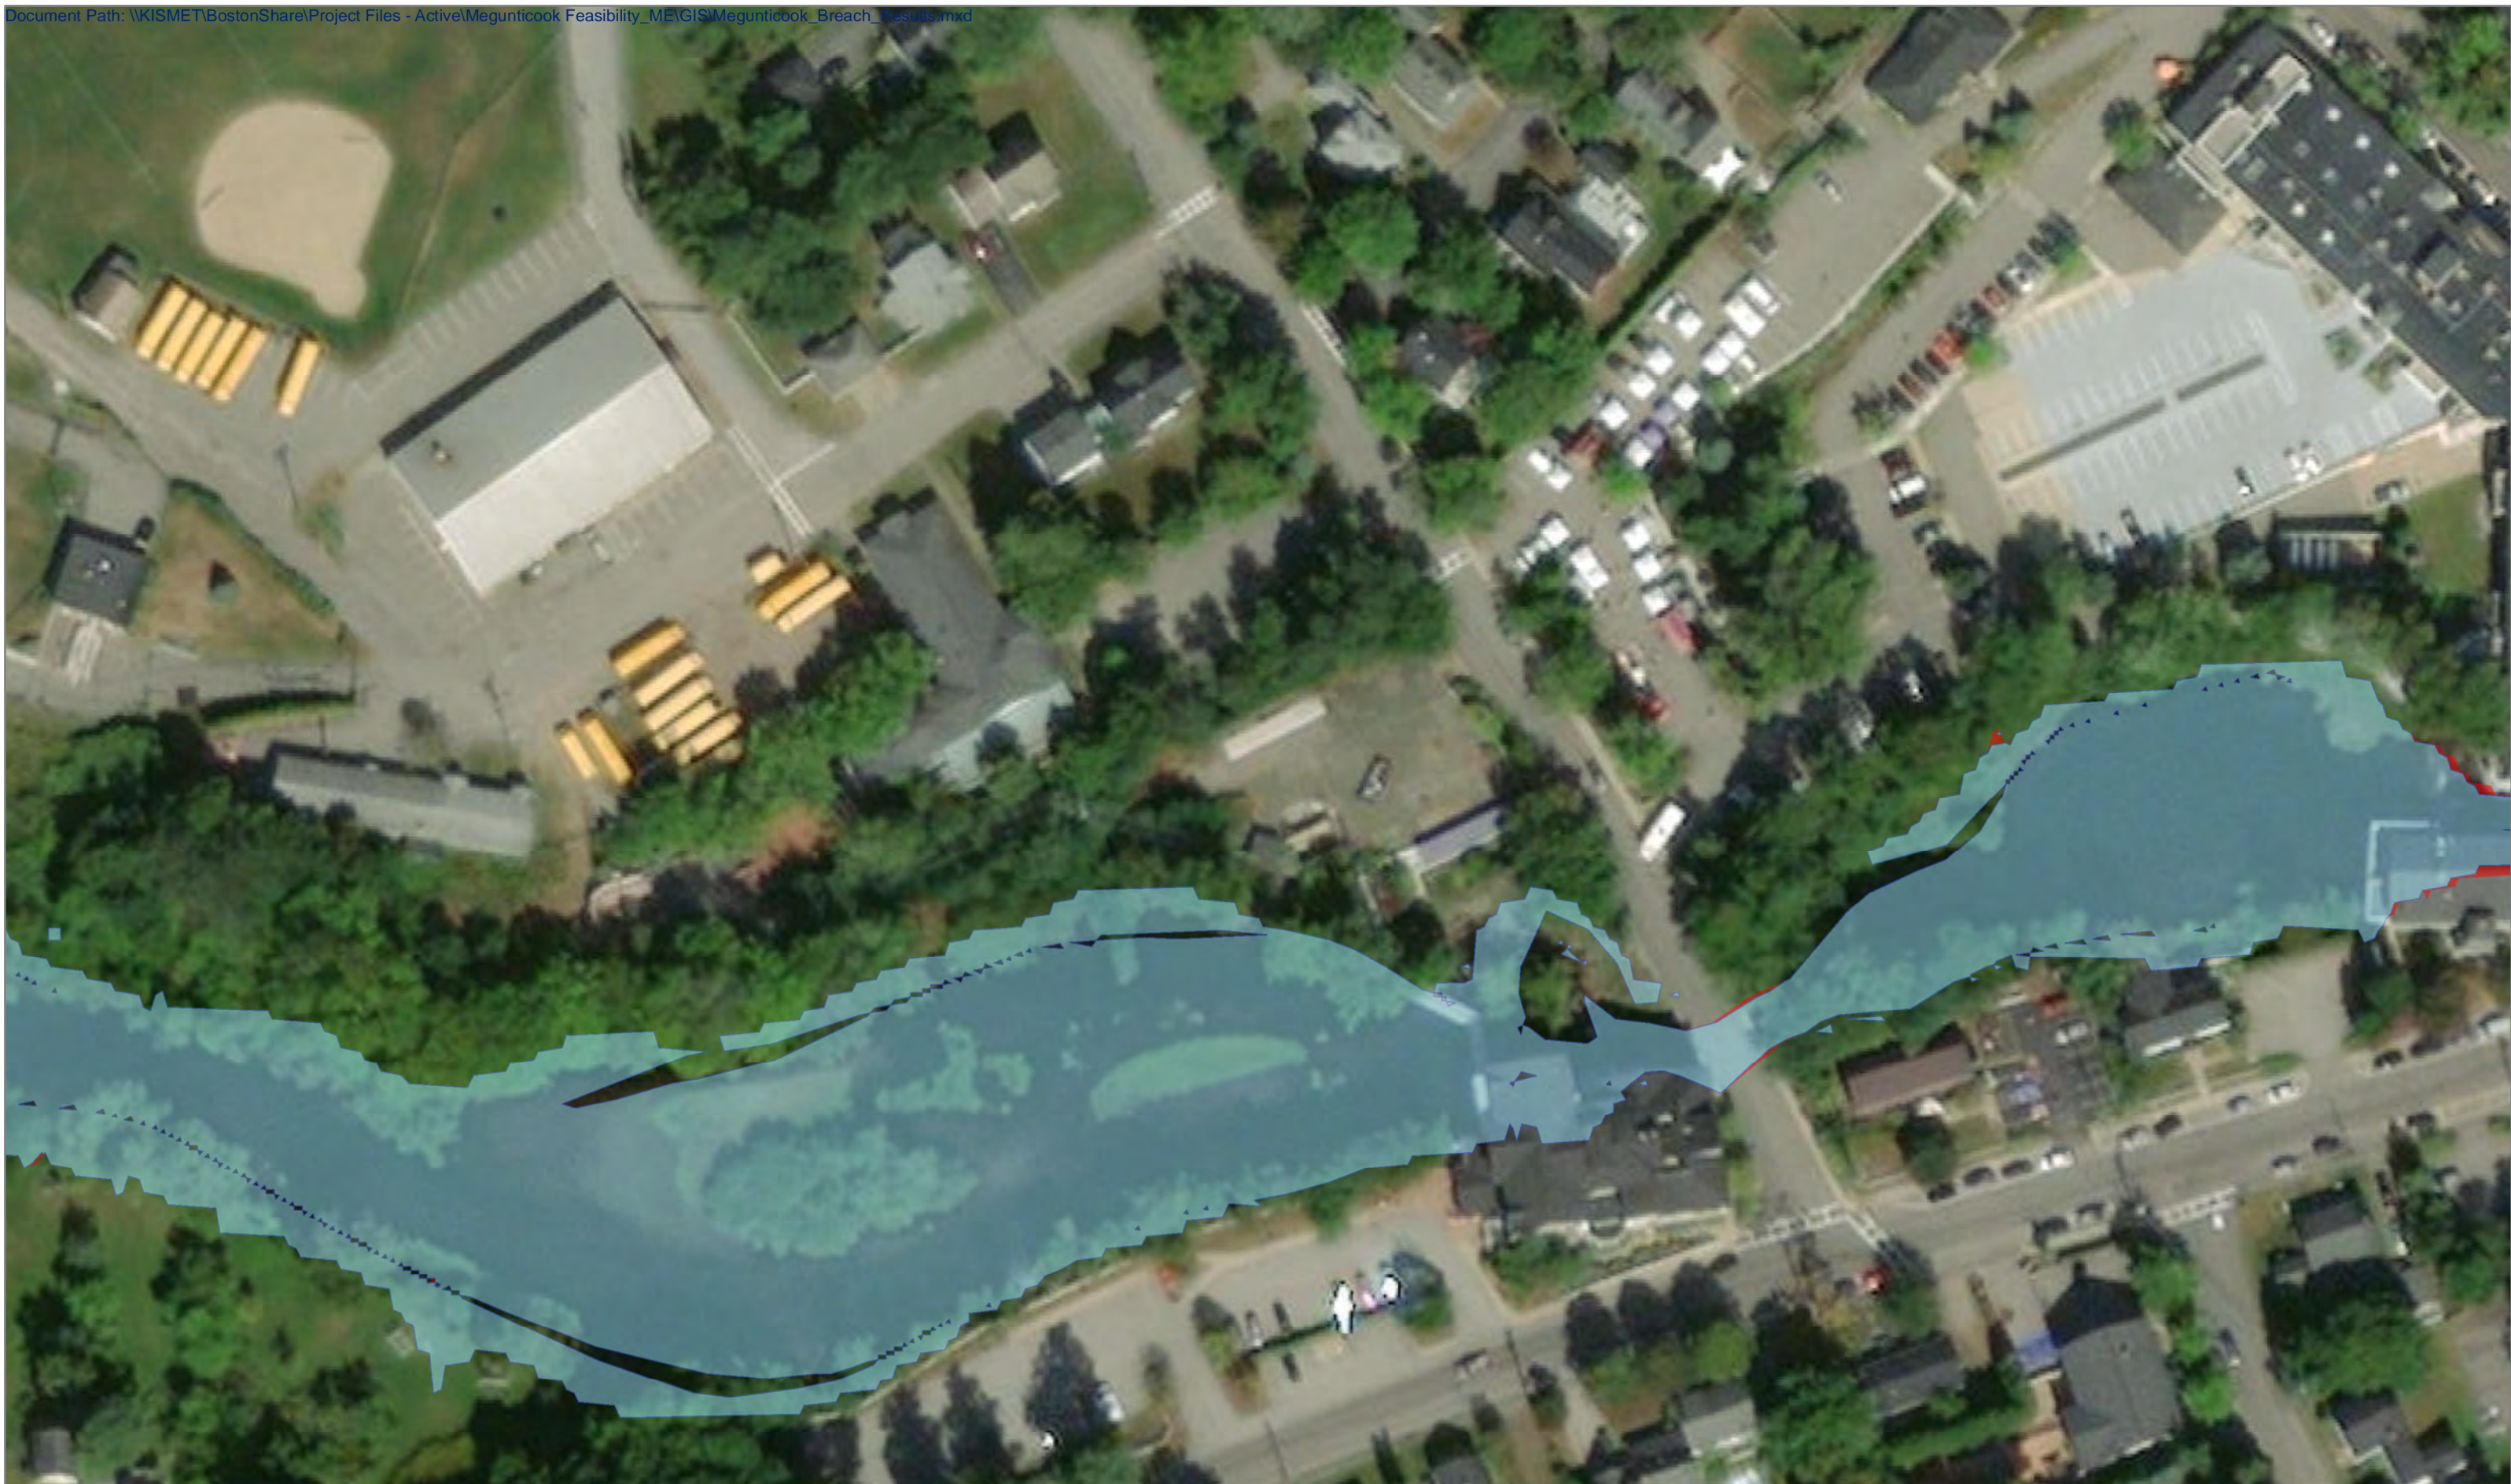
1-Year Event, Failure of Knox Dam
Impact of the Dam Breach
Inundation Area
