Megunticook River Feasibility Report

Camden, ME

July 31, 2021

Town of Camden,
Maine

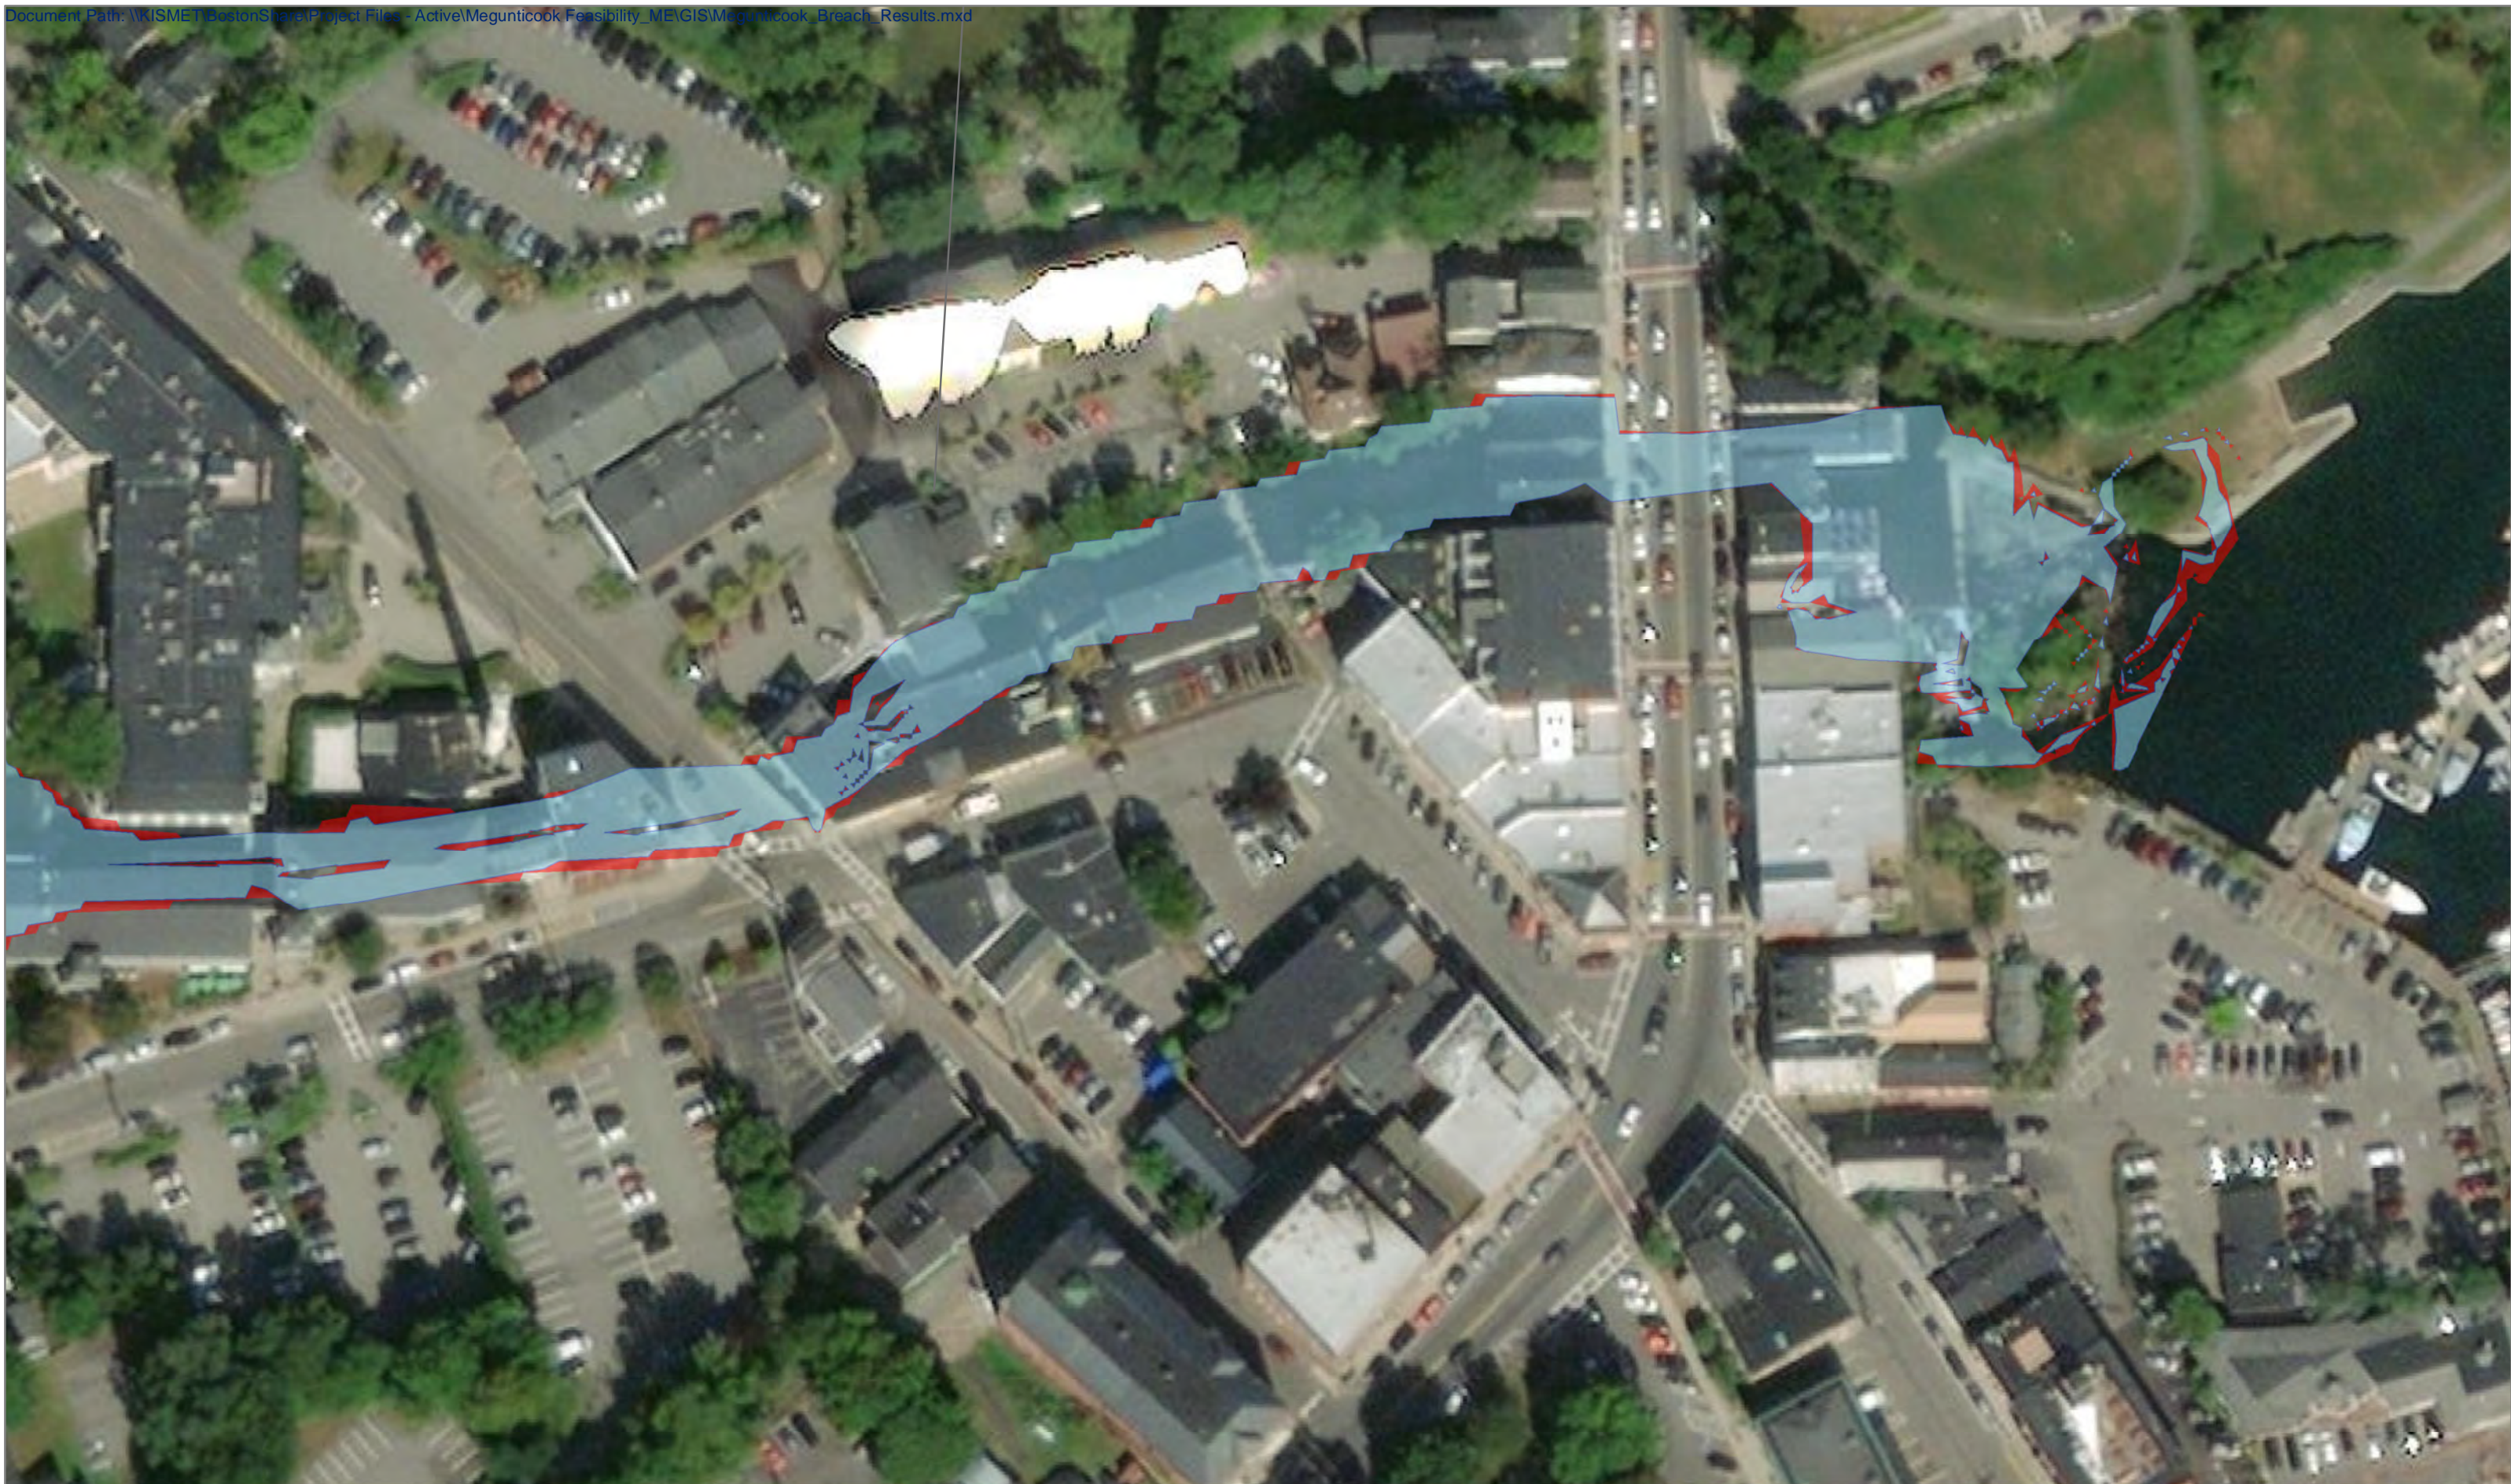
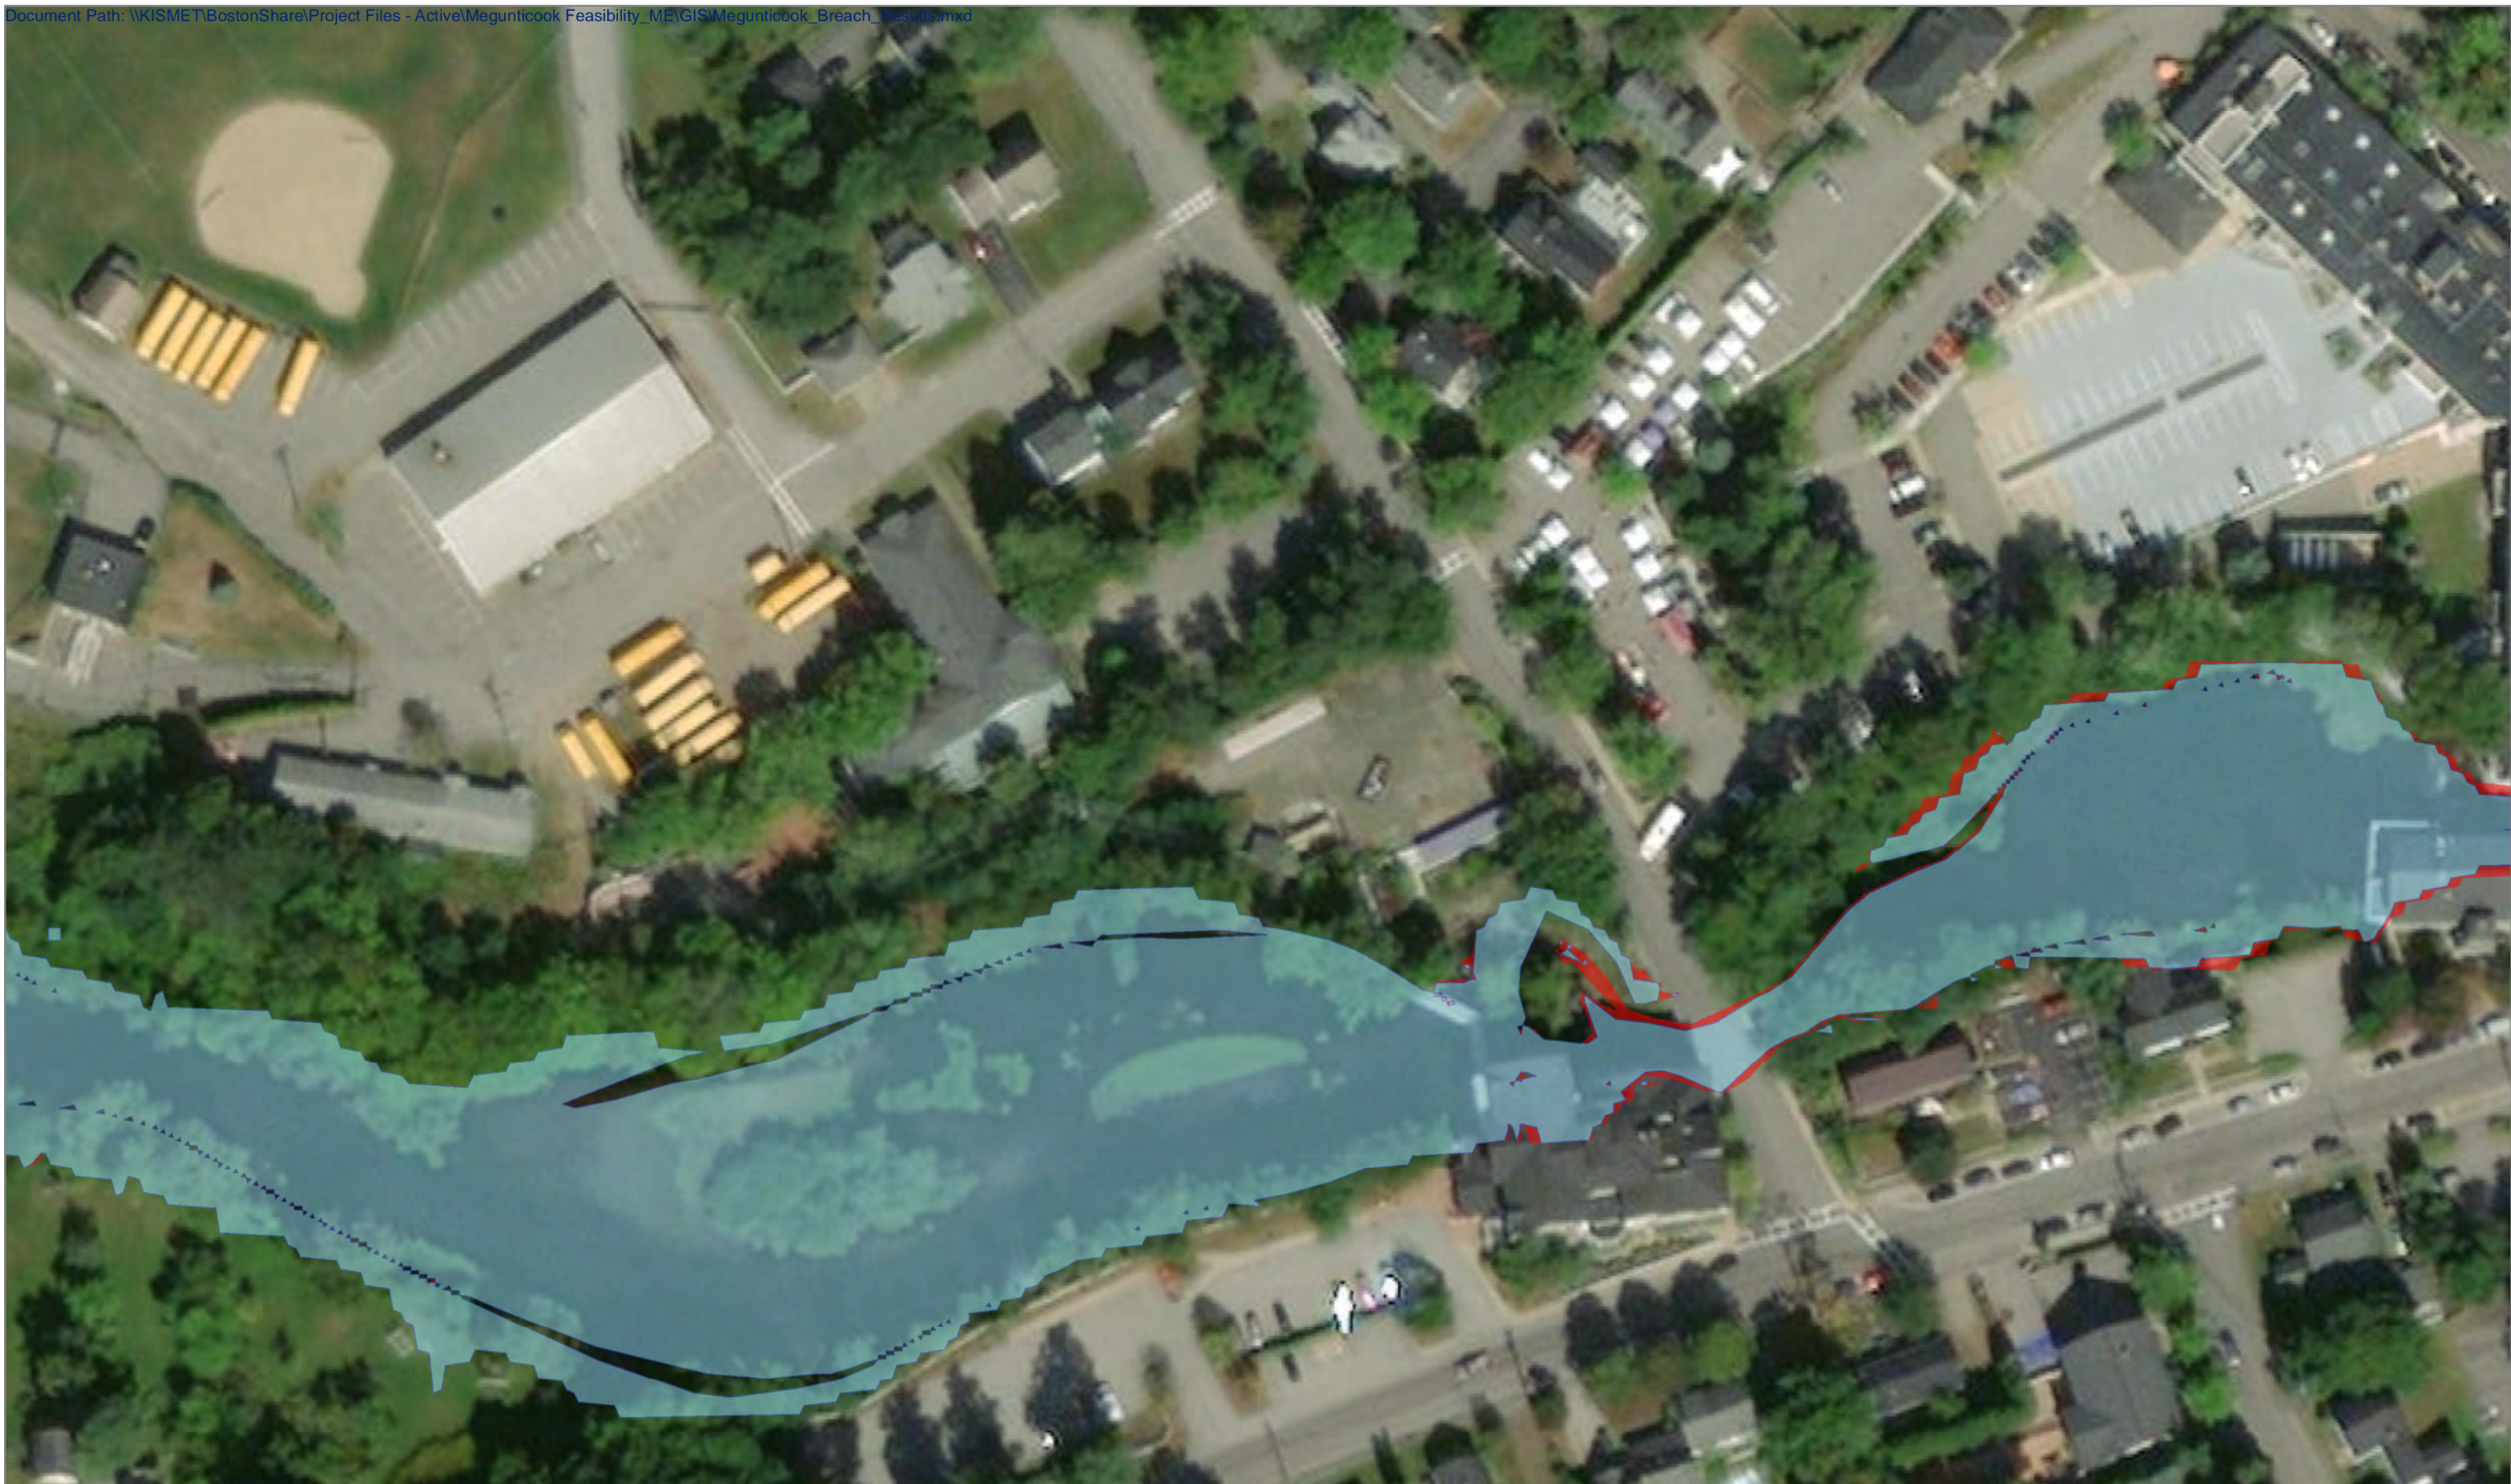
1-Year Event, Failure of Knowlton Street and Knox Mills Dams
Non-Breach Inundation Area
Incremental Impact of Dam Failure

- The breach wave will remain within the channel (Figure 10, Figure 11, Figure 12).
- The breach wave will not cause the water surface profile to rise more than 2 feet at any point along the river (Figure 4, Figure 5, Figure 6).

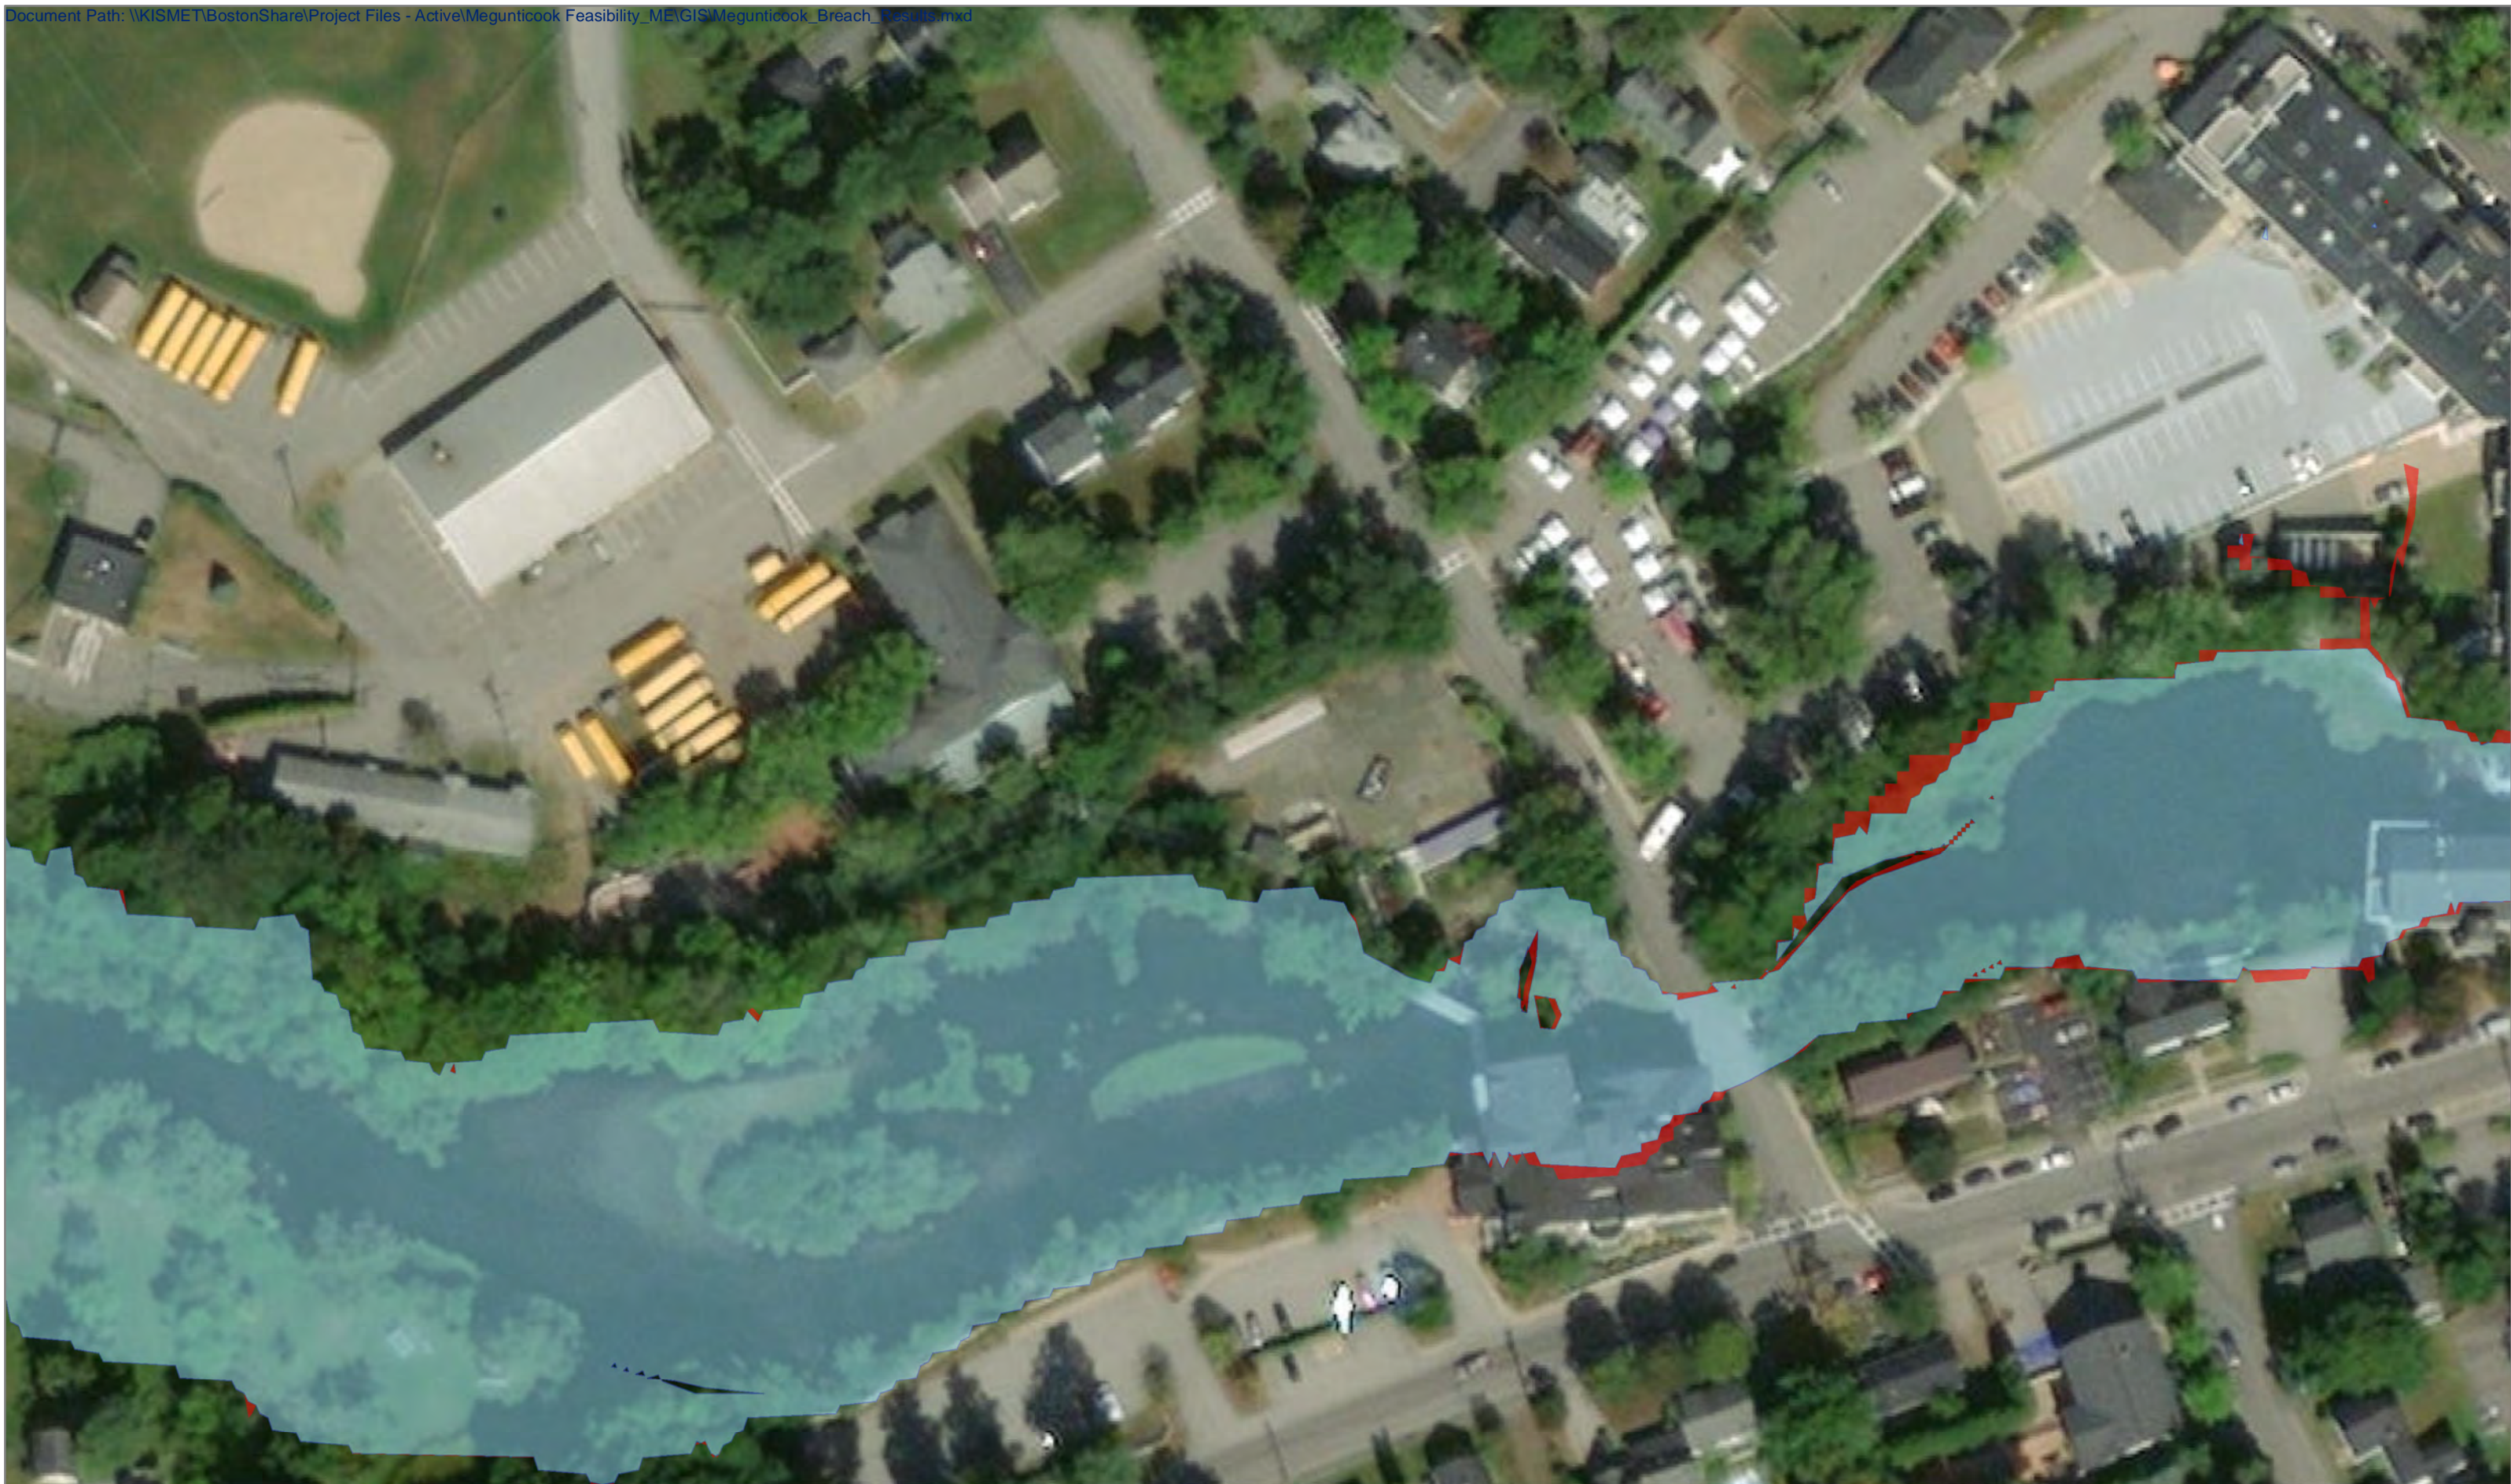
Figure 13

100-Year Event, Failure of Knowlton Dam

100-Year Event, Failure of Knowlton Dam
Inundation Area
Impact of the Dam Breach

- The flood profile does not remain within the channel, the breach wave increases the footprint of the inundated areas (Figure 13, Figure 14, Figure 15).

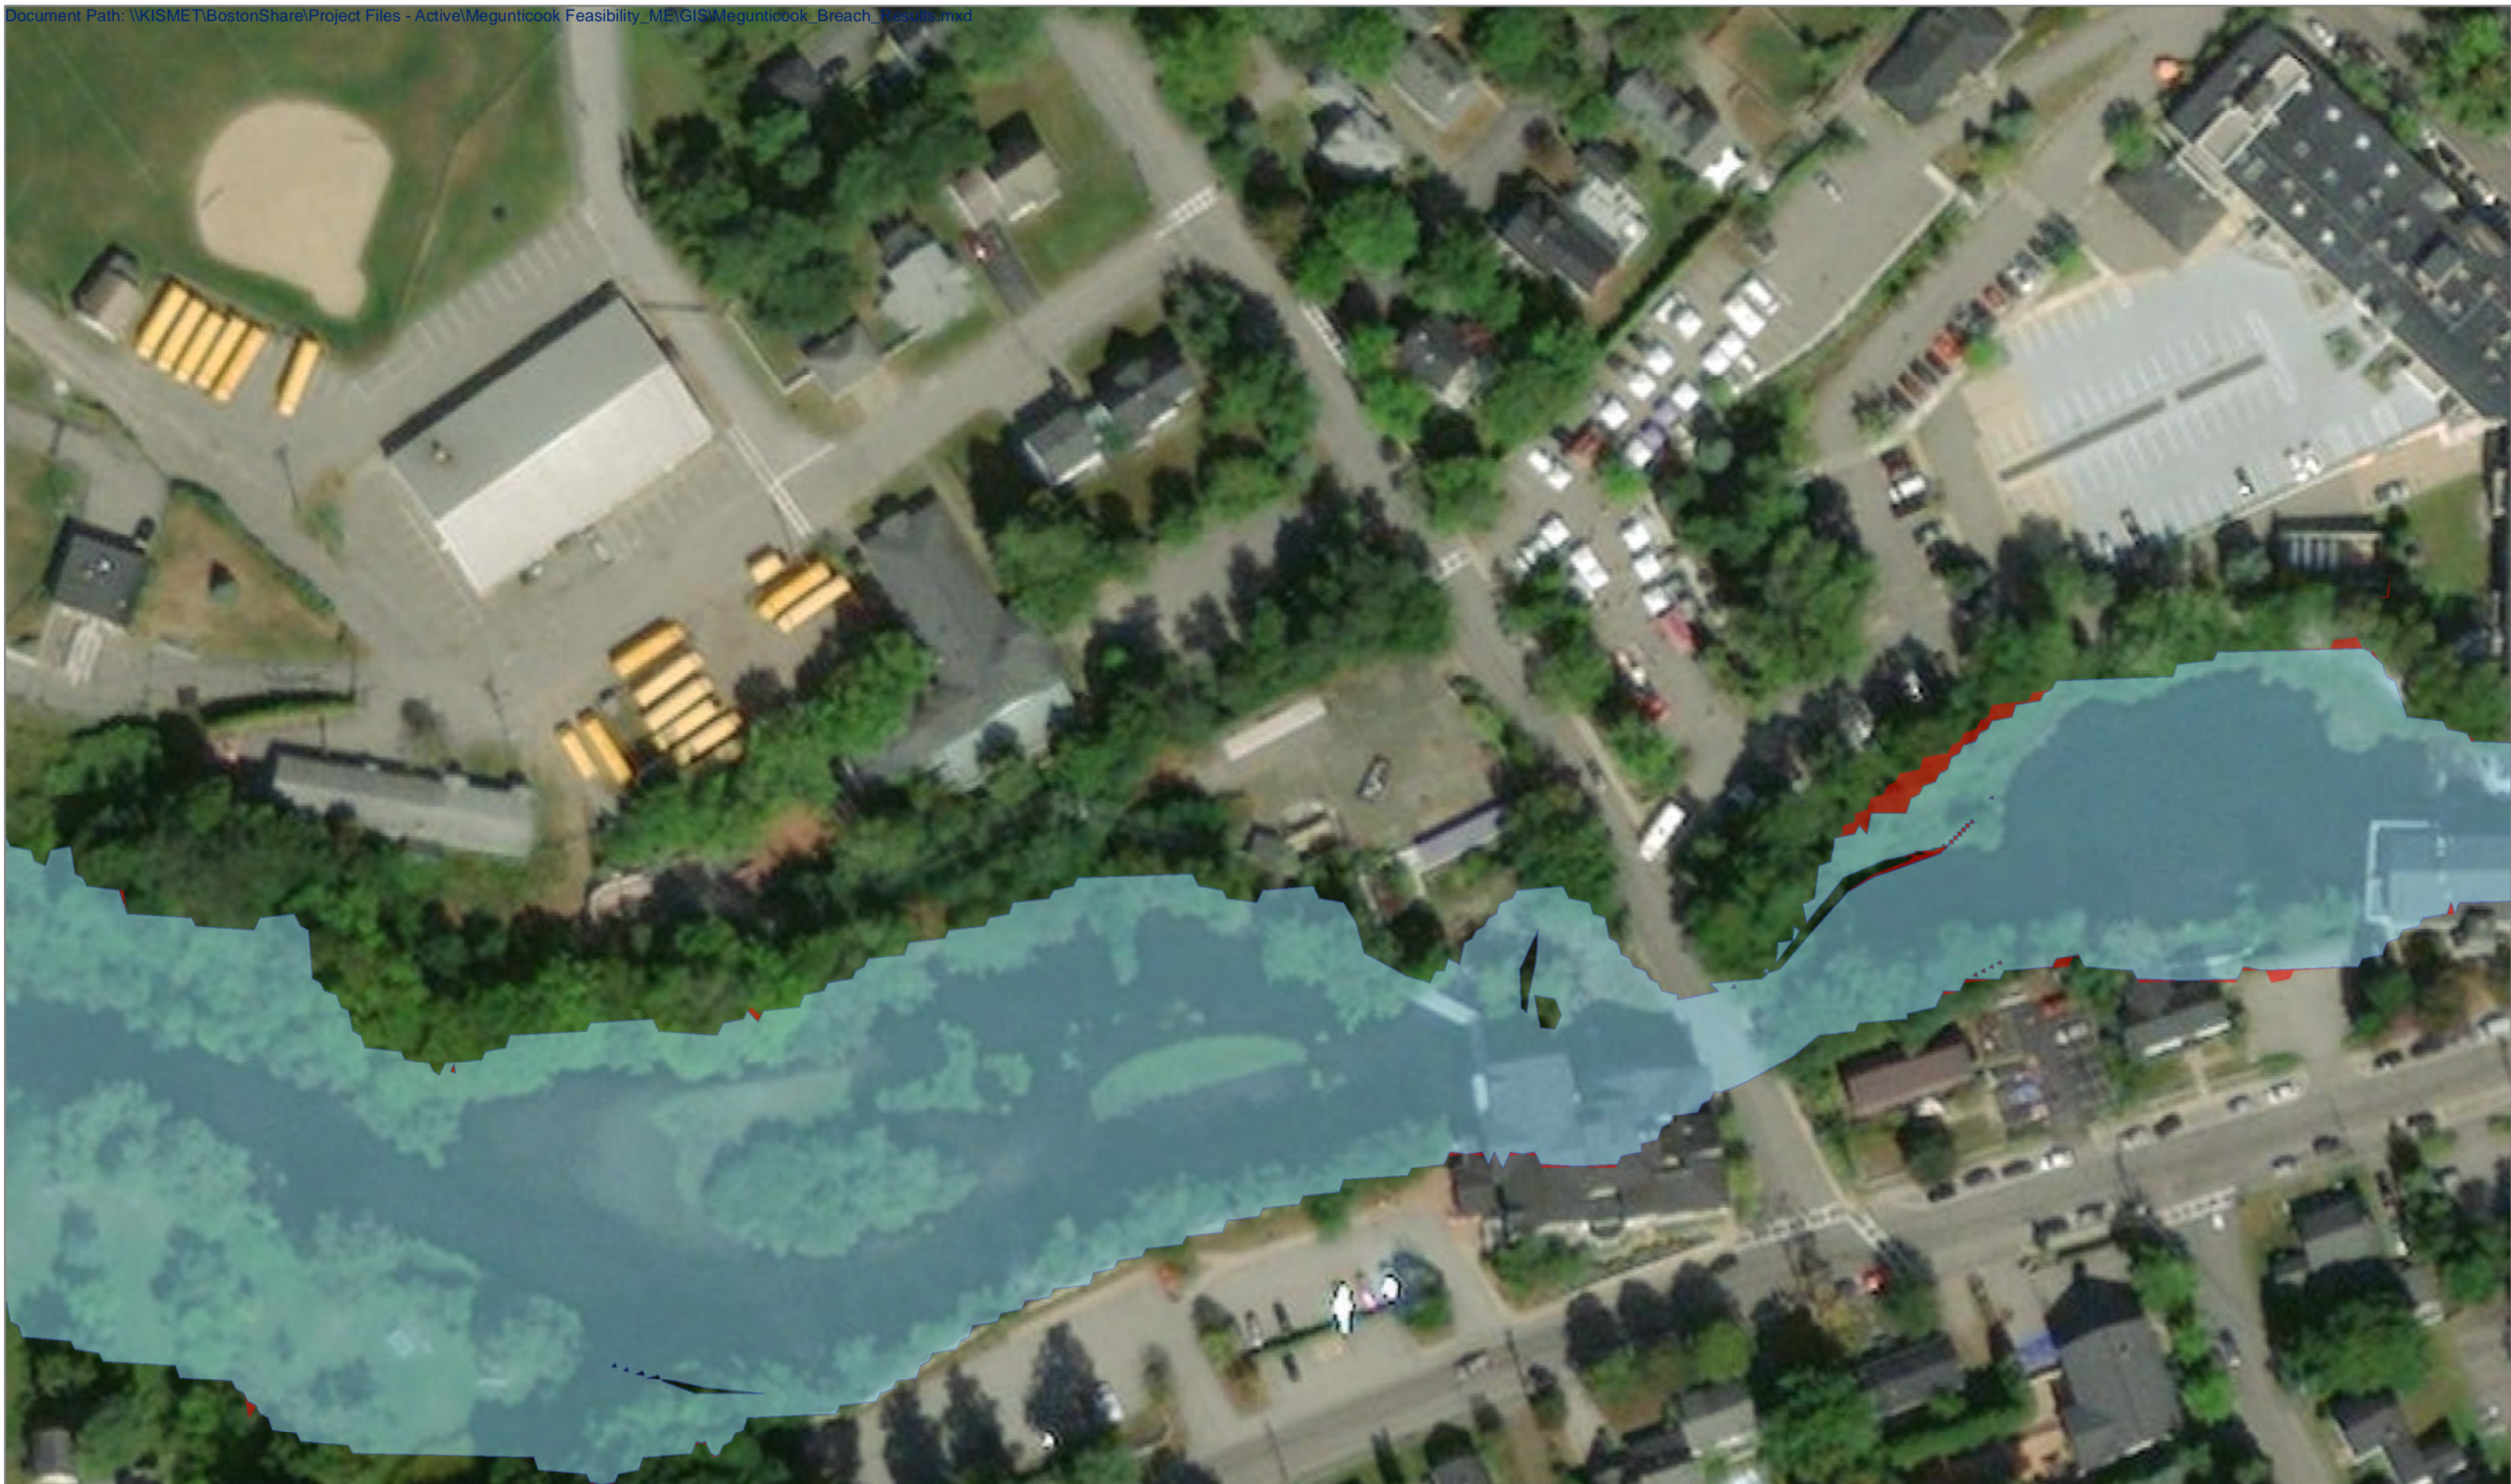
Figure 14

100-Year Event, Failure of Knox Dam

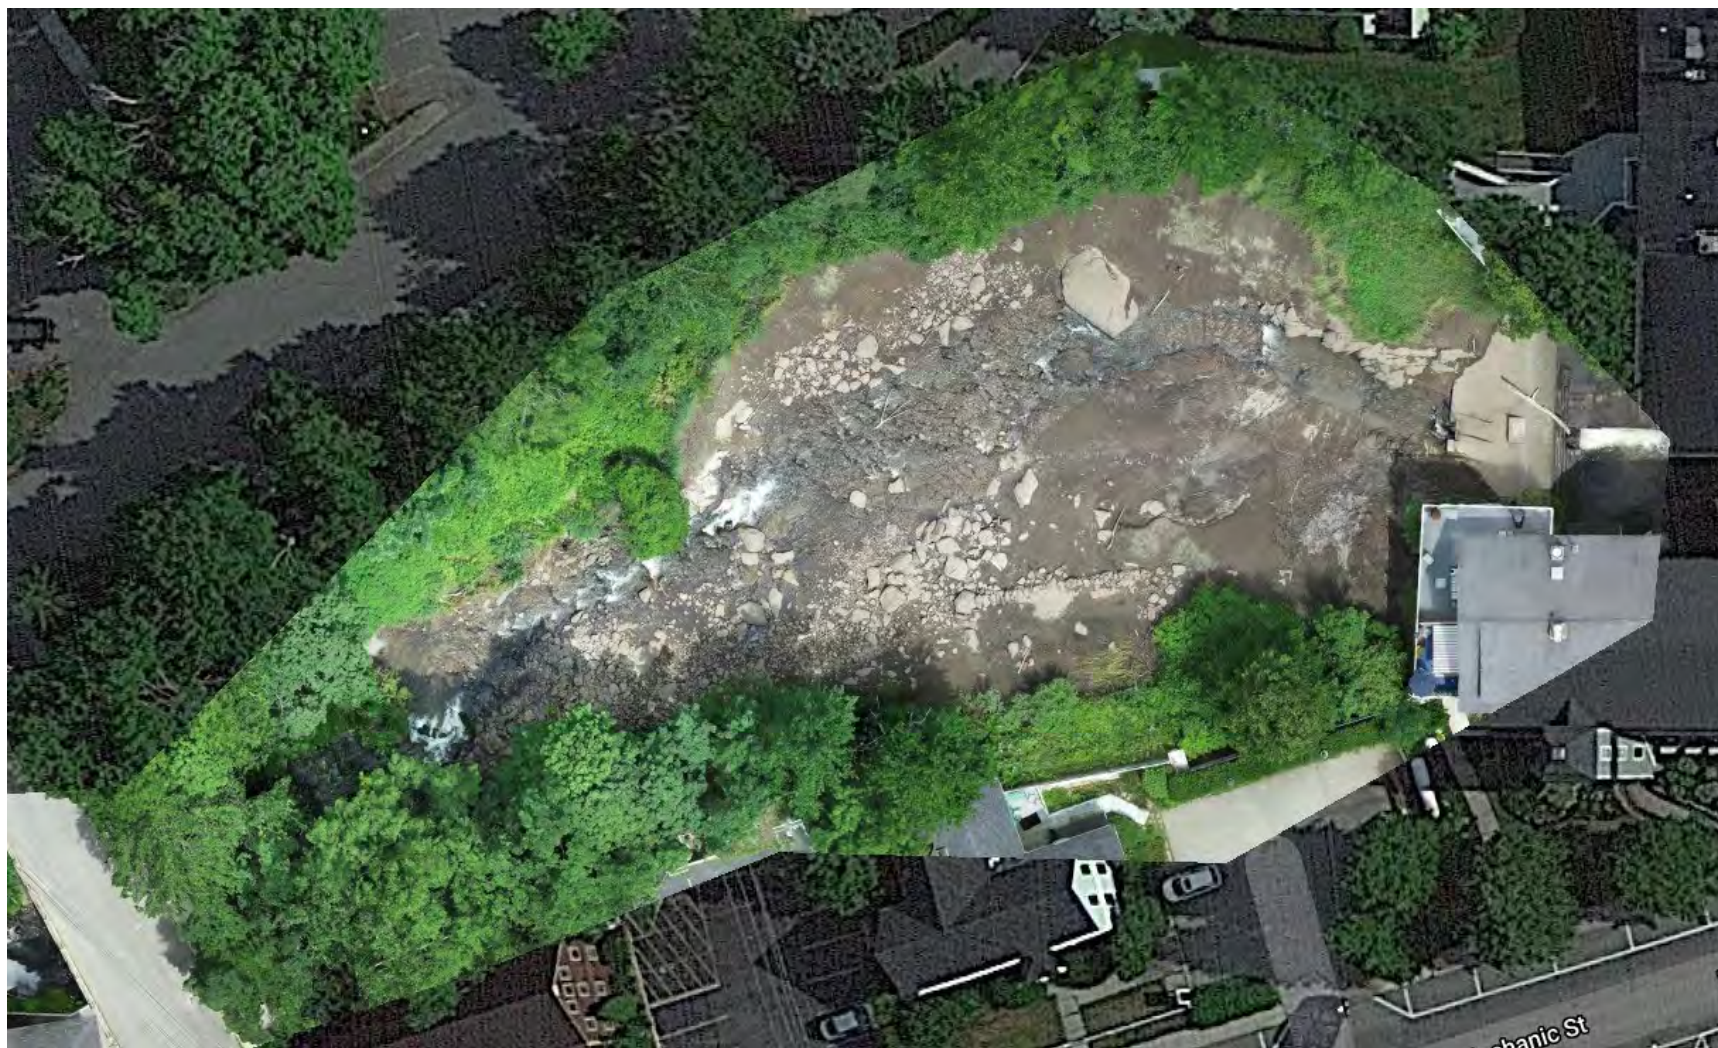
Figure 104. Drone image of the Knox Mill dam site during draw down, July 2020.

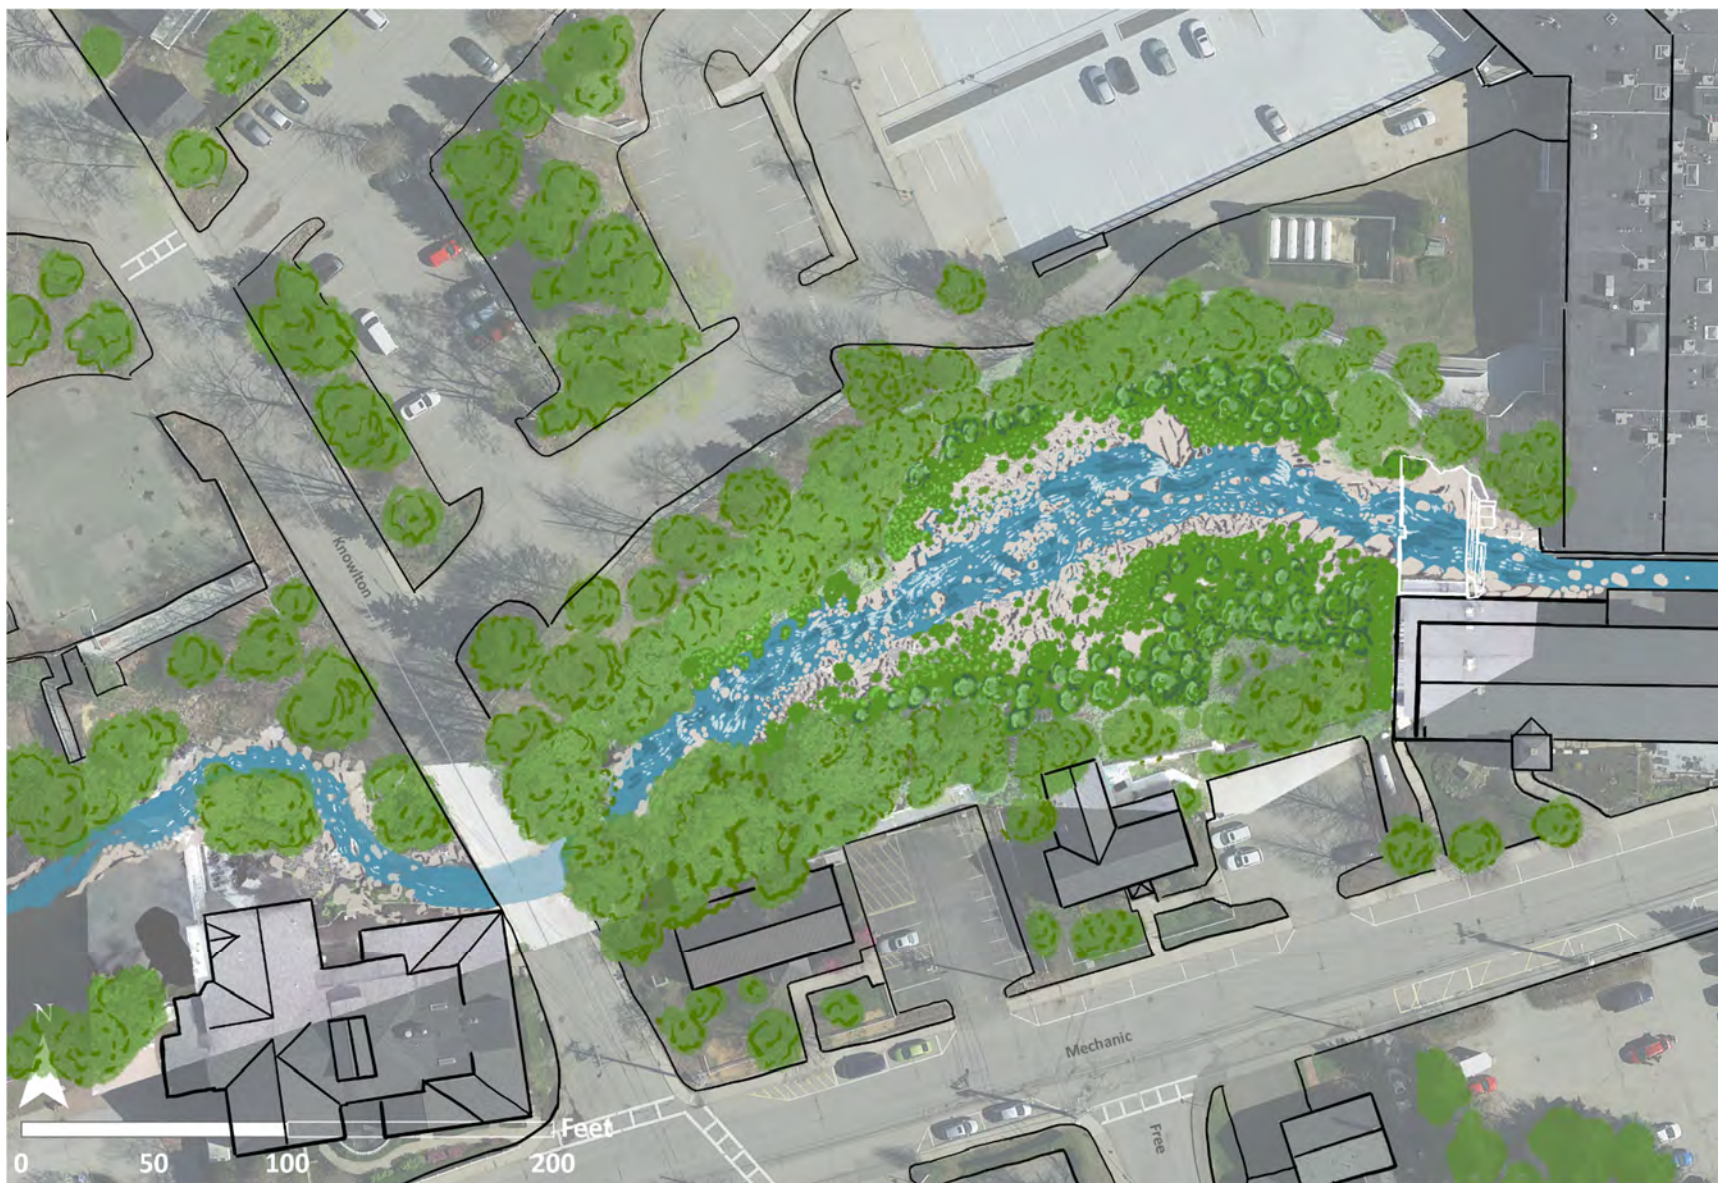
Figure 105. Plan rendering of the long-term conditions of the Knox Mill dam site following dam removal.

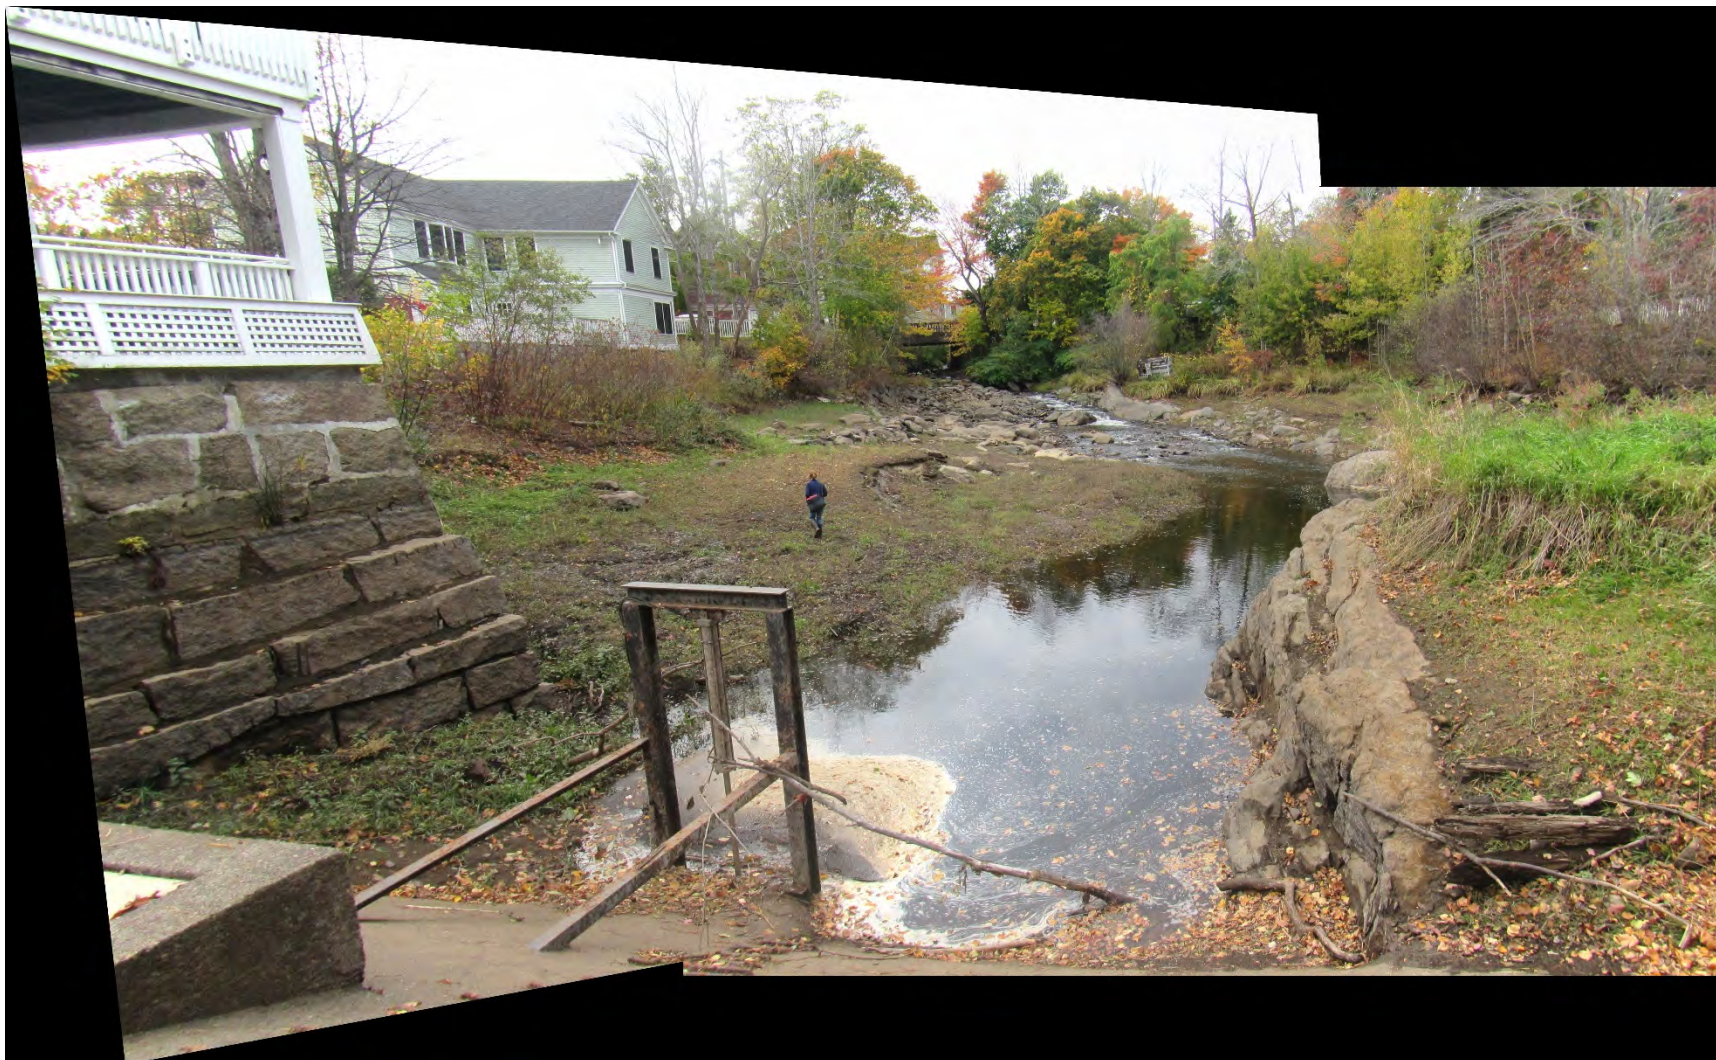
Figure 106. Ground-level composite image of the Knox Mill dam site during draw down, July 2020.

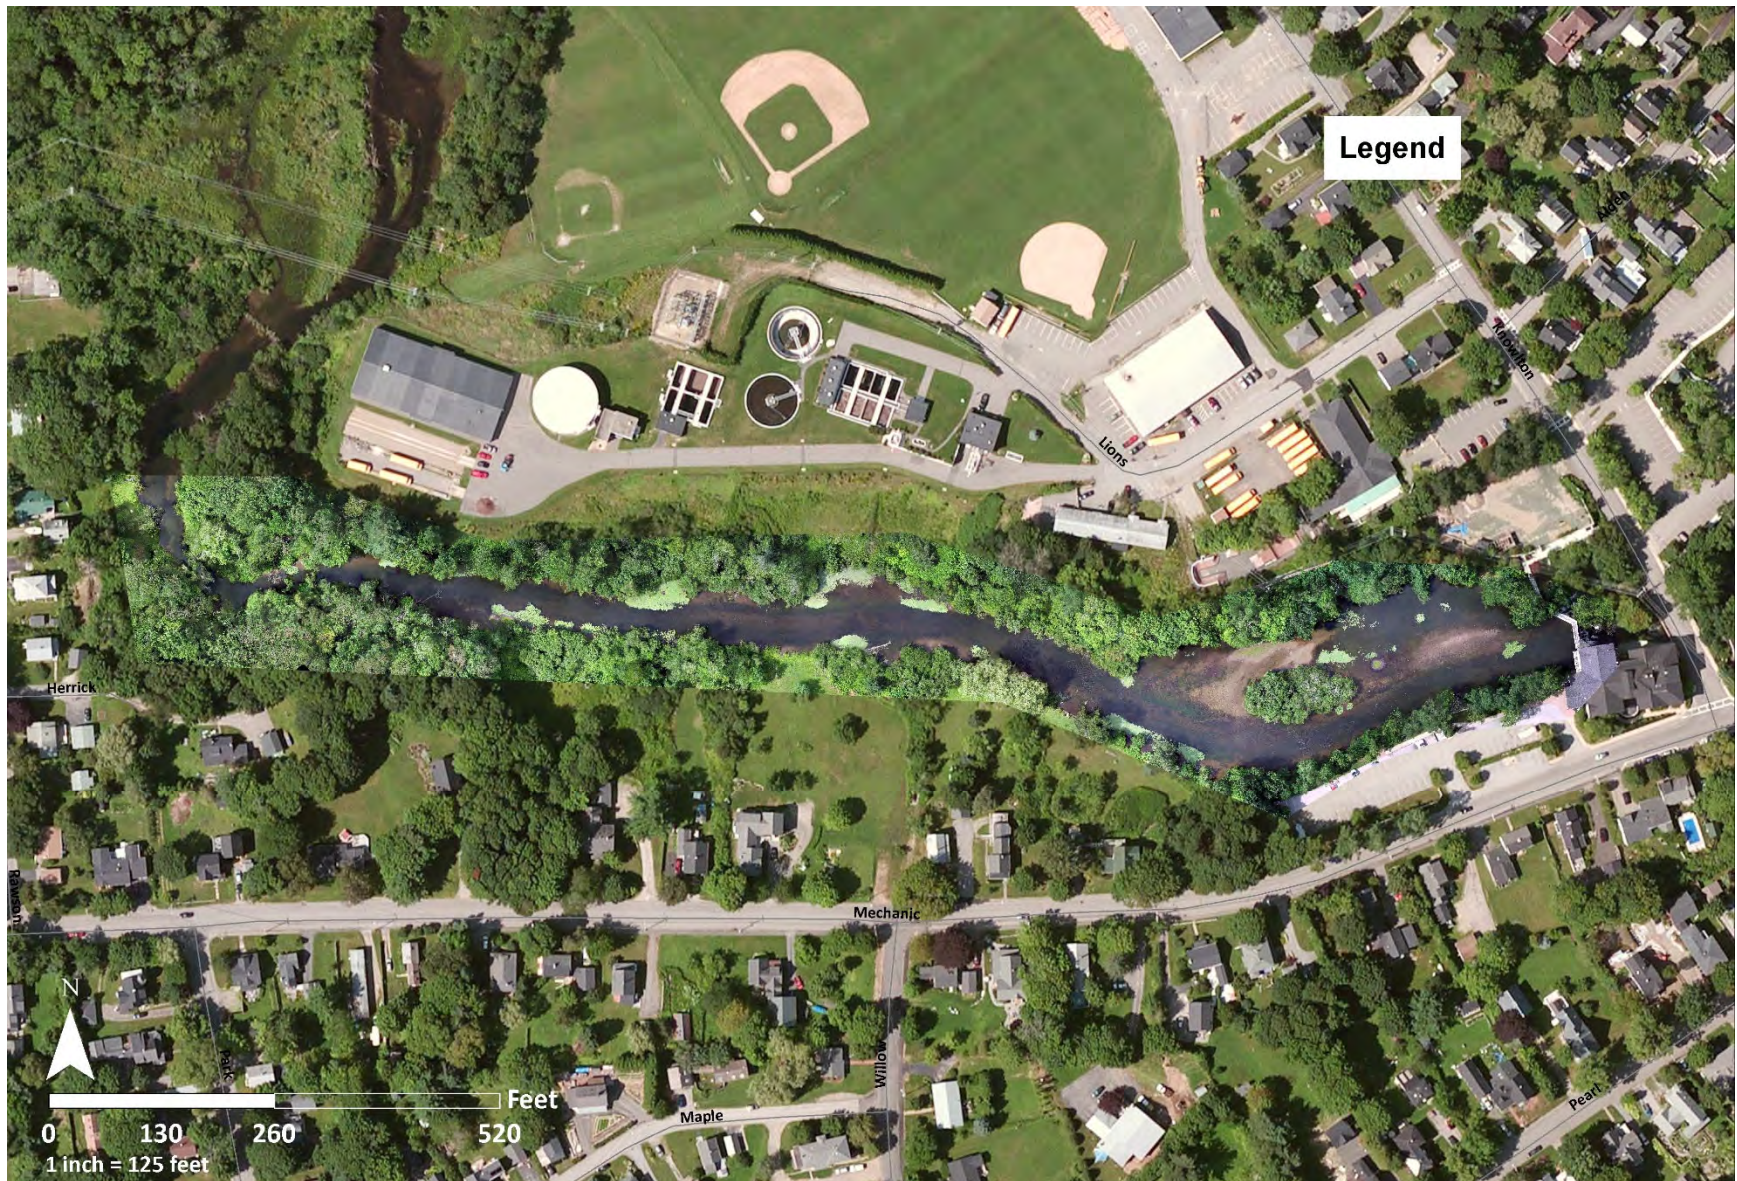
Figure 108. Drone image of the Knowlton Street dam site during draw down, July 2020.
