Megunticook River Feasibility Report

Camden, ME

July 31, 2021

Town of Camden,
Maine

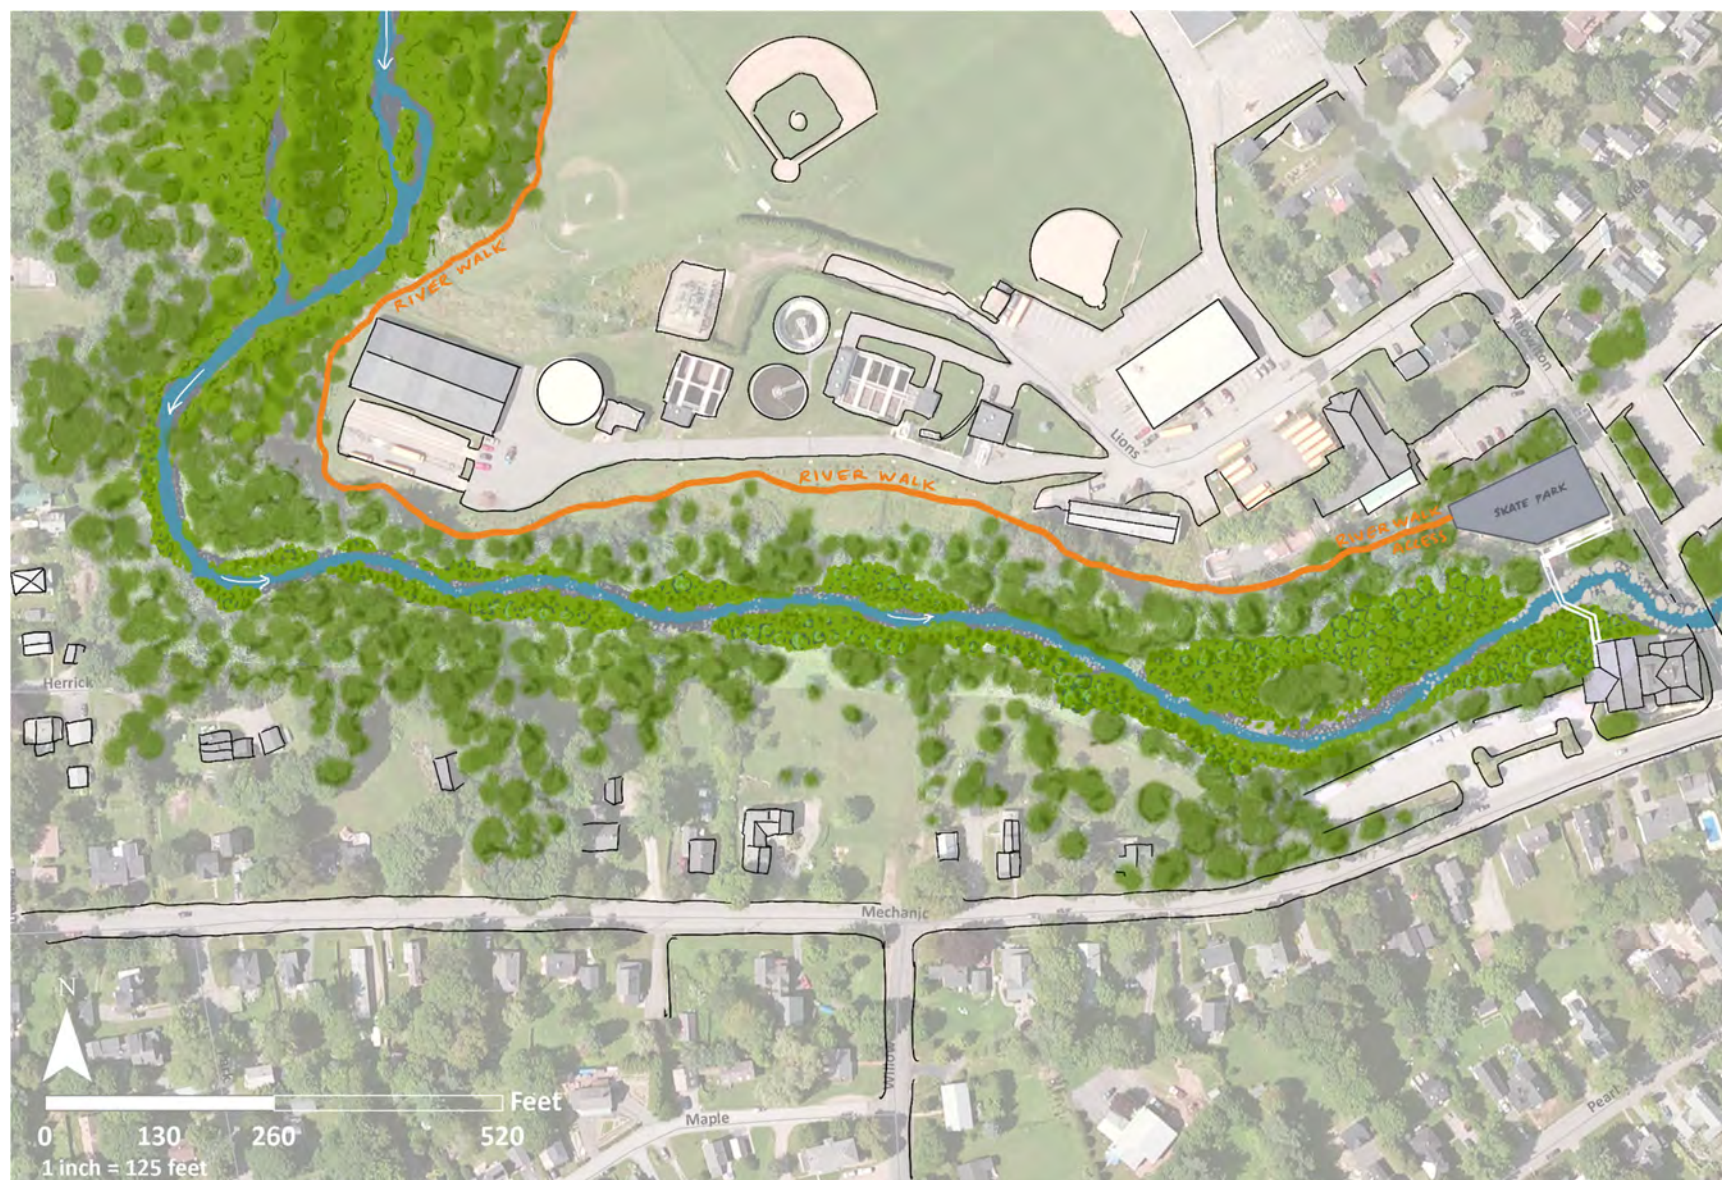
Figure 109. Plan rendering of the long-term conditions at the Knowlton Street dam site following dam removal.

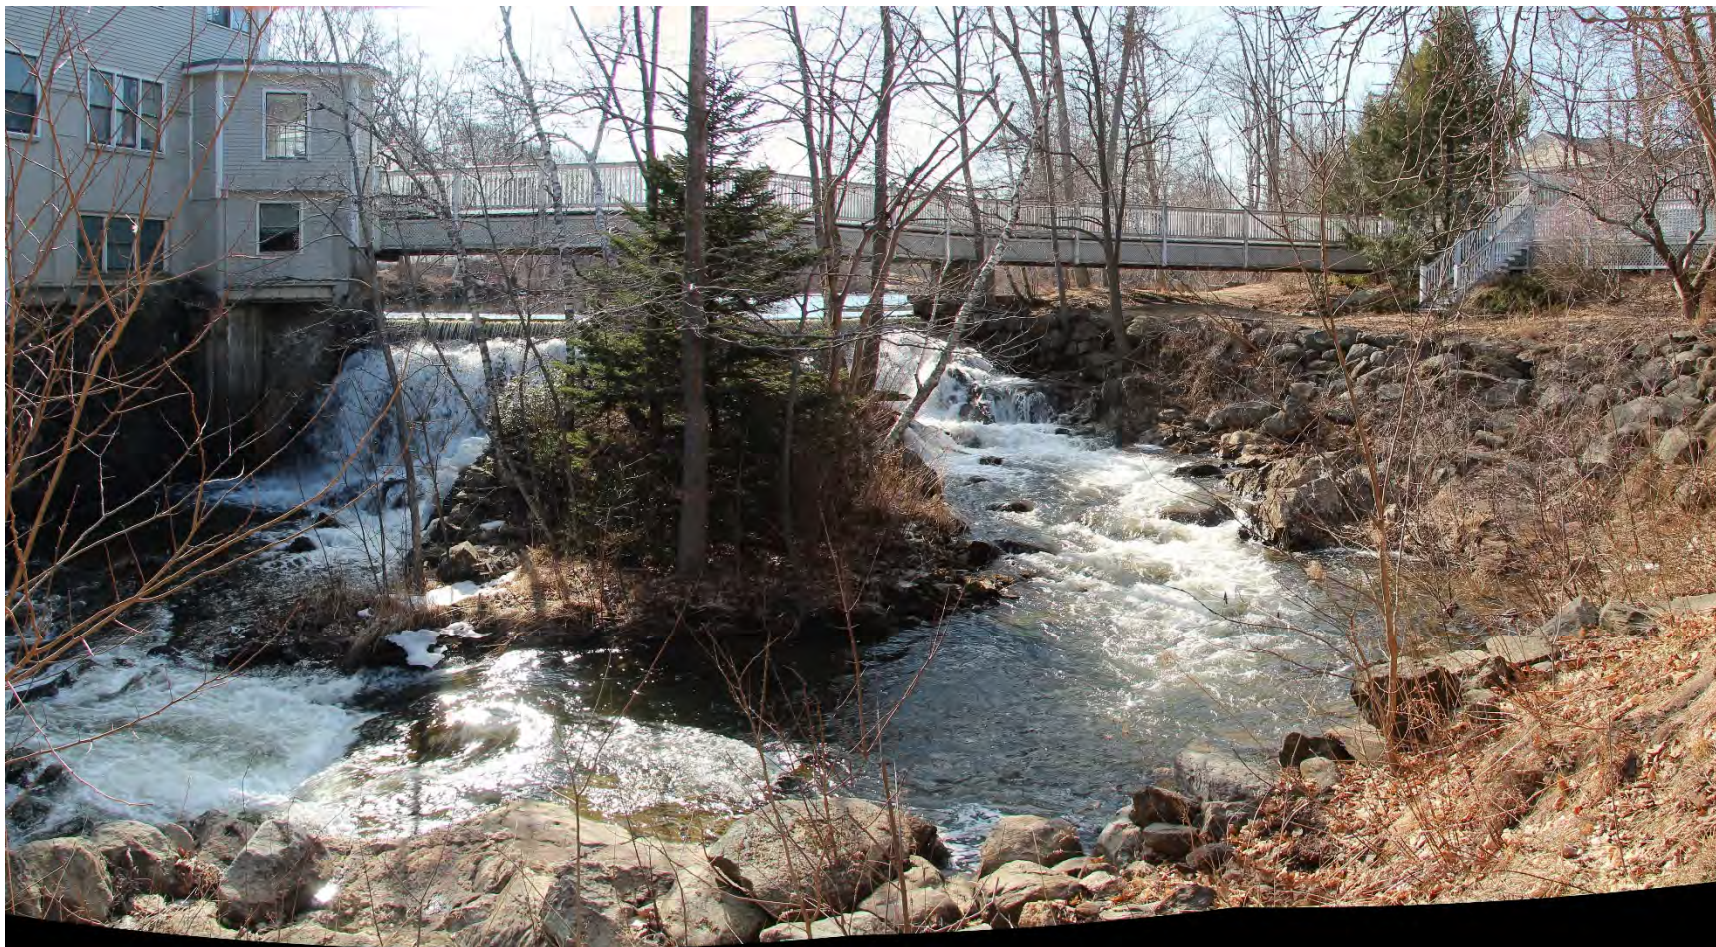
Figure 110. Ground-level composite image of the Knowlton Street dam site, March 2021.

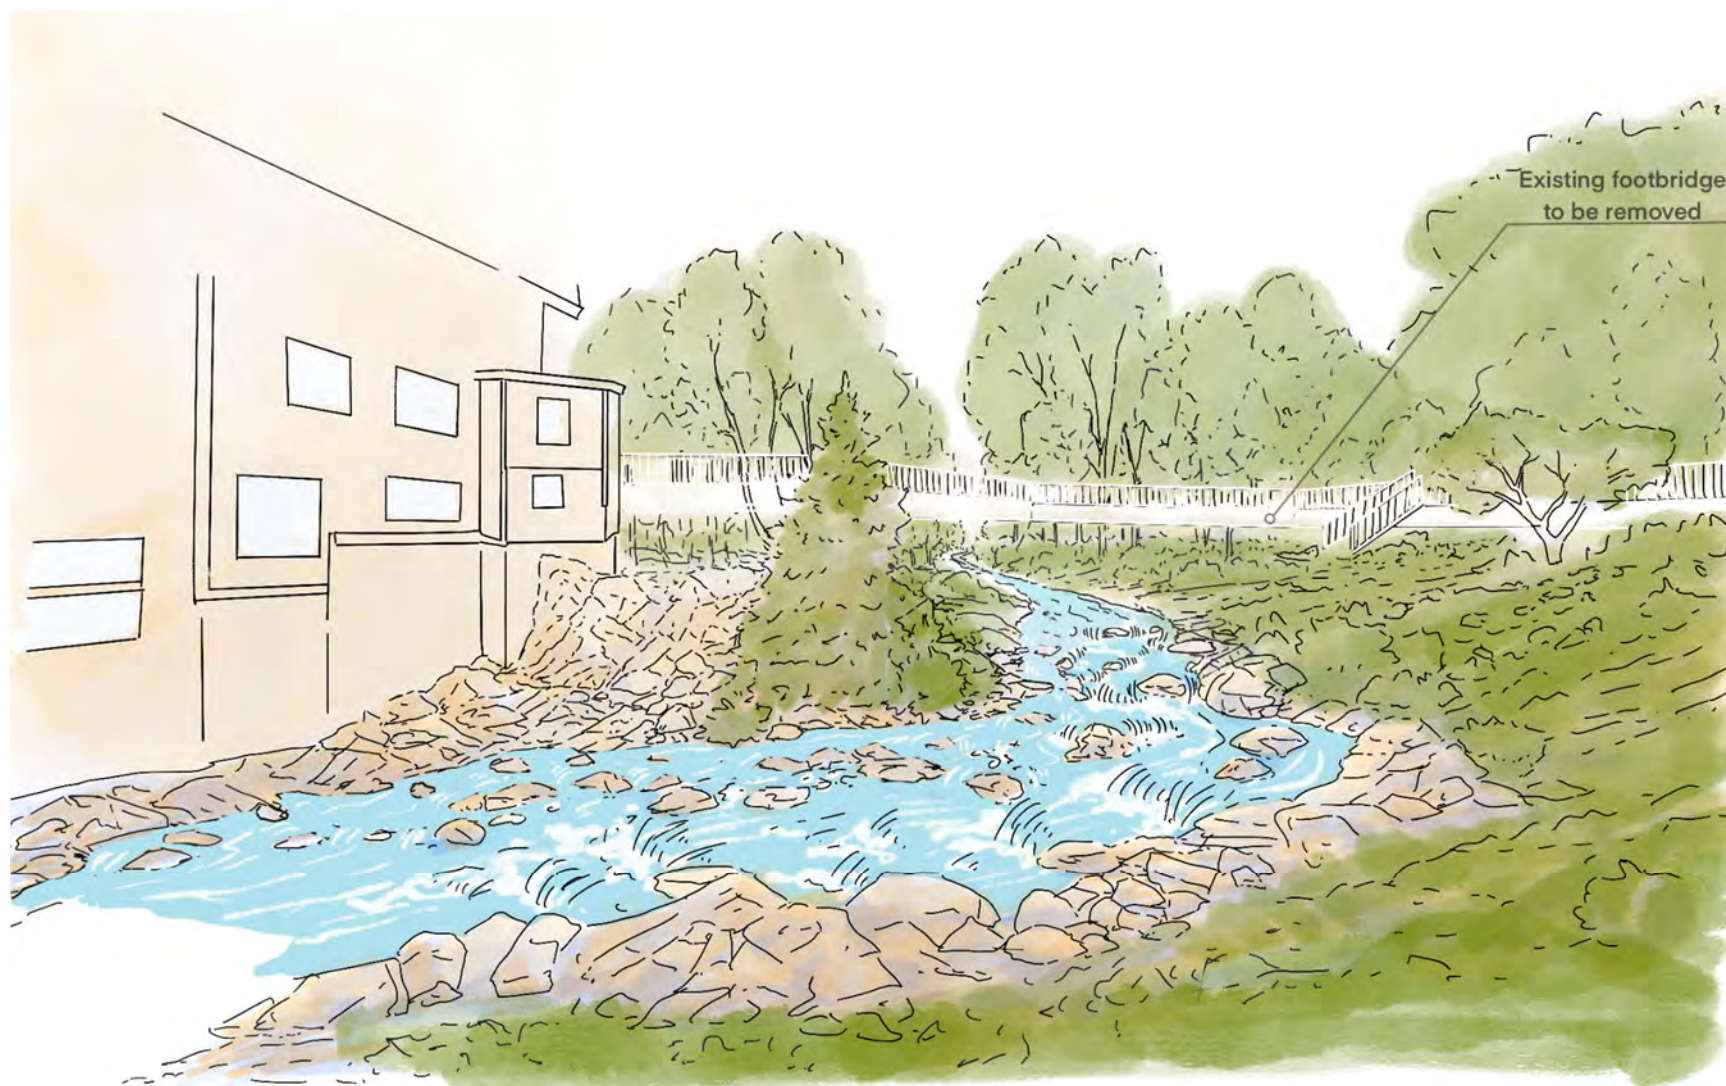
Figure 111. Ground-level rendering of the long-term conditions at the Knowlton Street dam site following dam removal, looking upstream from the dam location.
